BRIDGE MAINTENANCE CAPACITY BUILDING IN ZAMBIA

BRIDGE ROUTINE MAINTENANCE GUIDELINES

2024

**Road Development Agency
Japan International Cooperation Agency**

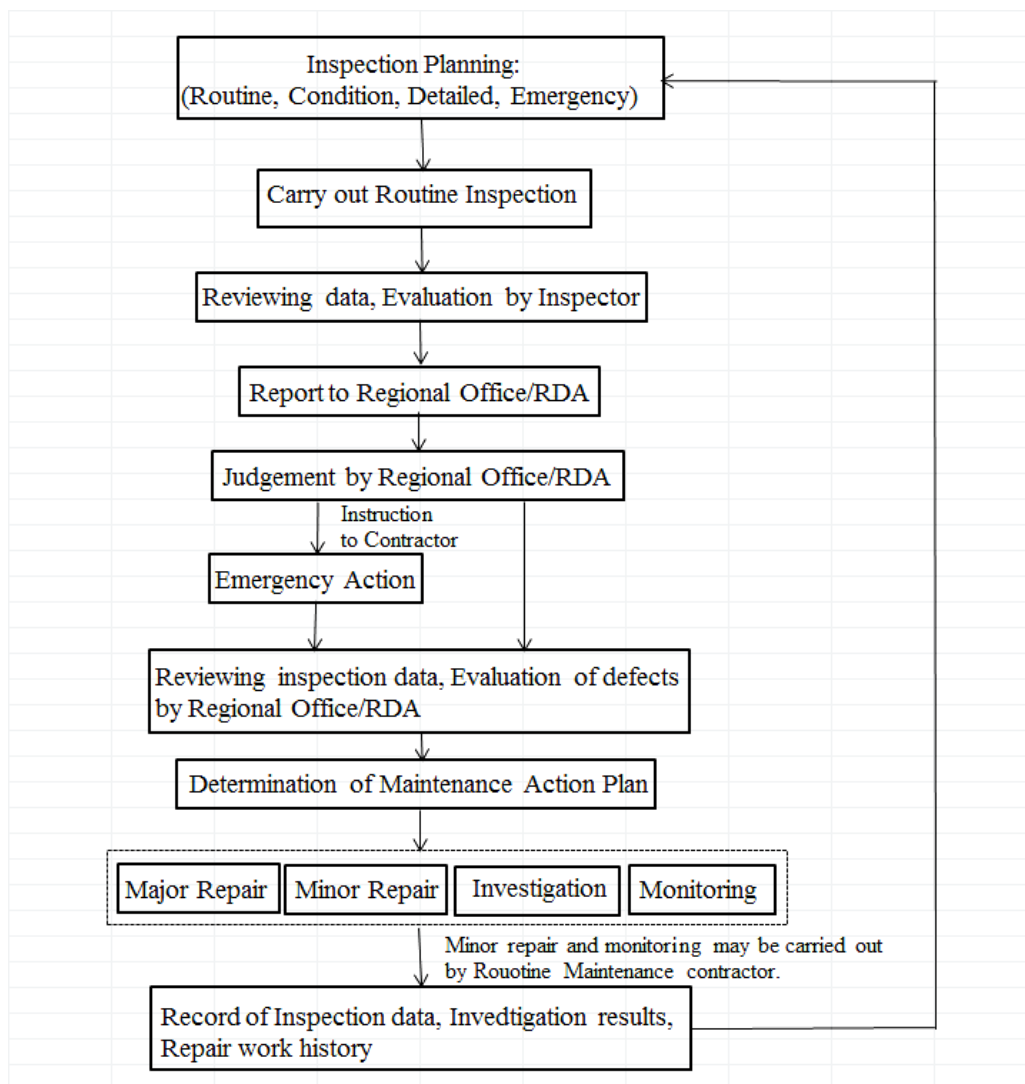
Figure 2-1 Routine Inspection Process

The process for conducting Routine Inspection is shown in Figure 2-1.

The procedure in accomplishing the Routine Inspection Forms and sketches is straightforward and involves visual inspection. The Routine Inspection Forms and is shown in Table 2-4. A copy of the previous Routine Inspection report should be brought to the site as reference. The bridge inspector of contractor, responsible for bridge routine maintenance, should review that the defects, actions and condition ratings for the bridge as listed in the previous inspection reports are accurate and without oversight. The contractor's inspector should check the defects and draw them on sketch drawings sheet, as needed, and photographs should be used to document any major defects or situations concerned. Upon returning to the office, the inspectors determine the Routine Inspection Condition Rating and required maintenance action plan based on the severity of defects. The result of inspection should be compiled as a deliverable and submitted to the regional offices/RDA. If there are any defects that require Emergency Action (AE), it should be reported immediately without waiting for the completion of report. Immediately judged by the regional office/RDA, the contractor will be instructed to carry out emergency repair including temporary work. The condition rating for Routine inspection and Required Maintenance Actions for each defect are shown in Table 2-1 and 2-2. Regarding inspection intervals, this routine inspection shall be in principle performed as frequently as every three months: e.g. 2 times in wet season and 2 times in dry season. In particular, the inspections related to waterways should be carried out after any significant storm events.

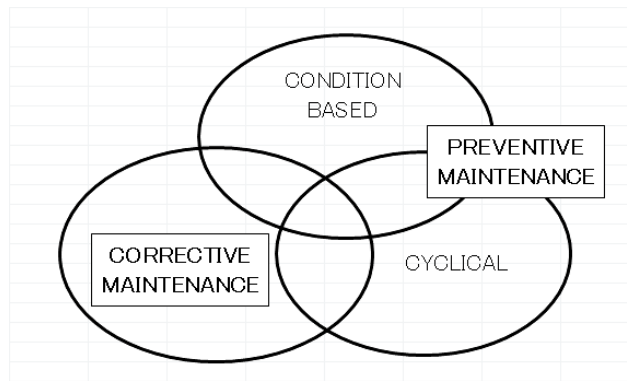
Figure 3-1 Treatment Categories

Despite even the most progressive preventive maintenance program, some deterioration or damage of elements will occur. To repair typical deterioration or damages, including damages from natural disasters and vehicle hitting, the corrective activities that can be performed in Routine Maintenance are as follows:

- Joint sealing;
- Patching on concrete members;
- Deck repair;
- Rail repair;
- Curb/sidewalk repair.

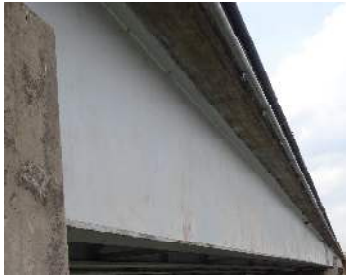
| Location | Defects | Photography | Causes/Measure |
|---|---|--|--|
| Steel Superstructure | Paint Peel-off | | Pinpoint rusting can occur at pinholes in the paint, which are tiny, deep holes in the paint exposing the steel. It can also be caused by thin paint coverage. Measure: Touch-up/Re- Painting |

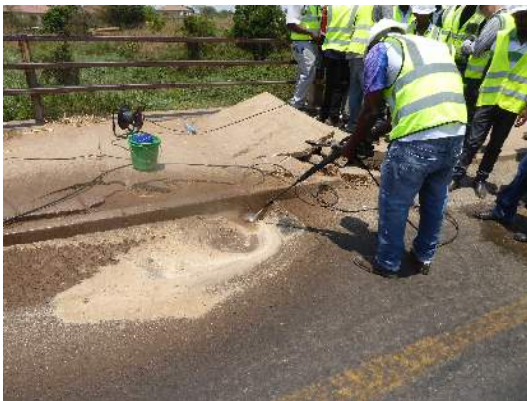
Photo 4-7 Cleaning of the Deck Slab and Its Drainage Inlet

All foreign materials such as dirt, dust, sand, rainwater and moss on concrete surfaces and at the gaps between girders shall also be completely removed manually and then washed using a high-pressure water bluster. The following areas on the deck should also be carefully cleaned:

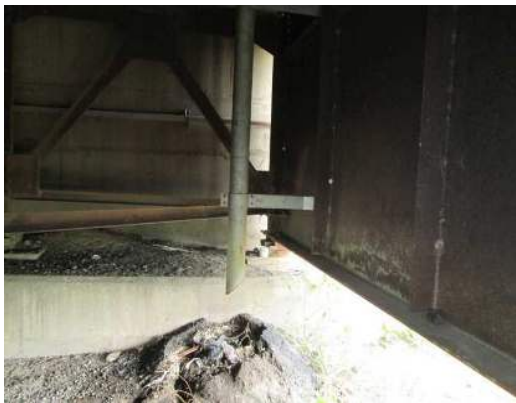
Photo 4-9 Accumulated dirt around abutment may hamper the drainage

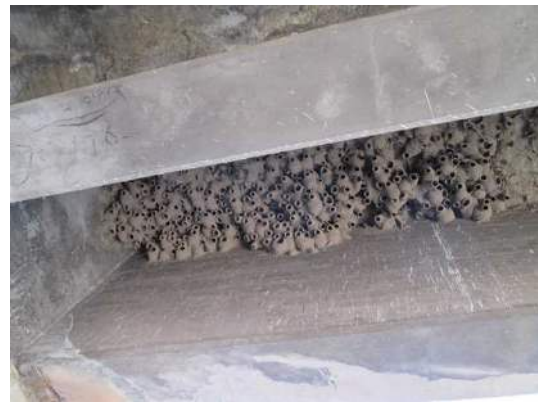
Photo 4-10 Nest and dropping of birds is a problem for bridge maintenance

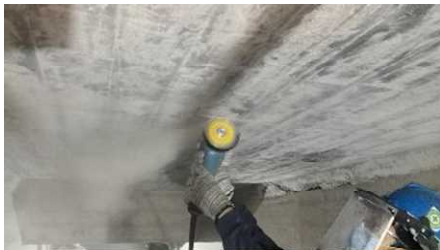
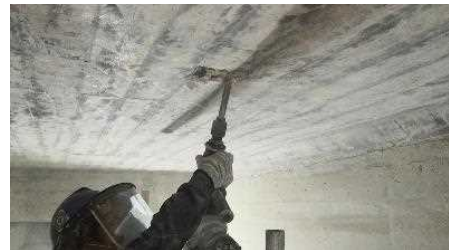
Cutting of spalled area using a grinder.

If the reinforcement is covered with loose corrosion elements and has developed pits, all the rust should be removed by power tools or wire brushing. Protection to the reinforcement can be provided by the use of zinc-rich epoxy primer.

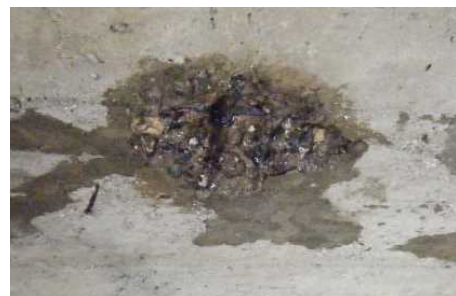
The bonding surface should be thoroughly saturated to provide a saturated surface dry condition prior to placing mortar. Epoxy bonding agents can be applied in order to bond firmly, as needed.

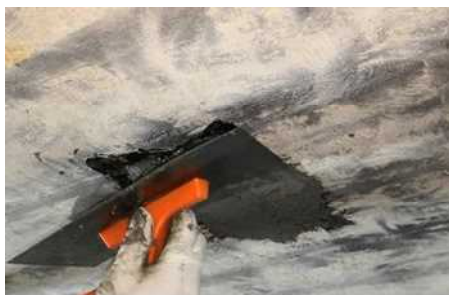
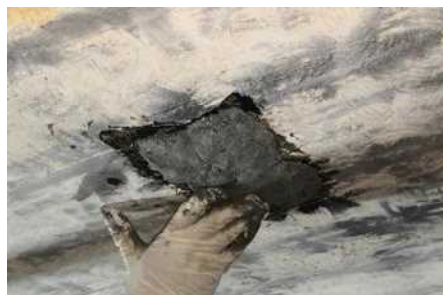
- Hand-mix the emulsion and water for two (2) minutes.
- Put the mixed emulsion and water into the Pail and then add Polymer Cement Mortar. The mixture should be hand-mixed for two (2) minutes as well.

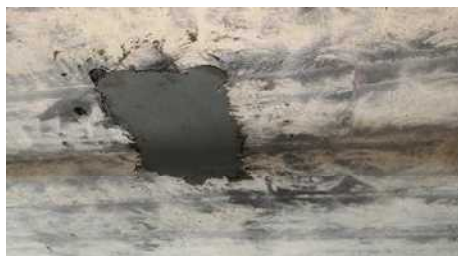
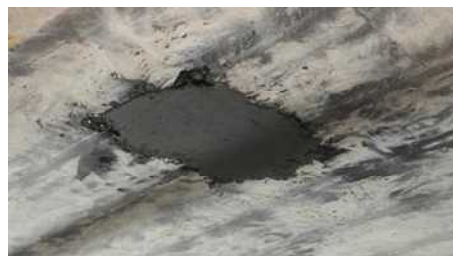
All types of cement repairs need thorough and continuous curing to develop strength and impermeability, and to minimize drying shrinkage while bond strength is developing. For initial curing, the surface should be covered with plastic against direct sun and wind and a waterproof coating can be applied for further protection.

Let the polymer cement mortar cure for 5 hours.

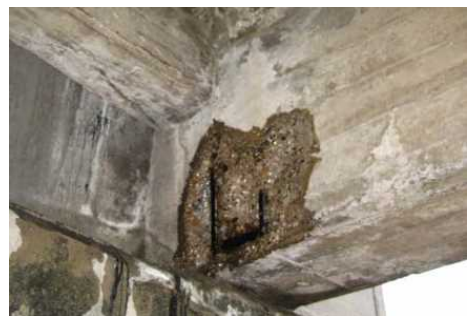
Remove loose particles and dust using high-pressure water or a vacuum cleaner. Concrete surfaces to be bonded have to be free from dirt, oil, grease, and asphalt. Corrosion has to be removed before placing the new concrete. If the reinforcement is covered with loose corrosion elements and has developed pits, all the rust should be removed by power tools or wire brushing.

Protection to the reinforcement can be provided by the use of zinc-rich epoxy primer.

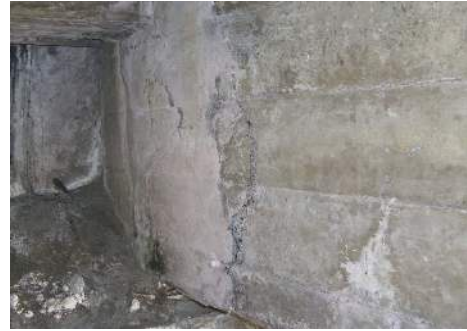
All types of cement repairs need thorough and continuous curing to develop strength and impermeability, and to minimize drying shrinkage while bond strength is developing. For initial curing, the surface should be covered with plastic against direct sun and wind and a waterproof coating can be applied for further protection.

Let the polymer cement mortar cure for 5 hours.

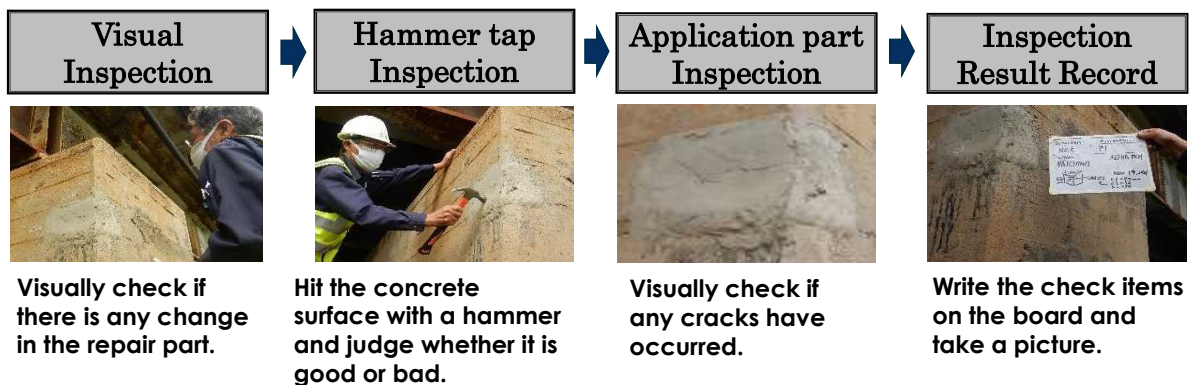
(5) Monitoring

Hammer tap inspection :

When struck with a hammer, the concrete in good condition will produce a ringing sound while the concrete that has voids, cavities etc will produce a flat or hollow sound. A good tapping waveform has a short decay time and a high-frequency distribution.

If cracks appear, it is due to the drying of the water that was mixed with Poymer Cement Mortar powder. And, if there is no delamination on the patched concrete, there is no urgent need for repair; however, if damage, such as widening of crack width, progresses in the future, repair will be required. To repair the cracked part, apply Epoxy Coating and/or Epoxy Injection to fill the grooves on the patching surface before patching with Poymer Cement Mortar.

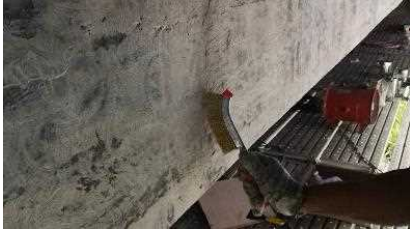
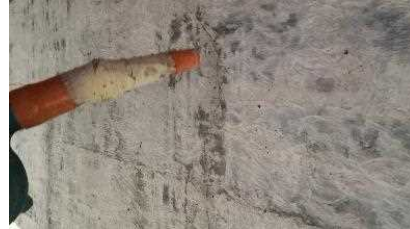
(1) Preparation of Concrete Surface

The concrete surface shall be cleared from dust, loose dirt and other foreign materials using a steel brush and vacuum/blower.

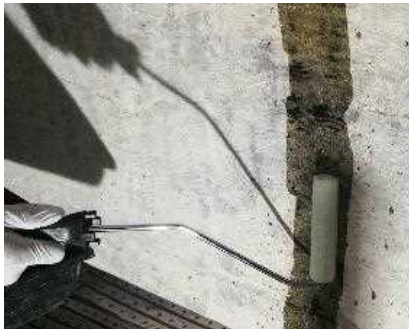
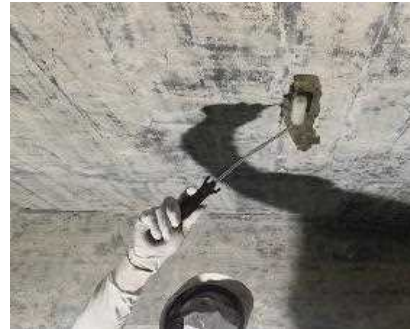
(2) Application of Epoxy Sealant

Using a 5 cm (2 inches) wide roller brush, apply the sealant to concrete cracks. If the cracks are straight, a wider roller may be used. The Epoxy Sealant starts to rise from the cracked surface right after application but eventually moves inside the crack. The speed of penetration varies depending on the crack situation.

Repeat this application about 10 times within 30 minutes. The pot life of the sealant is 30 minutes (if the temperature is at 30 °C).

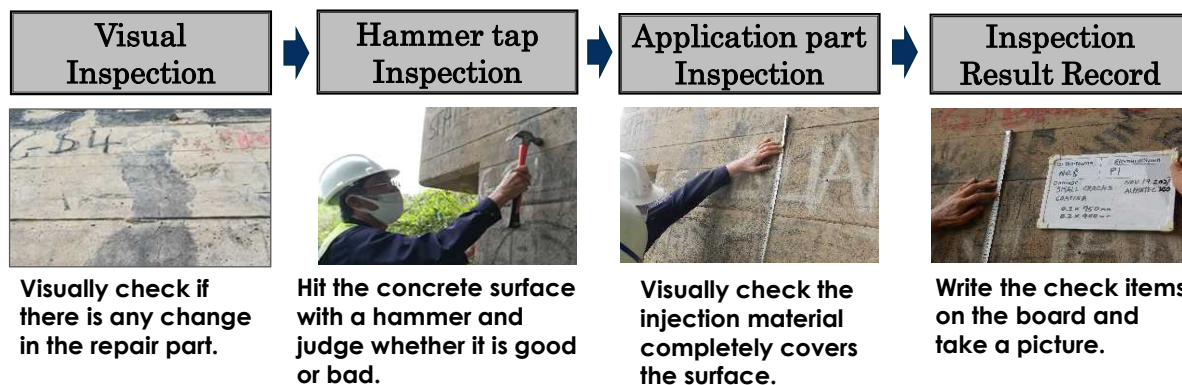
(4) Monitoring

The Crack shall be covered by Epoxy sealant completely or not.

Hammer tap inspection :

If the sealant has not penetrated the crack in the concrete, it is recommended that you apply it 7 to 10 times with a roller, and then fill the cracked groove with a spatula when it begins to harden in about 60 minutes. It appears to have penetrated immediately after about ten applications, but it requires several more applications to fill the crack groove.

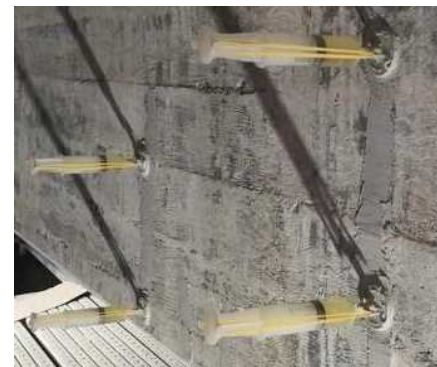
Figure 4-8 Crack Injection Method

(After Injection)

This method involves crack repairs to concrete structures, particularly to deck slabs as shown in Figure 4-8. The works include the preparation of the concrete surface, insertion of pipe fittings bonded with adhesive, injection of epoxy, curing and conducting performance tests. Epoxy injection for concrete cracks requires a highly skilled process and its effectiveness depends mostly on the proficiency of the certified applicator. The said person should be qualified based on his previous work records, and approved by the Engineer.

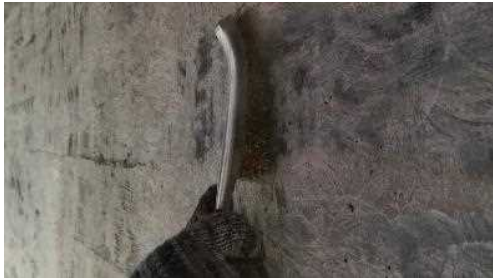
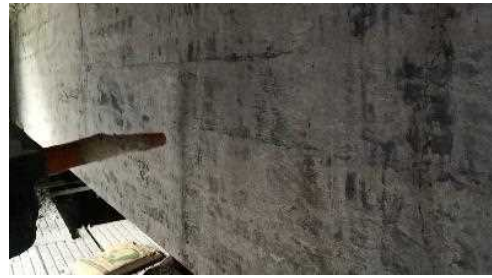
(1) Cleaning of Cracks

All loose debris such as dirt, concrete fine particles and contaminants (oil, grease, etc.) should be removed from the cracks using high-pressure water, or a special and effective solvent. Remove the residual water or solvent in the crack with filtered (dust and oil-free) compressed air and allow adequate time for drying.

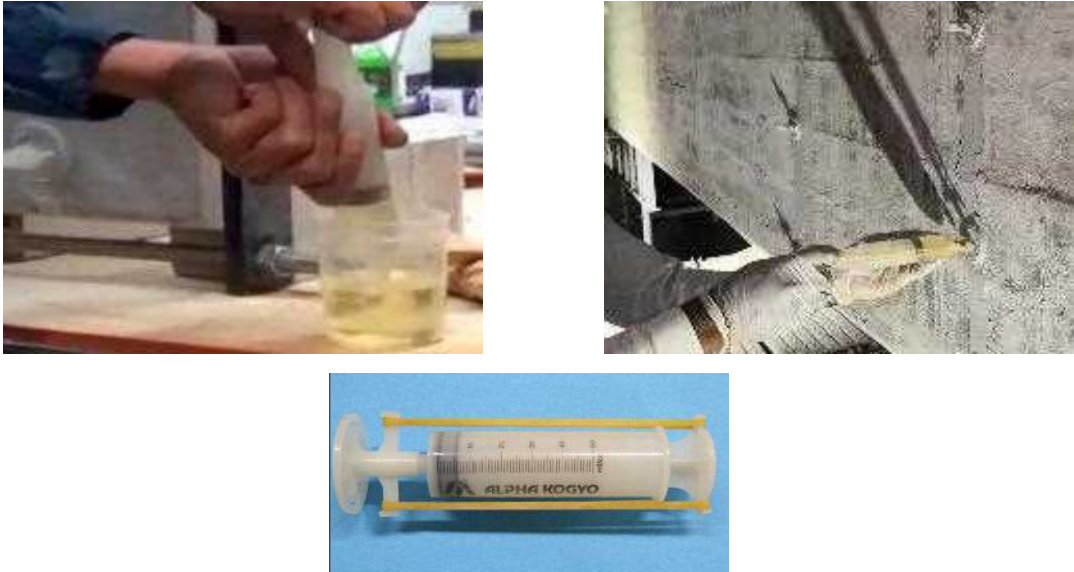
Figure 4-9 Crack Injection Method

(4) Injection of Epoxy

Epoxy shall be injected using Cylinders as shown below. Duration of the injection operation shall be in accordance with the supplier's instruction.

Prepare the Epoxy Resin and fill all cylinders that will be used within 15 minutes. Use the next 15 minutes to place all the cylinders on the entry ports to commence the

injection of epoxy. The total application time for epoxy injection at a temperature of 30°C is 30 minutes.

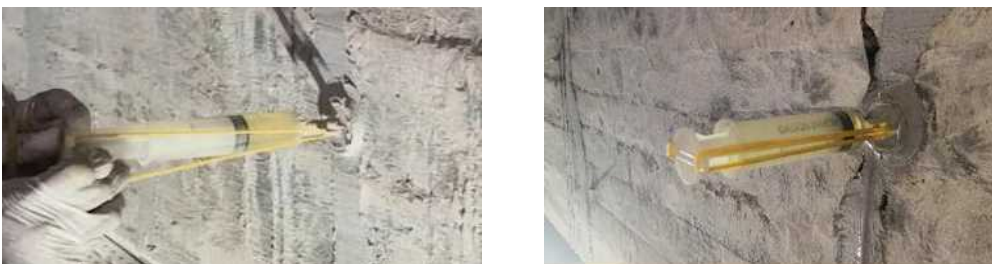
(5) Curing

Set all of the cylinders to the entry ports after filling them with the Epoxy Resin, and then fasten rubbers to the cylinders to apply low pressure. If the crack is vertical, commence the setting of cylinders at the lowest entry port fitting to the topmost port. For a horizontal crack, the placing of cylinders onto the ports is done from one end of the crack to another. Continue the injection until there is no more epoxy discharged from the cylinders.

Let the Epoxy Resin cure overnight (about 12 hours), prior to the removal of the cylinders and entry ports. Any damaged areas shall be made good to the satisfaction of the Engineer.

If it leaks 1 to 2 minutes after injection, remove the cylinder and inject again.

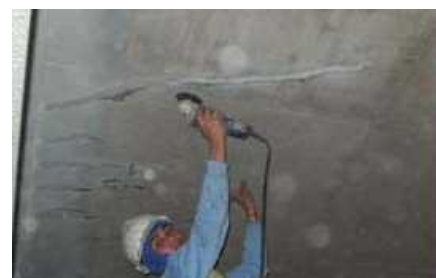
(1) Cleaning of Cracks

Remove all loose debris such as dirt, concrete fine particles and contaminants (oil, grease, etc.) from the cracks using high-pressure water, or a special and effective solvent. Remove the residual water or solvent in the crack with filtered (dust and oil-free) compressed air and allow

adequate time for drying.

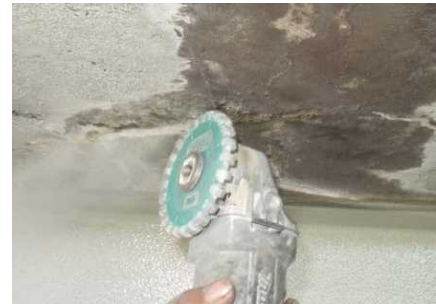
(2) Preparation of Caulking

Using a concrete saw, hand tools or pneumatic tools, a V-groove or U-groove of approximately 10 mm in width and depth is prepared at the surface along the crack.

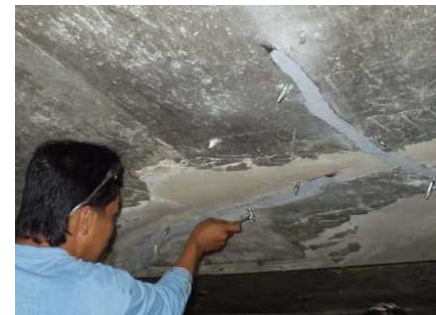
(3) Application

Apply the sealant into the groove using a caulking gun to ensure a smooth continuous flow. The sealant should be tooled to a smooth finish using a spatula.

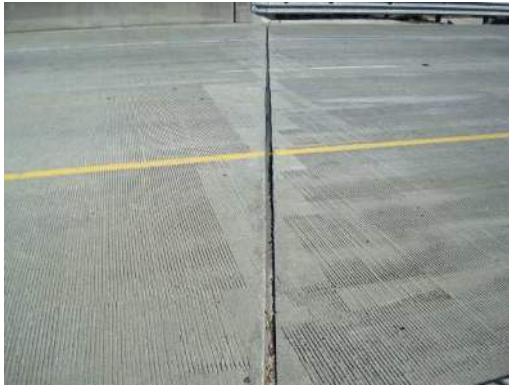
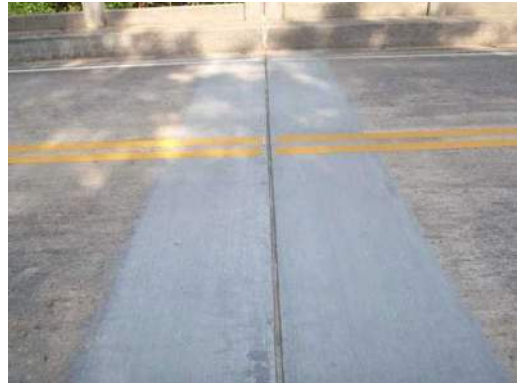
Before Repair

After Repair

The need for repairs to this joint usually results from the sealant material coming loose and falling out of the joint or the joint becoming tight from filling with incompressible materials which enter through a broken seal at the top.

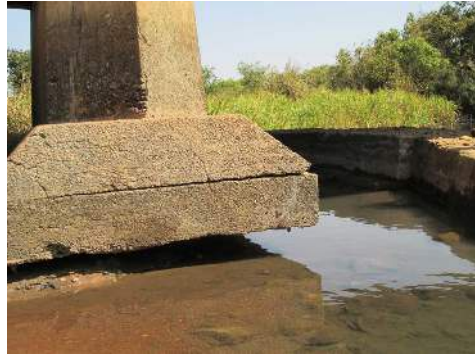
Photo 4-19 Exposed Pier Footing

The Gabion Mattress is used for all areas at and adjacent to bridge substructure units that are subject to scour. When footing/pile-cap of abutment/pier is exposed, this protection prevents further inward erosion.

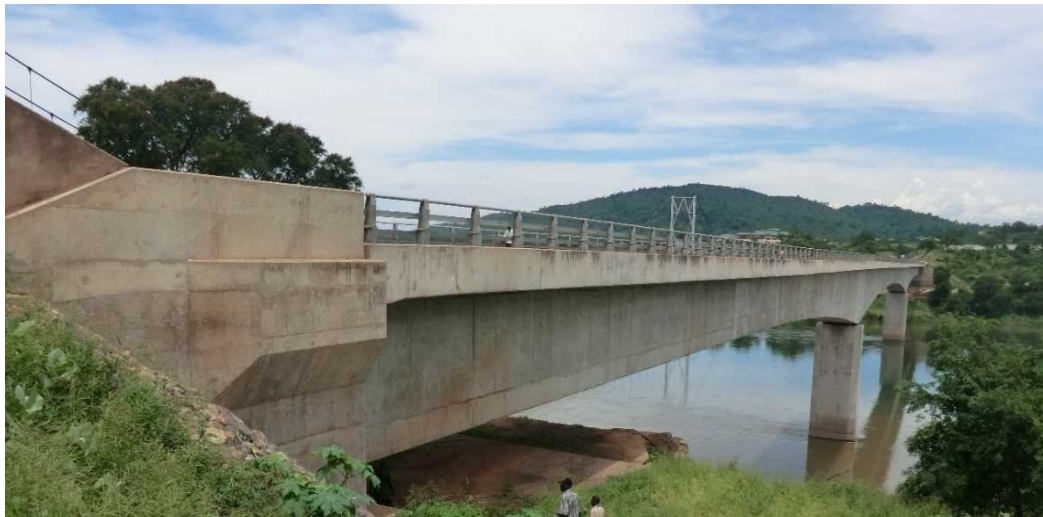
Figure 5-1-1 Structural System of Prestressed Concrete Box Girder Bridge

Prestressed concrete structure (hereinafter referred to as PC structure) is one in which a compressive force is introduced to concrete using the prestressing steel in advance not so as to be generated tensile stress. Even if cracks occur due to excessive load, the cracks will close after removing the load.

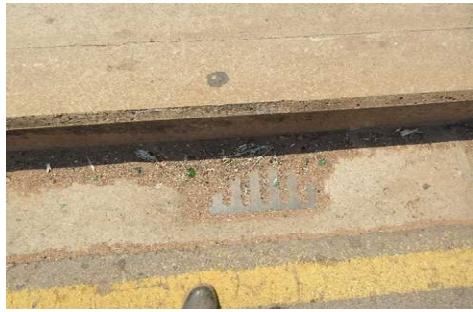
| Defect Type: | Accumulation of debris | Defect Type: | Insufficient length | Defect Type: | Brakage of rubber material |
| Description: | The drain outlets of the carriageway on the downstream side (Otto Beit Bridge side) is buried with earth and sand throughout the bridge. | Description: | The drain pipes under the girder are extremely short. | Description: | Both expansion joints (Hybrid Joint) are damaged. |

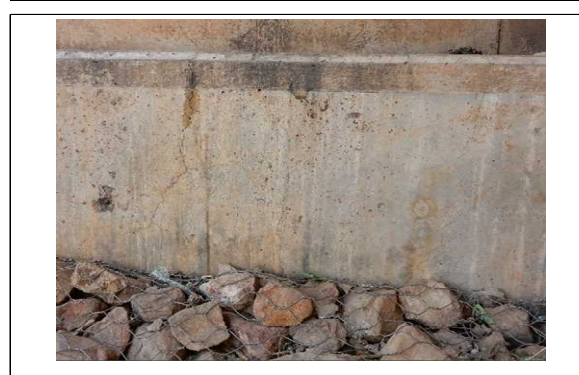
| Defect Type: | Cracks |
| Description: | There are many vertical cracks in the front surface of the Zambian side abutment. |

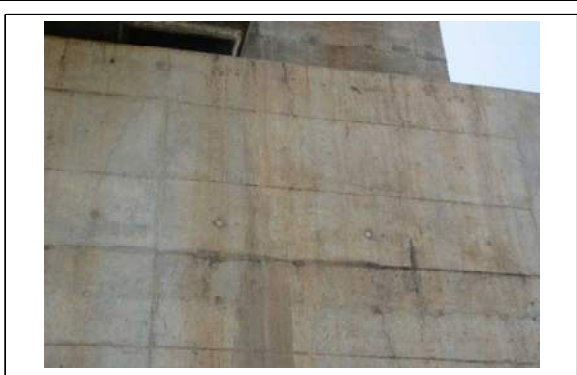
| Defect Type: | Cracks |
| Description: | There are many vertical cracks in the front surface of the Zimbabwe side abutment. |

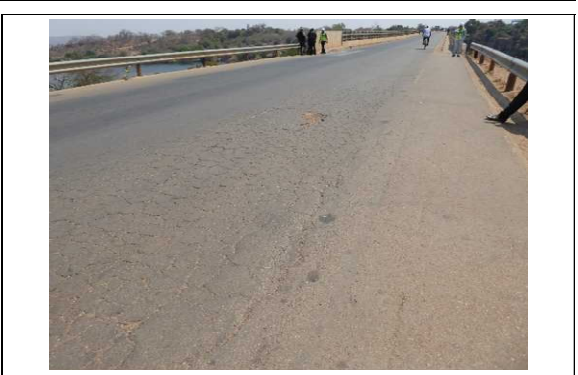
| Defect Type: | Cracks on pavement |
| Description: | Many alligator cracks are seen on the pavement of the Zimbabwe approach. |

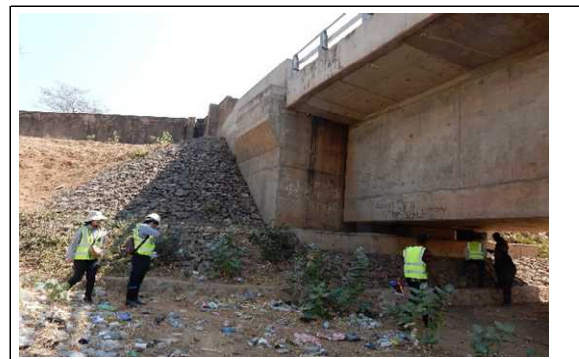
| Defect Type: | Acumulation of garbage |
| Description: | A lot of garbage such as plastic bottles is scattered around the Zambian side abutment. |

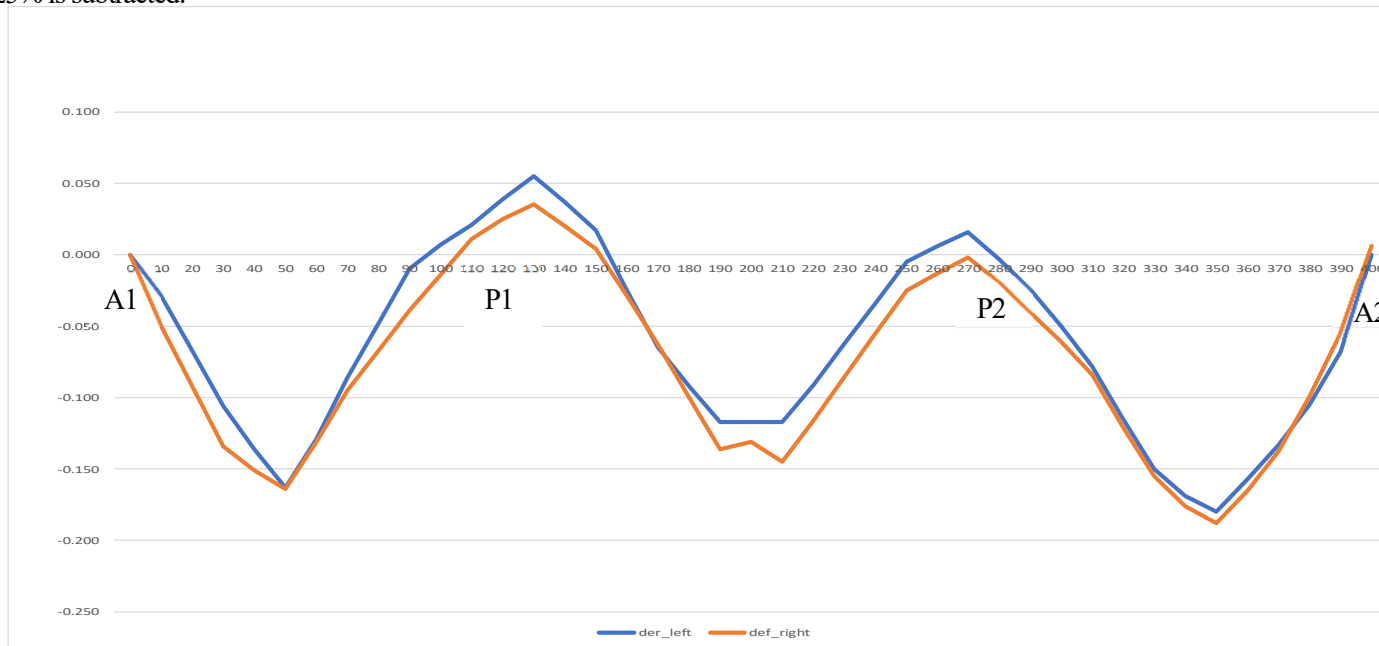
- Many of the defects observed during the 2019 inspection are about the same condition in this inspection.
- These are the damage of the rubber materials of the expansion joints, transverse cracks on the sidewalk and deck surface beside the sidewalk near the intermediate support points, vertical cracks on the front surfaces of the abutments, cracks on the Zimbabwe side approach pavement.
- What is different from the observation result in 2019 is that the previous inspection result in 2019 reported that the bridge surface of the central span seemed to subside, but this time, the RDA survey team measured the vertical profile of the bridge.
- As a result, it is clear that all three spans subsided. From the survey results, the vertical profile of the bridge becomes the vertical curve in the figure below when the vertical gradient -1.25% is subtracted.

- Even when observed with the naked eye in the field, all three spans appear to be lowered. The amount of subsidence is 16 cm in the Zambia side span, 12 to 15 cm in the central span, and 18 to 19 cm in the Zimbabwe side span.

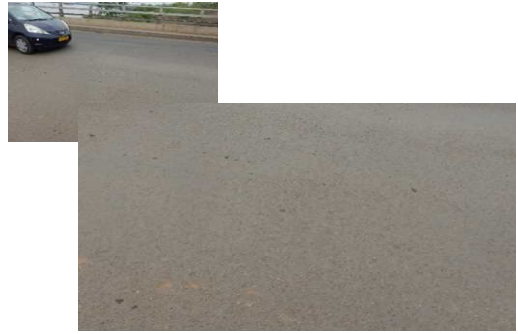
| Photo Record Sheet | | | | (Bridge Name: Chirundu Bridge) | |
|--|--|---|---|--|--|
| No. : | 1-1 | No.: | 1-2 | No.: | 2-1 |

| Photo Record Sheet | | | | (Bridge Name: Chirundu Bridge) | |
|--|--|---|---|--|--|
| Defect Type | Scaling | Defect Type | Pothole | Defect Type | Rubber material broken |
| Description: | Scaling has occurred over the entire length of the bridge. | Description: | No scaling has occurred, but a large pothole can be seen. | Description: | The rubber member on the approach side is broken. |

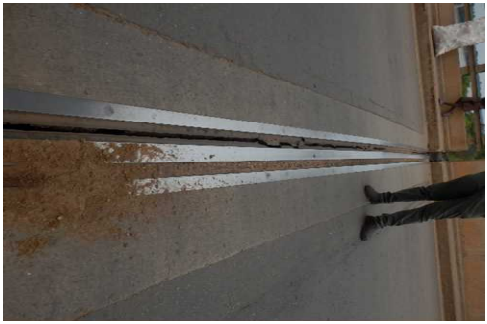
| Photo Record Sheet | | | | (Bridge Name: Chirundu Bridge) | |
|--|--|---|---|--|--|
| No.: | 2-2 | No.: | 3 | No.: | 4-1 |

| Photo Record Sheet | | | | (Bridge Name: Chirundu Bridge) | |
|--|--|---|---|--|--|
| Defect Type | Rubber material broken | Defect Type | Abnormal deflection | Defect Type | Transverse crack |
| Description: | The rubber member on the river side is broken. | Description: | The surface of the bridge is subsided in all three spans. | Description: | Transverse cracks on the sidewalk surface near the intermediate support points |

| Date: | | Contractor Name: | | | | Contract Ref. No. : | | | Province: | |
|---|---|---|---|---|---|---|---|---|---|--|
| 3 | Expansion Joint | Hybrid Joint (Maurer Joint) | Brakage of rubber members | Bad | 2 joints | MM repair | Existing | 2021/11/23 | Replacement of 2 joints is necessary. (Photo: 2-1, 2-2) | |

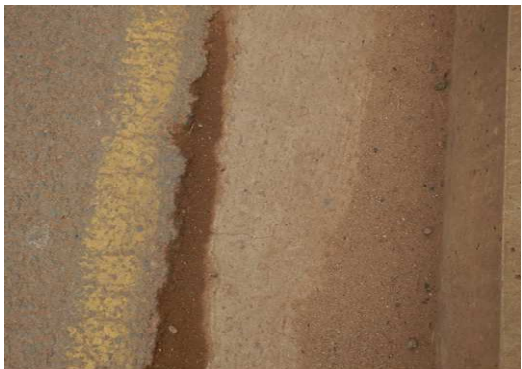
| No.: | 4-2 | No.: | 5-1 | No.: | 5-2 |

| Defect Type | Cracks | Defect Type | Clogged | Defect Type | Very Short |
| Description: | Transverse cracks on the deck surface beside the sidewalk near the intermediate support points | Description: | Several scuppers are filled with earth and sand. | Description: | Length of the drain pipes are short. |

| Date: | | Contractor Name: | | | | Contract Ref. No. : | | | Province: | |
|---|---|---|---|---|---|---|---|---|---|--|
| 5 | Superstructure | Sidewalk & Deck surface | Cracks | Poor | 2 locations | RM repair | Existing | 2021/11/23 | Epoxy coating or Epoxy injection is necessary. (Photo: 4-1, 4-2) | |

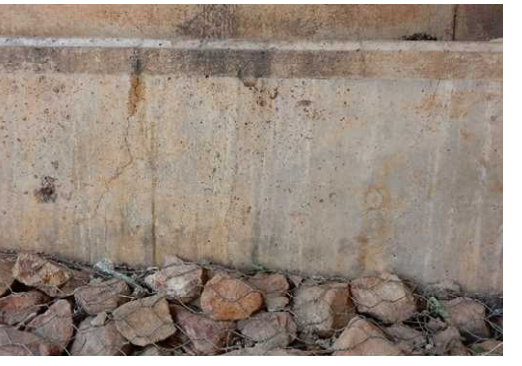
| No.: | 6-1 | No.: | 6-2 | No.: | 7-1 |

| Defect Type | Cracks | Defect Type | Cracks | Defect Type | Cracks |
| Description: | There are many vertical cracks in the front surface of the Zambian side abutment. | Description: | There are many vertical cracks in the front surface of the Zimbabwe side abutment. | Description: | Many alligator cracks are seen on the Zimbabwe approach. |

| Date: | | Contractor Name: | | | | Contract Ref. No. : | | | Province: | |
|---|---|---|---|---|---|---|---|---|---|--|
| 8 | Substructure | Abutment | Cracks | Poor | 18m (Crack length) | RM or MM repair | Existing | 2021/11/23 | Epoxy injection is necessary (A1 & A2, Photo: 6-1, 6-2) | |

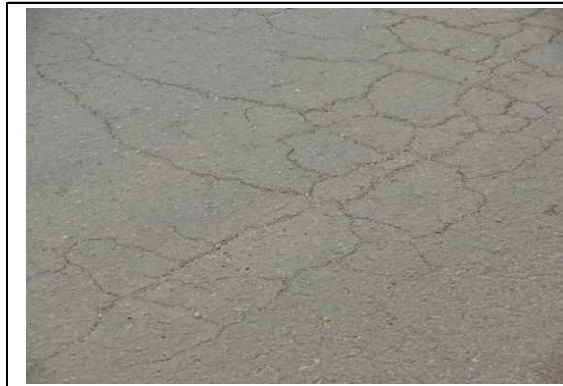
| No.: | 7-2 |

| Defect Type: | Crack |
| Description: | Enlarged photo of cracks |

| Date: | | Contractor Name: | | | | Contract Ref. No. : | | | Province: | |
|---|---|---|---|---|---|---|---|---|---|--|
| 9 | Site/Others | Approach | Crack on pavement | Bad | 200m ² | MM repair | Existing | 2021/11/23 | Zimbabwe approach. (Photo: 7-1, 7-2) Removal & reconstruction of the pavement is required. | |

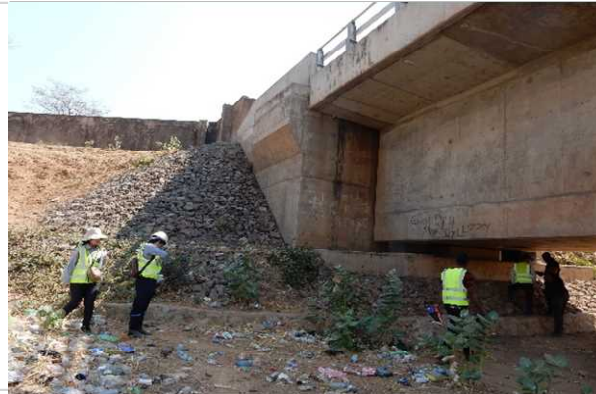
| No.: | 8 |

| Defect Type: | Accumulation of garbage |
| Description: | A lot of garbage such as plastic bottles is scattered around the Zambia side abutment. |

| Date: | | Contractor Name: | | | | Contract Ref. No. : | | | Province: | |
|---|---|---|---|---|---|---|---|---|---|--|
| 10 | Site/Others | Around Zambia side abutment | Accumulation of garbage | Poor | 300m ² | RM repair | Existing | 2021/11/23 | Cleaning is necessary. (Photo: 8) | |

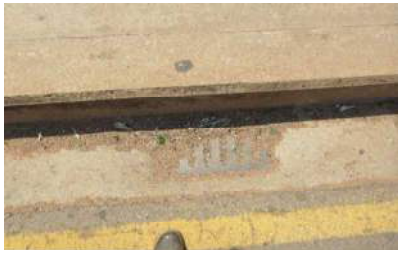
| Location+A2:D7 | Defects | Photography | Presumed Causes |
|---|---|--|--|
| Drainage (Scupper) | Accumulation of debris | | Soil that adhered to the vehicle or was carried by the vehicle fell on the road surface and was carried to the drain scupper by rainwater/wind and accumulated. |

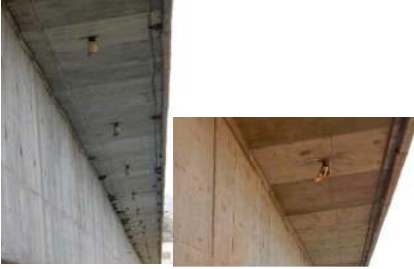
| Location+A2:D7 | Defects | Photography | Presumed Causes |
|---|---|--|--|
| Drainage (Drain pipe) | Insufficient length | | If the drain pipe is short, when it rains with wind, the water flowing down from the pipe is blown by the wind and hits the girder. The water seeps into the girder and may eventually lead to corrosion of the steel. When rainwater contains chloride ions, the progress of corrosion is especially fast. |

| No. | Bridge Component/ Sub-Component | Defect Type | Routine Maintenance Activity | Applied Item in Chapter 4 and 5 | Other Activities |
|---|---|---|---|--|---|
| 2 | Drainage/Drain pipe | Insufficient length | 1-10 Drain extension | 4-12 Drain Extension | Monitoring: Though no major damage has not occurred so far, it is recommended to repair it when the budget allows. Until the budget is available, it is also recommended to check the girder condition near the drain pipes at the time of routine inspection |

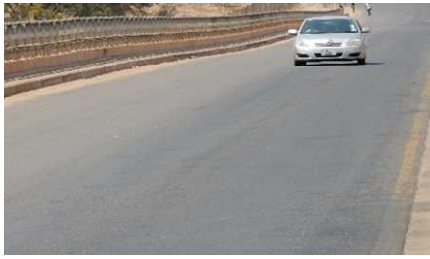
| Location+A2:D7 | Defects | Photography | Presumed Causes |
|---|---|--|--|
| PC Girder | Abnormal deflection | | After the bridge was completed, the shrinkage strain due to the drying of the concrete and the creep strain due to the action of the sustained stress due to the dead load progressed more than expected, and as a result, the deflection of the girder increased. Therefore, it is presumed that the rubber bearing was deformed and destroyed diagonally downward toward the river, the expansion joint was pulled in the direction of the bridge axis, and the rubber part could not withstand and was damaged. |

The Chirundu Bridge, completed in 2002, the rubber bearings were replaced in May 2015. During the 13 years since completion, the rubber bearings were sheared and the upper half of the bearings was greatly displaced toward the river side. This time, as a result of surveying the vertical profile of the bridge, it was found that all the spans were subsided. If the bridge surface did not sink at the time of completion and had an almost straight vertical profile, the following process can be inferred:

- The sinking of the girder gradually progressed after completion.
- Due to the sinking of the girder, the lower surface of the girder on the bearing was pulled toward the span (river) side, the rubber bearing was sheared and broken, and the expansion joint on the upper surface of the girder was pulled in the direction of the bridge axis.
- The beam inside the Maurer joint did not move with respect to the extension width larger than expected, and one of the two rubber parts could not withstand the extension and was damaged.

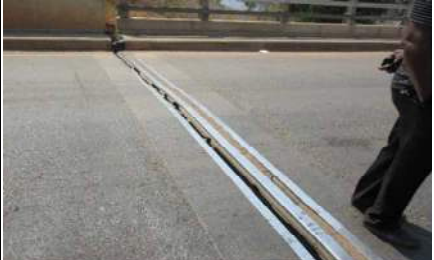
| Location+A2:D7 | Defects | Photography | Presumed Causes |
|---|---|--|--|
| Expansion Joint | Brakage of rubber material | | After the bridge was completed, the shrinkage strain due to the drying of the concrete and the creep strain due to the action of the sustained stress due to the dead load progressed more than expected, and as a result, the deflection of the girder increased. Therefore, it is presumed that the rubber bearing was deformed and destroyed diagonally downward toward the river, the expansion joint was pulled in the direction of the bridge axis, and the rubber part could not withstand and was damaged. |

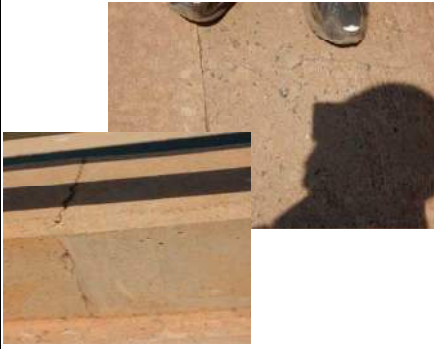
| Location+A2:D7 | Defects | Photography | Presumed Causes |
|---|---|--|--|
| Sidewalk, Kerb | Transverse cracks on pier (P1, P2) | | Cracks are seen on the sidewalk surface on the piers due to the negative bending moment. The state of the upper surface of the main girder should be inspected. |

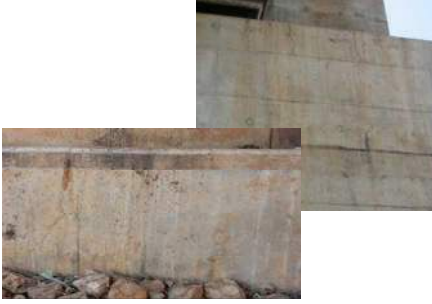
| Abutment | Vertical cracks | | <p>The following cause is considered: Cracking occurred because the temperature deformation due to the heat of hydration was constrained by the temperature difference between the post-cast and the first cast and/or the temperature difference in the cross section.</p> |

| No. | Bridge Component/ Sub-Component | Defect Type | Routine Maintenance Activity | Applied Item in Chapter 4 and 5 | Other Activities |
|---|---|---|---|--|---|
| 6 | Substructure/ Concrete member(Abutment) | Cracks | 3-2 Injection into cracks (Repair scale of cracks is small) | 4-7 Epoxy Injection | Injection by MM Repair: Repair scale of cracks is large |

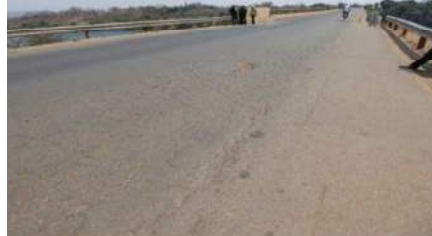
| Approach Pavement | Cracks | | <p>It would be considered a cause of damage that heavy vehicles repeatedly passed the pavement over a long period of time.</p> |

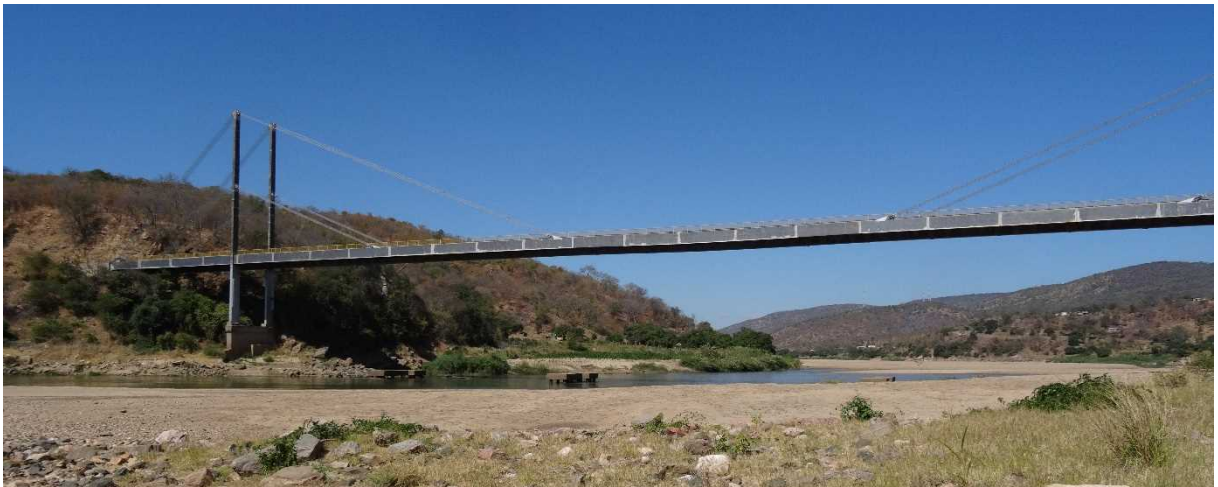
(Cable-stayed bridge)

When the span of the continuous girder bridge becomes long, the dead load increases rapidly and reaches the application limit at a certain span length. The cable-stayed bridge is a structure in which the main girder is hung (supported) by a cable stretched diagonally from a tower erected on the intermediate pier of the continuous girder bridge. Therefore, since the main girder behaves as an elastically supported structure at the cable attachment point, the girder height can be kept low.

On the other hand, in a cable structure such as a cable-stayed bridge, since the damping property of the entire girder is reduced, vibrations due to wind are likely to occur, therefore, a girder structure considering wind resistance is desirable.

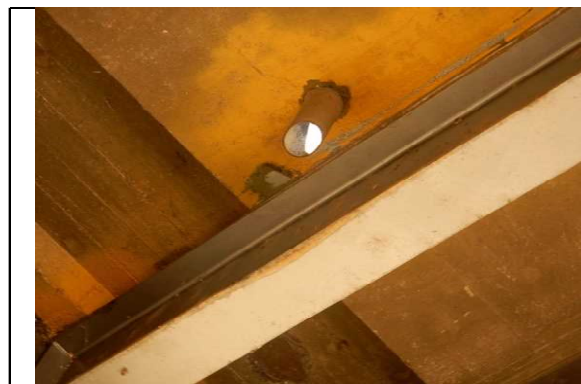
| No.: | 1.1 |

| Defect Type: | Short drain pipe & corrosion on cross beam |
| Description: | Insufficient length of drain pipes (all pipes), cross beam near the drain pipe is corroded. |

| 9 | Drainage | Drain pipe | Insufficient length | Poor | Extension: L=80 m | RM Repair | Existing | 27/10/2020 | Short drain pipes observed. Suspected to cause corrosion on the cross beams. See sketches and photos 1.1 & 1.17. |

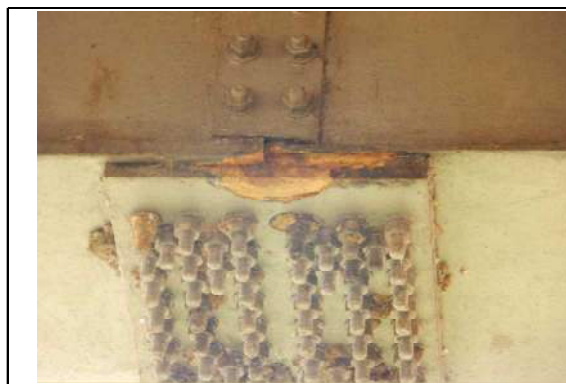
| No.: | 1.2 |

| Defect Type: | Corrosion on girder joint |
| Description: | Many joint plates and bolts are corroded. |

| Date: 27/10/2020 | | Contractor Name: Dorman Long Limited | | | Contract Ref. No. : | | Province: Eastern | | |
|---|---|---|---|---|---|---|---|---|---|
| 1 | Superstructure | Steel member (Main girder and Cross beam) | Paint deterioration, Corrosion | Fair | Touch-up painting: A=250m ² | RM Repair | Existing | 27/10/2020 | Corrosion observed on the joints and lower flange of girders and cross beams. Paint deterioration observed on entire girder surface. See sketches and photos 1.1 – 1.4. |

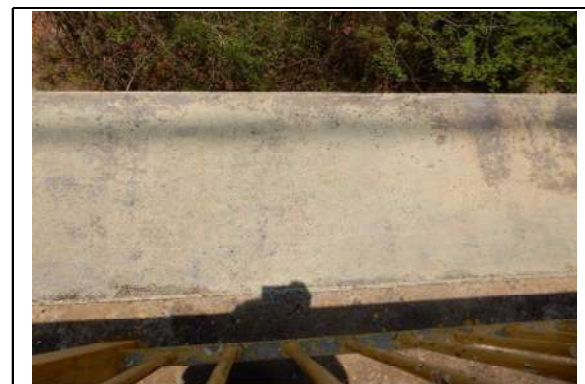
| No.: | 1.3 |

| Defect Type: | Paint deterioration on upper flange of main girder |
| Description: | Paint deterioration is observed on upper flange of main girder. |

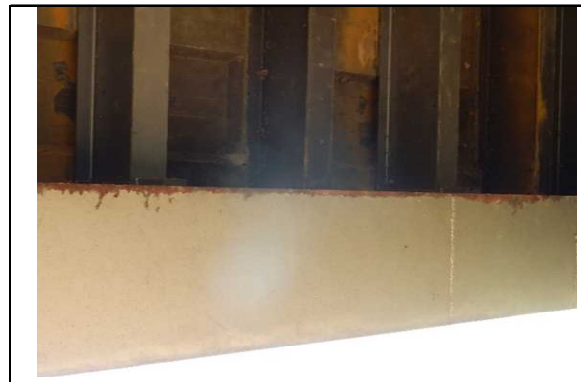
| No.: | 1.4 |

| Defect Type: | Corrosion on girder lower flange |
| Description: | Corrosion is observed at the edge of lower flange on the main girder. |

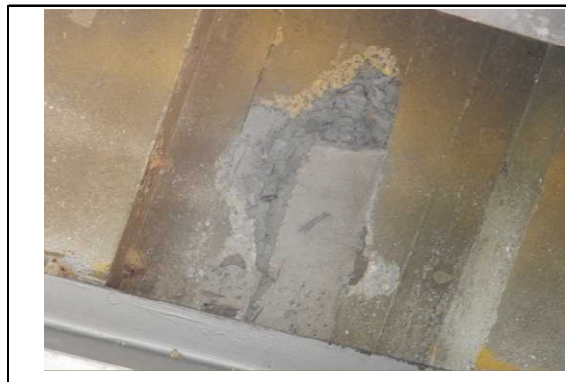
| No.: | 1.5 |

| Defect Type: | Spalling on bottom surface of deck slab |
| Description: | A big spalling is observed on bottom surface of deck slab. |

| 8 | Deck | Concrete deck (Lower surface) | Cracks, Spalling | Poor | Epoxy injection: V=2,800cm ³ Patching: V=75,000cm ³ | RM Repair | Existing | 27/10/2020 | A big crack is observed on bottom of slab on P1. A big spalling is observed near P2. See sketches and photos 1.5 & 17. |

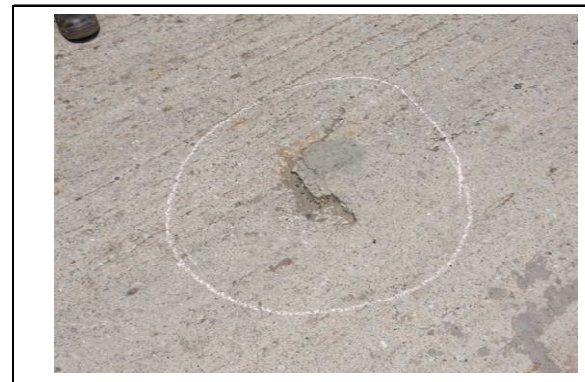
| No.: | 1.6 |

| Defect Type: | Spalling & disintegration on top surface of deck slab |
| Description: | Spalling & disintegration are observed on the top surface of deck slab. |

| Date: 27/10/2020 | | Contractor Name: Dorman Long Limited | | | Contract Ref. No. : | | Province: Eastern | | |
|---|---|---|---|---|---|---|---|---|---|
| 7 | Deck | Concrete deck (Upper surface) | Cracks, Spalling | Poor | Epoxy injection: V=250cm ³ Patching: V=400cm ³ | RM Repair | Existing | 27/10/2020 | Many cracks and spalled sections observed on deck surface. See sketches and photos 1.6 & 1.8. |

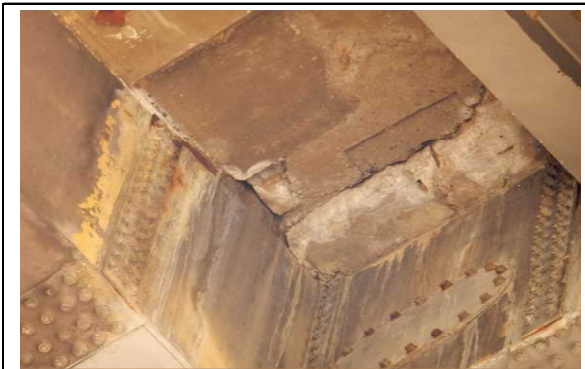
| No.: | 1.7 |

| Defect Type: | Big cracks on deck bottom surface |
| Description: | Big cracks are observed on the bottom surface of deck slab. |

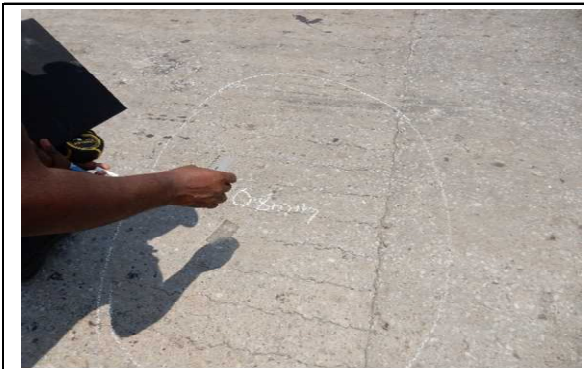
| No.: | 1.8 |

| Defect Type: | Cracks on deck top surface |
| Description: | Many cracks are observed on the top surface of deck slab. |

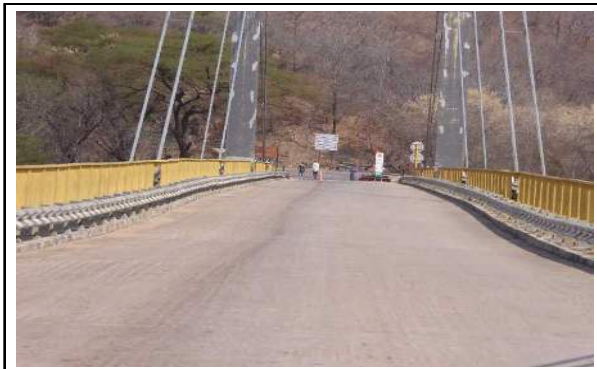
| No.: | 1.9 |

| Defect Type: | Sagging of superstructure |
| Description: | Sagging of superstructure is observed between the cable stays in the main span. |

However, the amount of depression between the center stays was 0.215m in 2003, 0.200m in 2004 (after raising), and 0.203m in 2021 (current), showing no change. What does this mean? It could mean that the decrease in cable tension is not the cause of the settlement between the center stays.

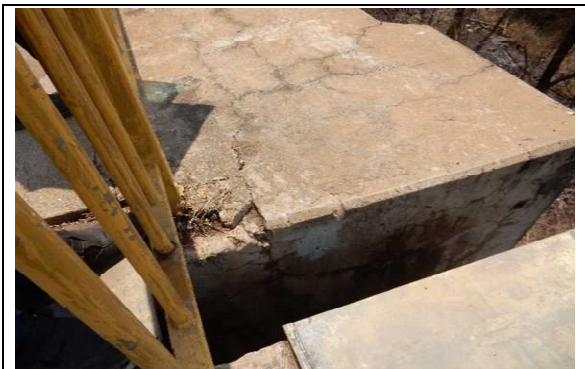
| No.: | 1.10 |

| Defect Type: | Cracks on western side abutment A1 |
| Description: | Cracks are observed on the top surface of western side abutment A1. |

| 10 | Substructure | Abutment A1 (Western side) | Cracks | Poor | Epoxy injection: V=300cm ³ Patching: V=18,000cm ³ | RM Repair | Existing | 27/10/2020 | Big cracks observed on the upper surface of the abutment. See sketches and photos 1.10. |

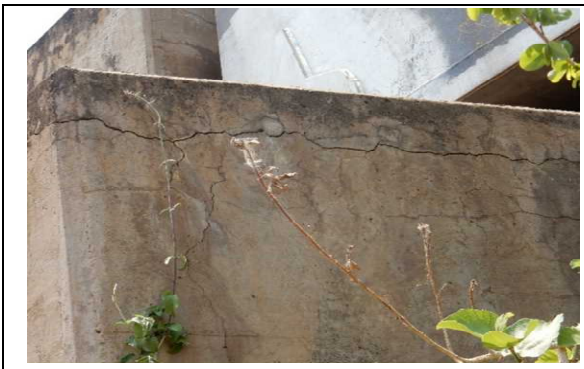
| No.: | 1.11 |

| Defect Type: | Cracks on eastern side abutment A2 |
| Description: | Cracks are observed on the front wall of eastern side abutment A2. |

| 11 | Substructure | Abutment A2 (Eastern side) | Cracks | Poor | Epoxy injection: V=409cm ³ | RM Repair | Existing | 27/10/2020 | Big cracks observed on the upper surface and front surface of the abutment. See sketches and photos 1.11 & 1.12. |

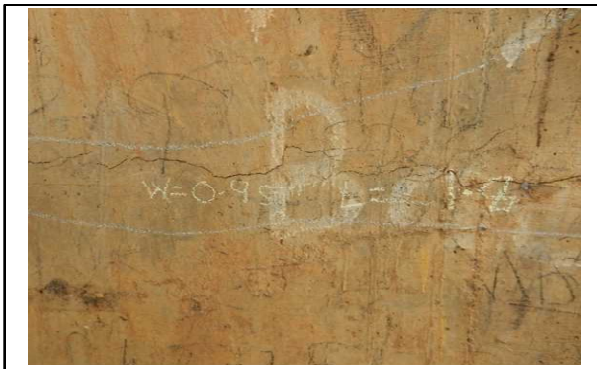
| No.: | 1.12 |

| Defect Type: | Cracks on eastern side abutment A2 |
| Description: | Cracks are observed on the front wall of eastern side abutment A2. |

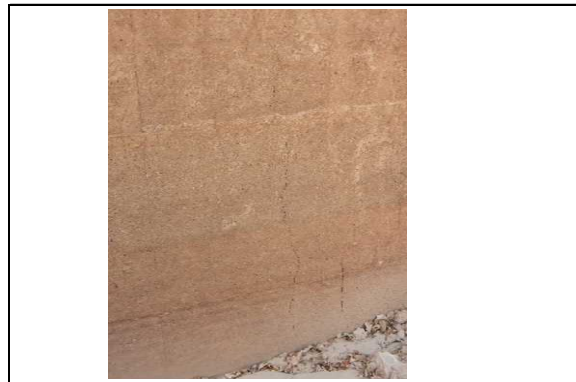
| No.: | 1.14 |

| Defect Type: | Cracks on western side pier (P1) |
| Description: | Cracks are observed on the eastern side wall of western side pier P1. |

| 12 | Substructure | Pier P1 (Western side) | Cracks | Poor | Epoxy injection: V=150cm ³ | RM Repair | Existing | 27/10/2020 | Cracks observed on the wall. See sketches and photos 1.13 & 1.14. |

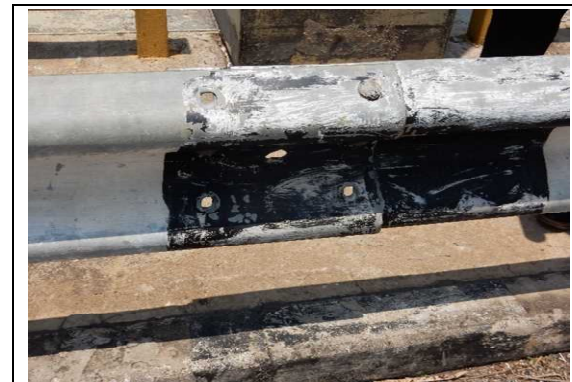
| No.: | 1.15 |

| Defect Type: | Missing bolts on guardrail |

| Date: 27/10/2020 | | Contractor Name: Dorman Long Limited | | | Contract Ref. No. : | | Province: Eastern | | |
|---|---|---|---|---|---|---|---|---|---|
| 4 | Railing | Guardrail | Missing bolts | Fair | Installation 2 bolts | RM Repair | New | 27/10/2020 | Missing bolts observed. See sketch and photo 1.15. |
