BRIDGE MAINTENANCE CAPACITY BUILDING IN ZAMBIA

BRIDGE ROUTINE MAINTENANCE GUIDELINES

2024

**Road Development Agency
Japan International Cooperation Agency**

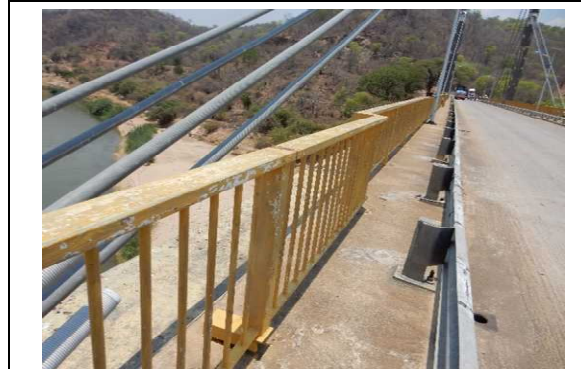
| No.: | 1.16 |

| Defect Type: | Paint deterioration on handrail |
| Description: | Paint deterioration is observed on handrail entirely. |

| Date: 27/10/2020 | | Contractor Name: Dorman Long Limited | | | Contract Ref. No. : | | Province: Eastern | | |
|---|---|---|---|---|---|---|---|---|---|
| 3 | Railing | Metal railing | Paint deterioration | Fair | Repainting All | MM Repair | Existing | 27/10/2020 | Paint deterioration observed on entire railing. See sketches and photo 1.16. |

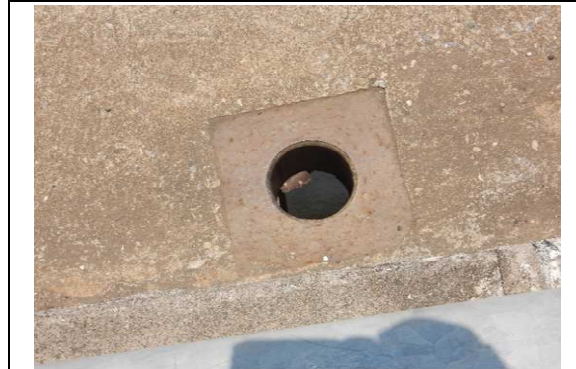
| No.: | 1.17 |

| Defect Type: | Drain scupper |

| 9 | Drainage | Drain pipe | Insufficient length | Poor | Extension: L=80 m | RM Repair | Existing | 27/10/2020 | Short drain pipes observed. Suspected to cause corrosion on the cross beams. See sketches and photos 1.1 & 1.17. |

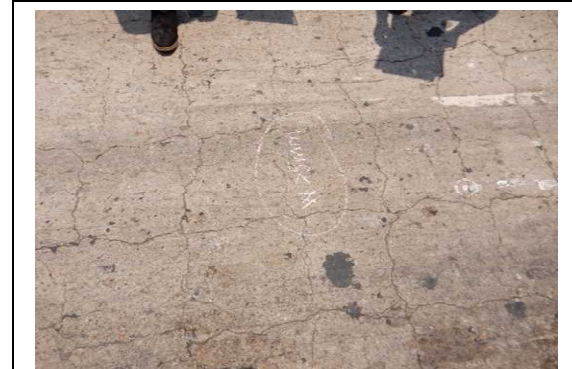
| No.: | 1.18 |

| Defect Type: | Cracks on approach slab |
| Description: | Many longitudinal & transverse cracks are observed on the approach slab |

| 14 | Site/Others | Approach (Eastern side) | Cracks | Poor | Epoxy injection: V=11,100cm ³ | MM Repair | Existing | 27/10/2020 | Many cracks observed. See sketch and photo 1.18. |

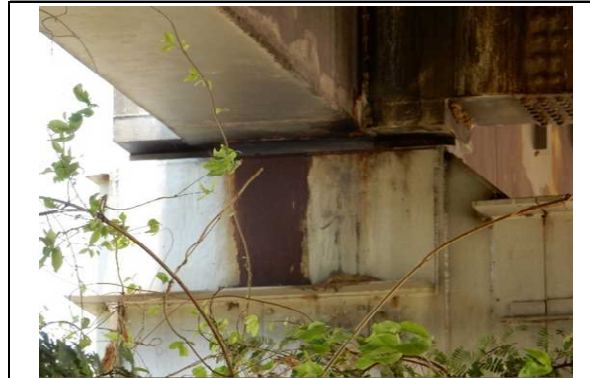
| No.: | 1.19 |

| Defect Type: | Water leakage & corrosion on eastern pier (P2) |
| Description: | Water leakage & corrosion are observed at the girder supporting portion of eastern pier P2. |

| 13 | Substructure | Pier P2 (Eastern side) | water leakage, Corrosion | Poor | Touch-up painting: A=1.2m ² | RM Repair | Existing | 27/10/2020 | Water leakage and corrosion observed at the part that support the girder and tower. See sketches and photo 1.19. |

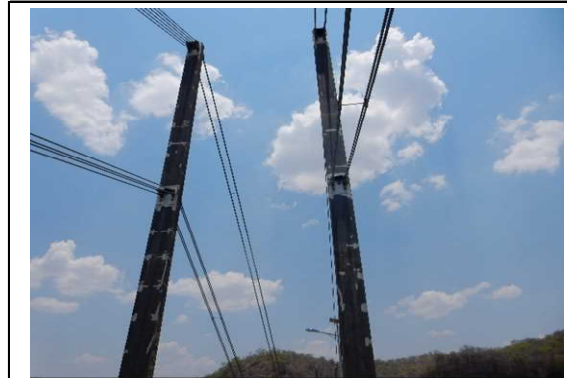
| No.: | 1.2 |

| Defect Type: | Paint deterioration on tower |
| Description: | Paint deterioration is observed on all tower members. |

| Date: 27/10/2020 | | Contractor Name: Dorman Long Limited | | | Contract Ref. No. : | | Province: Eastern | | |
|---|---|---|---|---|---|---|---|---|---|
| 5 | Cable system | Tower | Paint deterioration | Fair | Repainting All | MM Repair | Existing | 27/10/2020 | Paint deterioration observed on tower surface. See sketch and photo 1.20. |

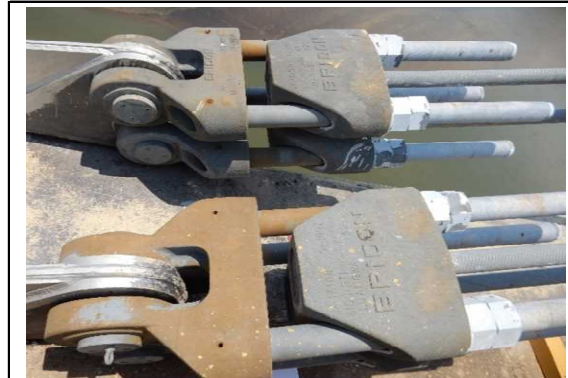
| No.: | 1.21 |

| Defect Type: | Corrosion & paint deterioration on anchorage |
| Description: | Corrosion & paint deterioration are observed on most anchorages. |

| Date: 27/10/2020 | | Contractor Name: Dorman Long Limited | | | Contract Ref. No. : | | Province: Eastern | | |
|---|---|---|---|---|---|---|---|---|---|
| 6 | Cable system | Anchorage | Corrosion | Fair | Repainting All | MM Repair | Existing | 27/10/2020 | Corrosion observed. See sketch and photo 1.21. |

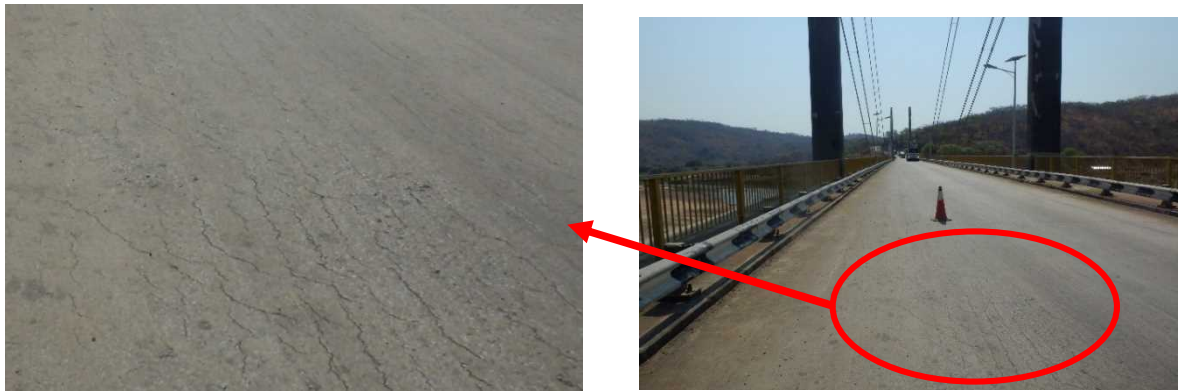
(4-1) Cracks on the top surface of the concrete deck slab

On the top surface of the concrete deck slab, the pavement layer is worn and the concrete surface is exposed. Moreover, many cracks are seen over the entire bridge length. Cracks in the bridge axis direction and in the bridge transverse direction were observed, especially more cracks in the bridge axis direction.

| Location | Defects | Photography | Presumed Causes |
|---|---|---|--|
| Deck Top Surface | Crack, Spalling, Bumpy Surface | | Possible causes of damage include poor quality of concrete deck slab materials, poor construction performance during concrete placement, drying shrinkage of concrete, and repeated passing of heavy vehicles. |

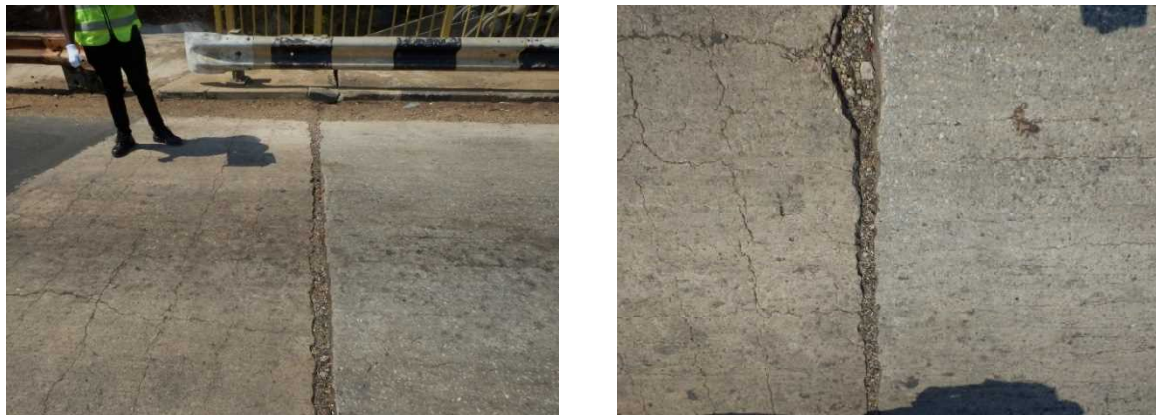
In addition, grid-shape cracks are seen throughout the concrete slab on the Chipata side approach. The left side is the concrete slab of the approach, and the right side is the concrete deck slab of the bridge.

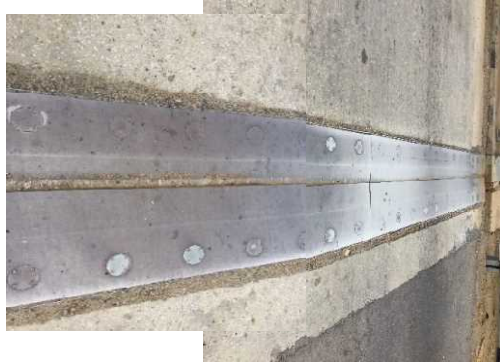
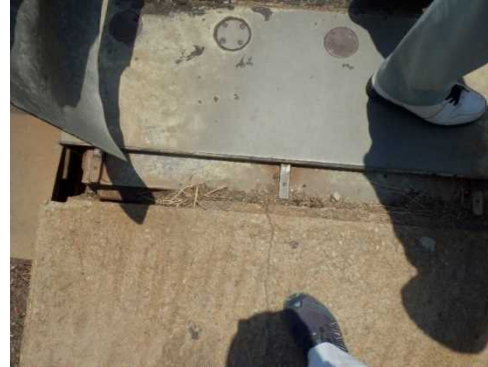
(4-2) Squeak of Expansion Joint

In the Lusaka side expansion joint (steel lap joint), the steel plate on the bridge side moves back and forth when a heavy-loaded vehicle passes by, and a squeak noise is generated. It was observed that there was a large movement when the vehicle was traveling from the center of the bridge to the tower on the Lusaka side, not when the vehicle was passing over the expansion joint.

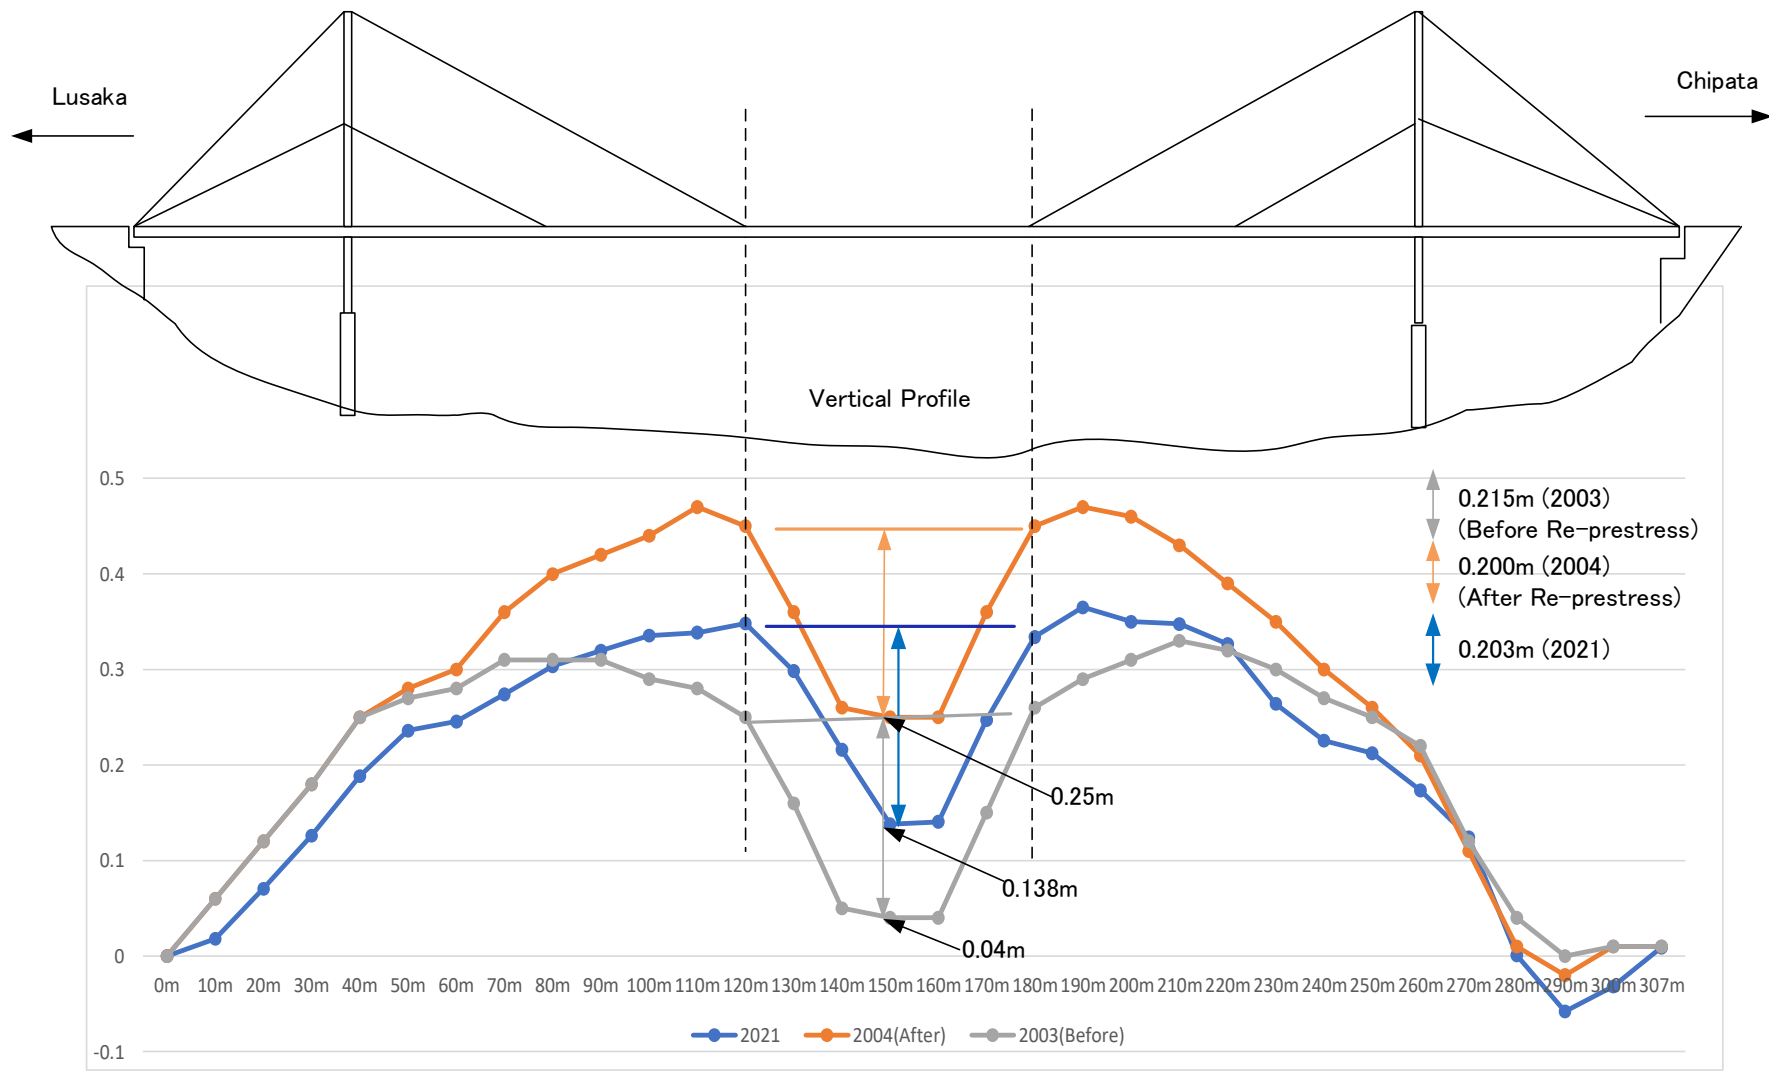
(4-3) Survey Results of Bridge Vertical Profile

The Luangwa Bridge was re-prestressed from 2003 to 2004. The survey results for October 2021 are shown in the graph along with the values before and after Re-prestressing.

However, the amount of depression between the center stays was 0.215m in 2003, 0.200m in 2004 (after raising), and 0.203m in 2021 (current), showing no change. What does this mean? It could mean that the decrease in cable tension is not the cause of the settlement between the center stays.

From the above, it seems that the consideration of the FS report* is the most promising cause of the depression at present. In other words, the girder between the center stays was erected upside down. (* Feasibility Studies and Assessment of the Luangwa Bridge across the Luangwa River on the Great East Road (T4) in Eastern Province, Zambia Final Feasibility Report, 16 February, 2016)

| Location | Defects | Photography | Presumed Causes |
|---|---|---|--|
| Superstructure between cable-stays | Sagging | | Probable cause 1: The main towers tilted toward the center during construction due to the short side span. Therefore the main girder hung down. Probable cause 2: The tension of the hanging cables decreased and the girder hung down. Probable cause 3: The main girder segment between the hanging cables was installed upside down causing the excessive sag as a sum of initial camber and dead-load deflection. According to the 2016 FS report, the response of the bridge girder due to heavy vehicle loading is normal throughout, including the sagging section, and there are no structural defects in the main structure of the bridge. As a result of considering the Vertical Profile measured in October 2021, Probable cause 2 is not considered to be the cause of sagging. (See 5-2-2 (4-3)) |

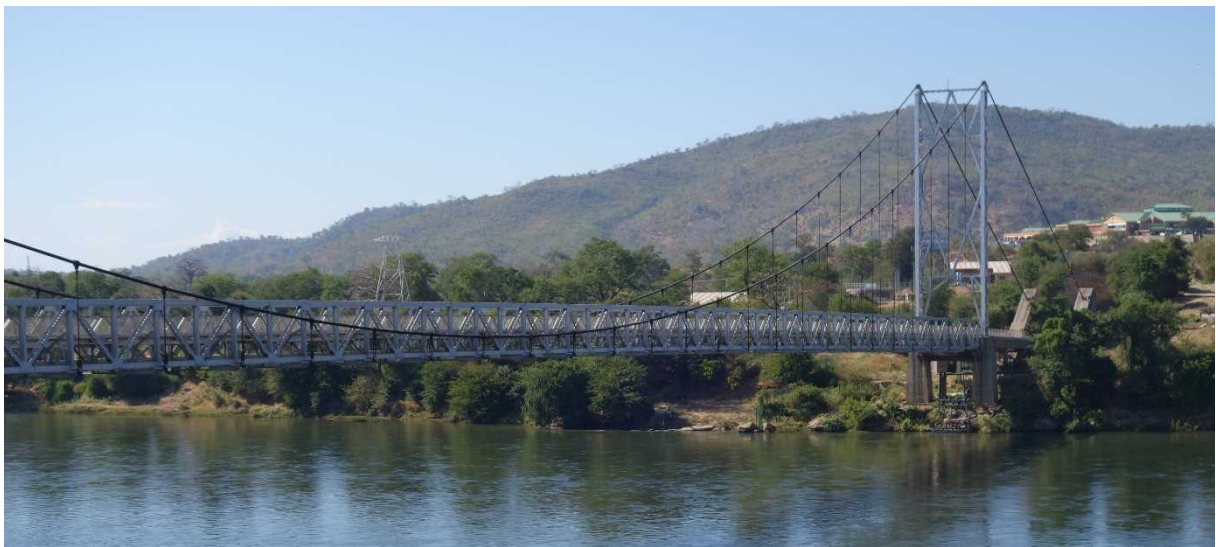
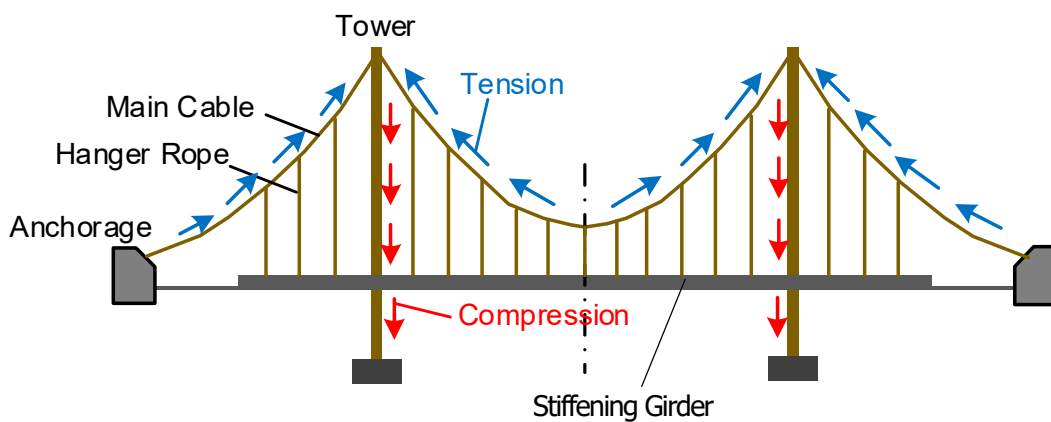
Figure 5-3-1 Structural System of Suspension Bridge

The suspension bridge has main cables which are stretched between the main towers and fixed to anchor blocks at both ends of the bridge, and has a structure in which the transportation route is suspended by hanger ropes hanging from the main cables. The leading role of the suspension bridge is a cable, but a stiffening girder is used in combination to give the suspension bridge appropriate rigidity, load distribution action to the cable, wind resistance, etc. The stiffening girder supports the upper traffic route (floor structure of road and/or railway). The cable and the stiffening girder are connected by hangers, and the load is transmitted to the cable through the hangers. Because of this, all the load becomes high tension of the high strength cable and transmits to the ground through the cable anchorage. Moreover, this cable tension has a restoring force on deformation, which increases the apparent stiffness, so the suspension bridge is a very suitable type of long span bridge.

On the other hand, since the stiffening girder of the suspension bridge is liable to be vibrated by wind, a structure considering wind resistance is desirable.

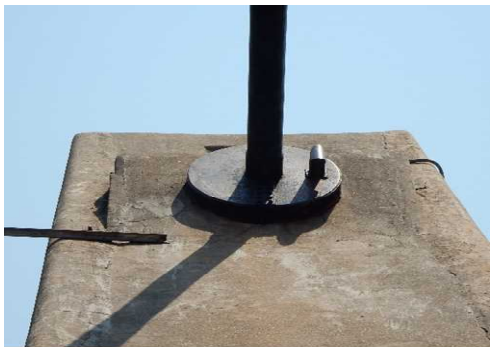
| Defect Type: | Cracks concrete part | Defect Type: | Wrapping wire broken | Defect Type: | Wrapping wire broken |
| Description: | Cracks are observed near the anchor device of the concrete anchorage | Description: | Broken wrapping wire between Zimbabwe west side tower and anchorage | Description: | Broken wrapping wire between west side hanger 34 and tower |

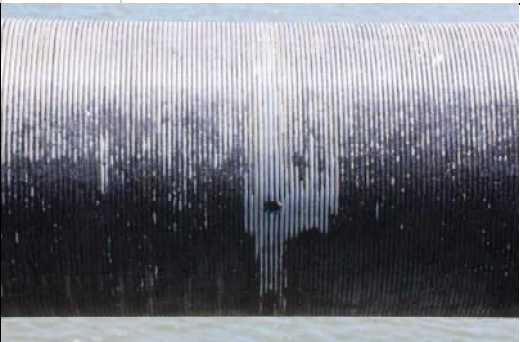
| Defect Type: | Wrapping wire chipped | Defect Type: | Rust on repaired wire | Defect Type: | Fractured wire |
| Description: | Chipped wrapping wire between hangers 21E and 22E | Description: | Rusted repaired area between hangers 20E and 21E | Description: | Fractured wire on hanger 2W |

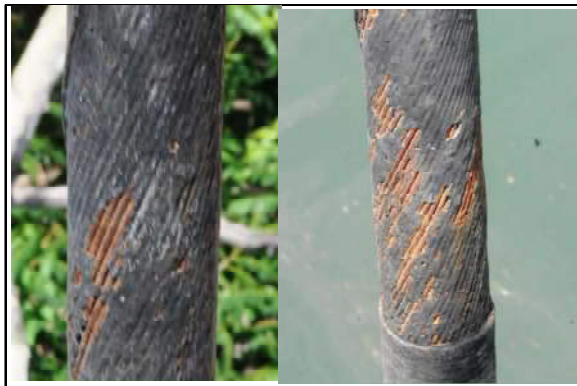
| No.: | 7 |

| Defect Type | Rusted |
| Description: | Rust caused by local loss of bituminous paint |

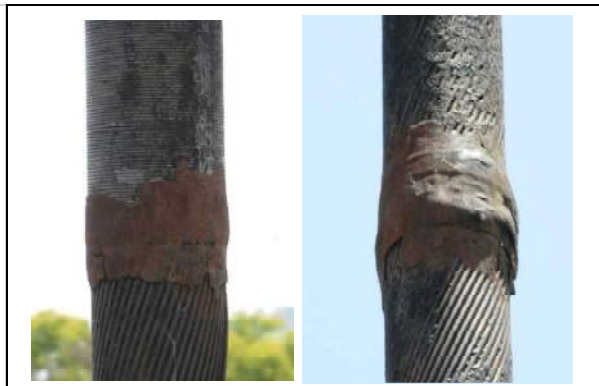
| No.: | 8 |

| Defect Type | Rust on some repaired area |
| Description: | Rust on some repaired area (Recent repairing) |

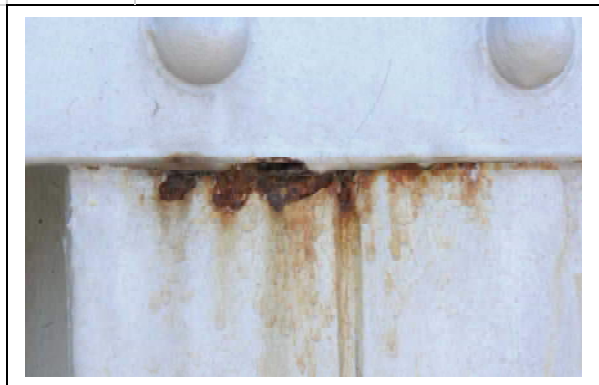
| No.: | 11 |

| Defect Type | Corrosion |
| Description: | Corrosion spot |

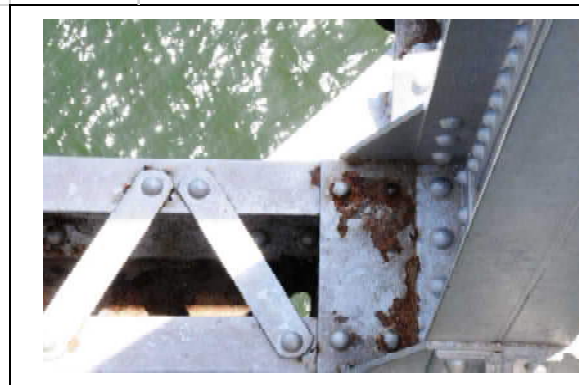
| No.: | 12 |

| Defect Type | Corrosion |
| Description: | Corrosion spot (Lower cords and their surrounding members) |

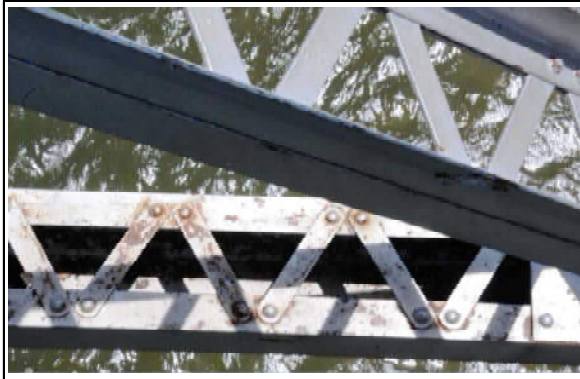
| No.: | 13 |

| Defect Type | Corrosion |
| Description: | Corrosion spot (Lower cords and their surrounding members) |

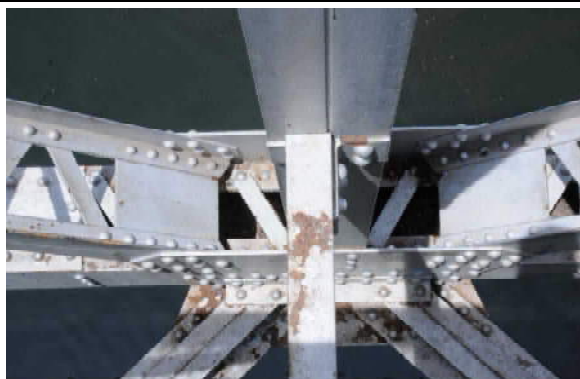
| No.: | 14 |

| Defect Type | Corrosion |
| Description: | Corrosion spot (Lower cords and their surrounding members) |

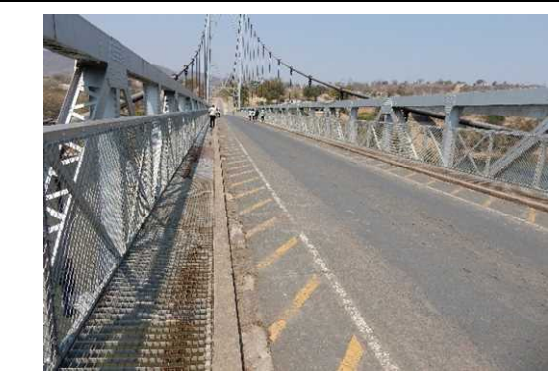
| No.: | 15 |

| Defect Type | Corrosion |
| Description: | Most of sidewalk are rusty |

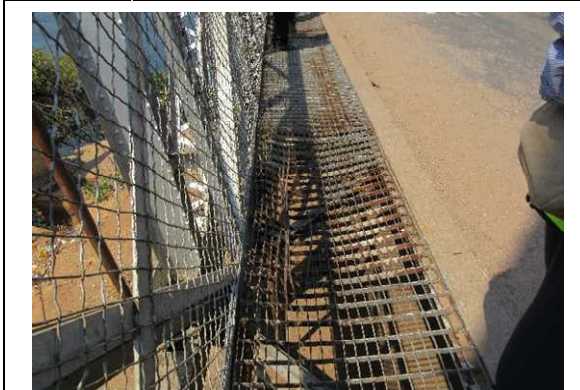
| No.: | 16 |

| Defect Type | Buckling |
| Description: | Some parts of sidewalk are buckled. |

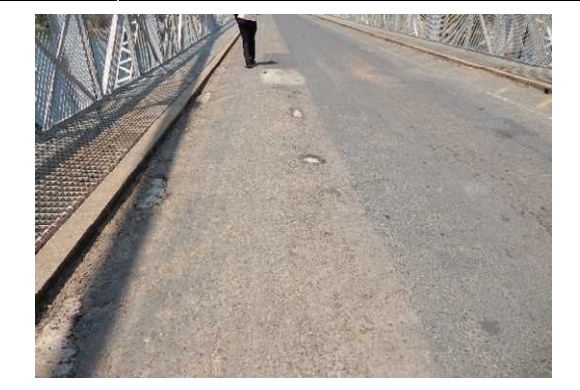
| No.: | 17 |

| Defect Type | Pothole |
| Description: | Many potholes in the asphalt pavement on the deck slab |

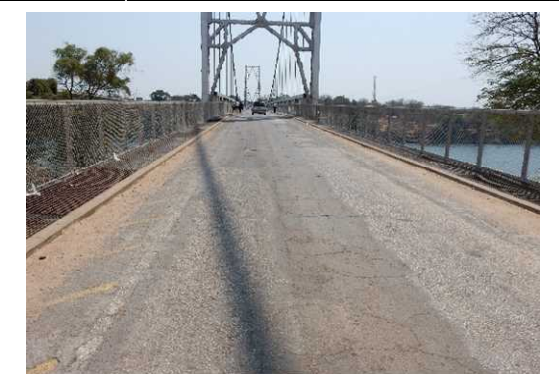
| No.: | 18 |

| Defect Type | Potholes and Cracks |
| Description: | Potholes and cracks in the asphalt pavement on the deck slab |

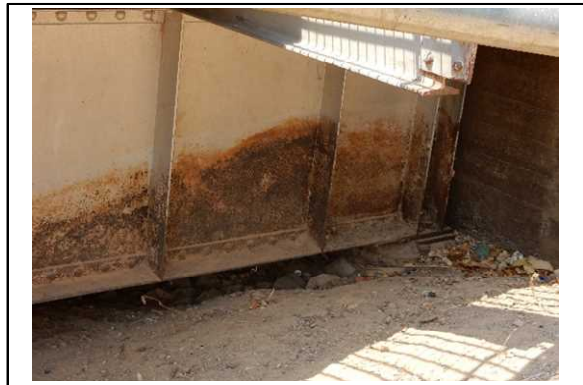
| No.: | 19 |

| Defect Type | Corrosion |
| Description: | Steel girder of span 4 is corroded near the abutment |

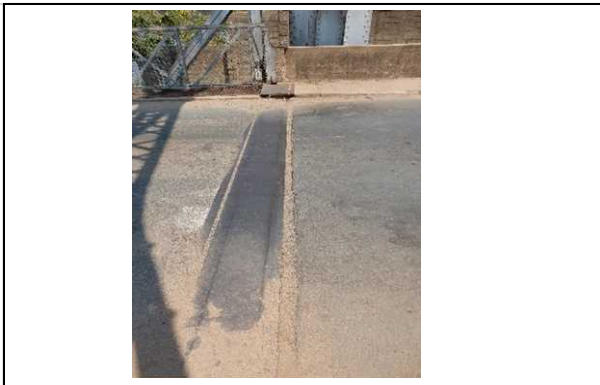
| No.: | 20 |

| Defect Type | Covered with sandy materials |
| Description: | Expansion device is covered with accumulated sandy materials |

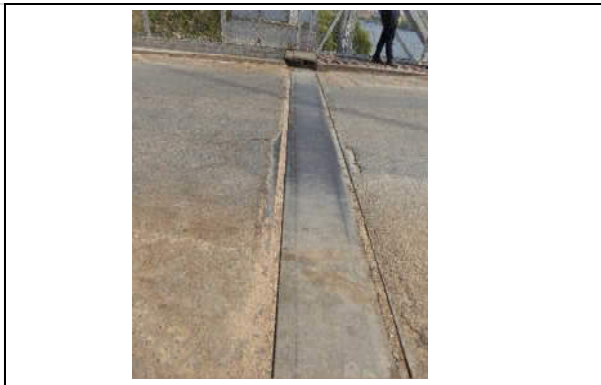
| No.: | 21 |

| Defect Type | Damage to adjacent pavement |
| Description: | Adjacent pavement is damaged |

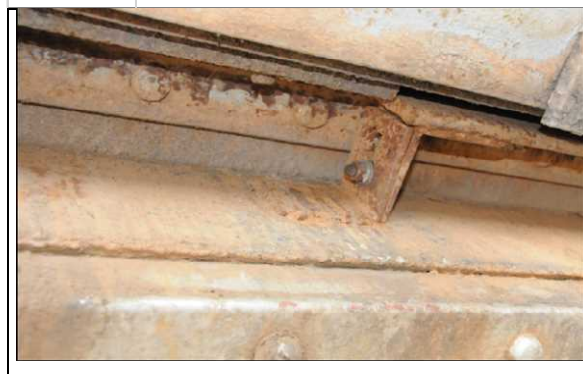
| No.: | 22 |

| Defect Type | Corrosion |
| Description: | The lower part of the expansion joint is corroded. |

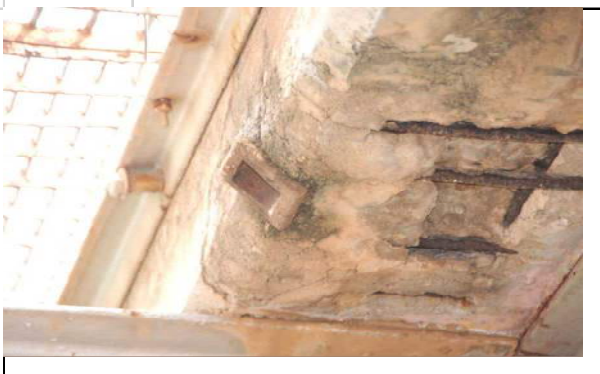
| No.: | 23 |

| Defect Type | Spalling, Rebar exposure |
| Description: | Spalling, rebar exposure and corrosion |

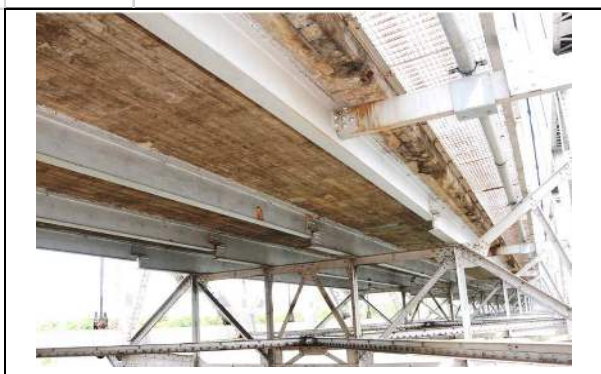
| No.: | 24 |

| Defect Type | Spalling, Rebar exposure |
| Description: | Spalling, rebar exposure and corrosion (distant view) |

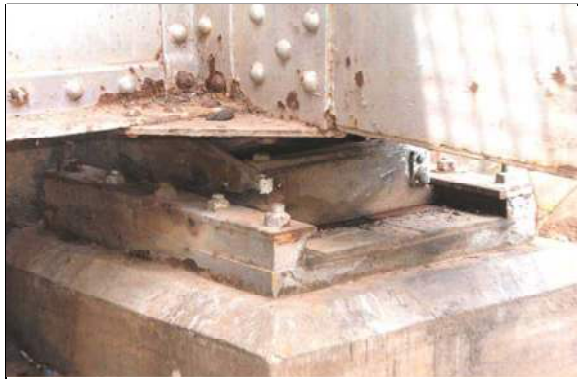
| No.: | 25 |

| Defect Type | Rusted |
| Description: | Rust on the steel surface |

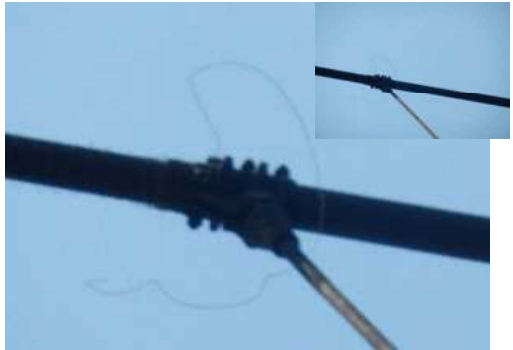
| Description: | Wrapping wire is broken (near 1E) | Description: | Wrapping wire is broken (between 7E & 8E)) | Description: | Wrapping wire is coming out. (near 28E) |

| Date: | | Contractor Name: | | | Contract Ref. No. : | | Province: | | | |
|---|---|---|---|---|---|---|---|---|---|--|
| 1 | Cable System | Main Cable | Wrapping wire broken | Bad | Replacement of wrapping wire | EA | New | Oct. 2021 | Wrapping wires are newly broken at several portions of the main cables. (1E, 7E-8E, 28E, & Tow-Ank E), (Photo: 1-1, 1-2, 1-3 & 1-4) | |

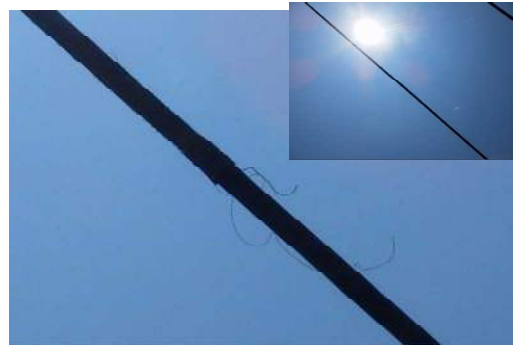
| Description: | Wrapping wire is broken (between Zimbabwe east side tower & anchorage) | Description: | Zimbabwe side anchorage houses are full of garbages | Description: | Hanger Rope is not straight (2E) |

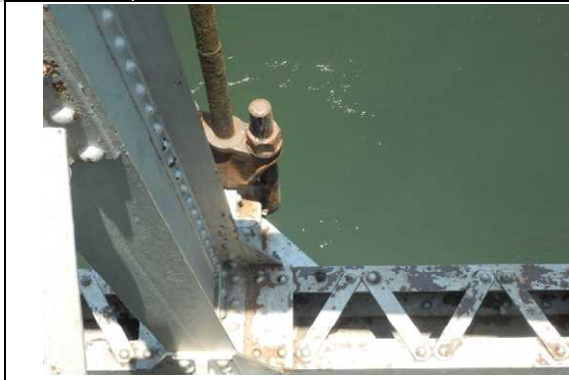
| No.: | 9-2 |

| Description: | Hanger shackle has been rotated (26W, 27W and 31W) |

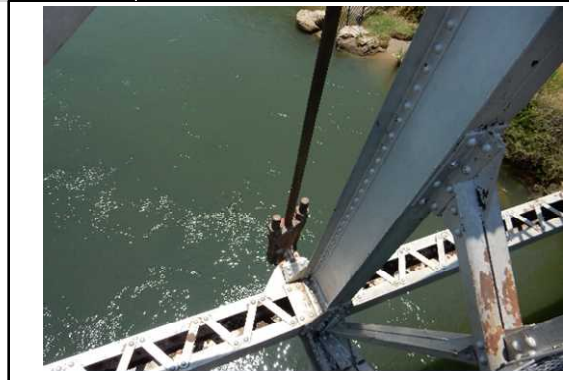
| No.: | 10 |

| Description: | Many lower cord members are rusted |

| Location | Defects | Photography | Presumed Causes |
|---|--|--|---|
| Superstructure - Stiffening Girder - | Many lower cord members are rusted | | When it rains, water from the upper structures such as the road surface and the upper chord members falls on the lower chord members, so it is presumed that the rust has progressed due to the repetition of those phenomenon. |

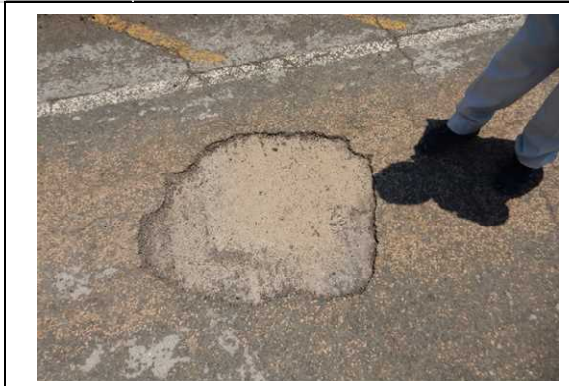
| No.: | 12 |

| Description: | Damages (Potholes & Cracks) are worse than at the last inspection |

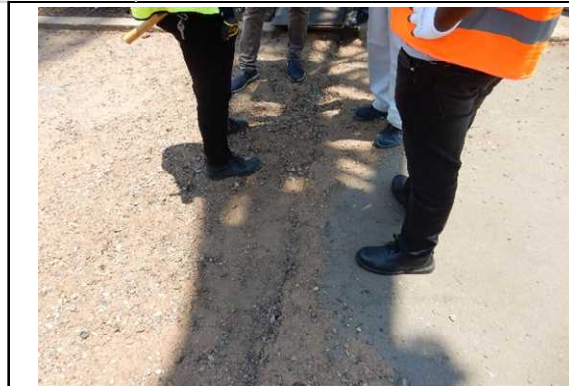
| No.: | 13 |

| Description: | Expansion joint is covered with more sandy materials than at the last inspection |

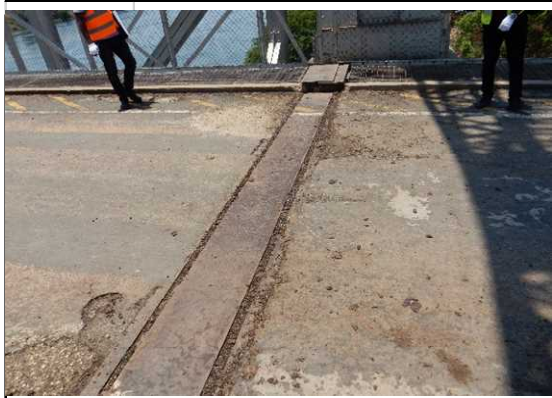
| No.: | 14 |

| Description: | Damage of adjacent pavement to the expansion joint became worse than at the last inspection |

| Location | Defects | Photography | Presumed Causes |
|---|---|---|--|
| Expansion Joint - Zimbabwe side - | Damage to adjacent pavement & lower part of expansion joint is corroded | | The adjacent pavement was damaged due to the passage of heavy vehicles for many years. In addition, it is presumed that rainwater on the road surface flowed into the lower side of the joint and the back side of the joint was corroded. |

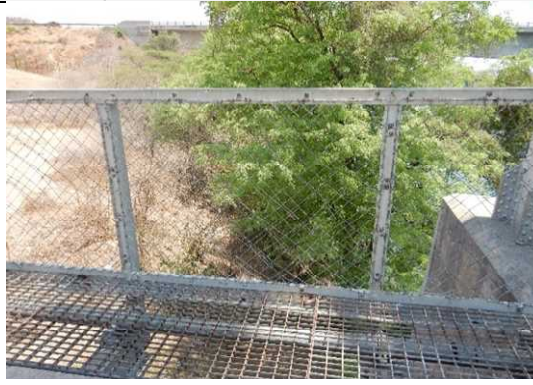
| No.: | 15 |

| Description: | Wire mesh of the guard fence is deformed in several places |

| No. | Bridge Component/ Sub-Component | Defect Type | Routine Maintenance Activity | Applied Item in Chapter 4 and 5 | Other Activities |
|---|---|---|---|---|---|
| 16 | Guard Fence/Access Bridge | Wire mesh deformed | 1-8 Collision damage repair to railing/parapet | 4-10 Repair to railing/ parapet | |

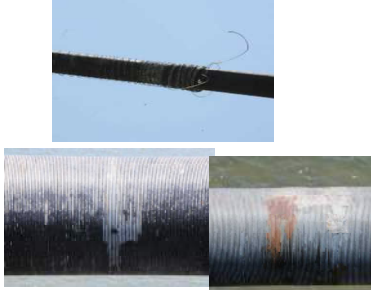
| Location | Defects | Photography | Presumed Causes |
|---|--|--|---|
| Cable System - Main Cable - | Wrapping wire broken, Chipped & rusted | | It seems that the main cable has never been repaired or otherwise maintained after the bridge was completed in 1939. It is presumed that the wrapping wire has deteriorated and damaged due to the effects of long-term wind and rain and vibration when the vehicle passes through. |

| No. | Bridge Component/ Sub-Component | Defect Type | Routine Maintenance Activity | Applied Item in Chapter 4 and 5 | Other Activities |
|---|---|--|---|---|---|
| 1 | Cable System/Main Cable | Wrapping wire broken, chipped & rusted | - | - | Replacing the wrapping wire for the damaged sections of the main cables (MM Repair) |

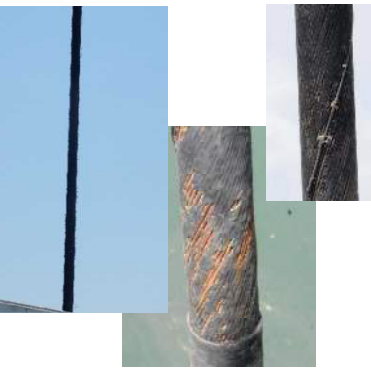
| Location | Defects | Photography | Presumed Causes |
|---|--|--|---|
| Cable System - Hanger Rope - | Bituminous paint deteriorated, Hanger rope rusted, Repaired wrapping wire broken | | The hanger ropes are covered with Bituminous Paint, but those paints have deteriorated over time, and at some portions, those coatings have peeled off and wires have been damaged. Those damaged portions have been partially repaired with wrapping wire, but the repaired portions are also deteriorating. |

| No. | Bridge Component/ Sub-Component | Defect Type | Routine Maintenance Activity | Applied Item in Chapter 4 and 5 | Other Activities |
|---|---|--|---|---|---|
| 5 | Cable System/Hanger Rope | Bituminous paint deteriorated, Hanger rope rusted, Repaired wrapping wire broken | - | - | Replacement of coating materials for all ropes (MM Repair) |

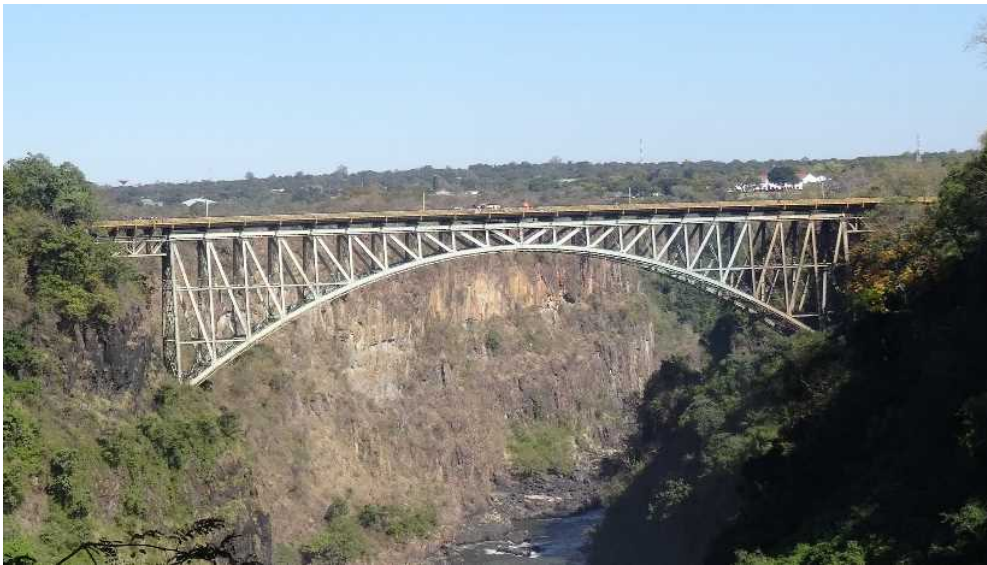
Arch bridge is a structure that transmits loads using a bow-shaped arch members (arch rib). As shown in the figure below, when an external load is applied, a compressive force (axial force) acts on the arch rib, and ground reaction forces (horizontal and vertical reaction forces) corresponding to the compressive force are generated on the support points at the both ends of the arch rib. The basis of arch design is to determine the axial shape so as to be resisted dead load by only axial force. Axial force increases in accordance with going to the springing from the crown portion, the dead load also increases in accordance with the going to the end. Therefore, the arch axis shape is a curve having a steep slope toward the end.

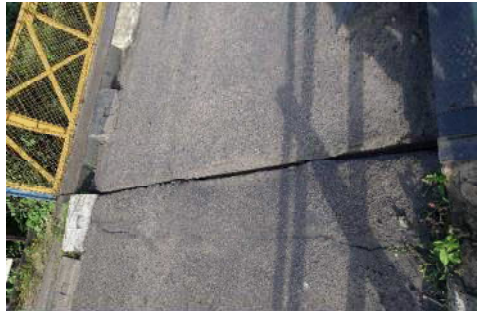
| Description: | It is considered a simple butt joint. A steel tray is installed under the expansion joint for the full width of the bridge, but the tray does not have a drainage pipe. | Description: | Same as the left column. The tops of the joints need to be cleaned. | Description: | The drainage tray below the joint has no drainage pipe connected to it. It may be need to monitor if tray overflows during rainy season. |

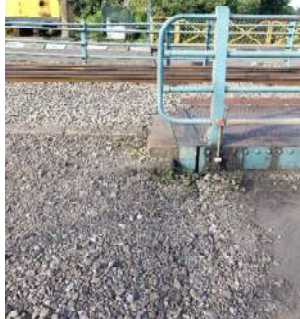
| Defect Type: | | Defect Type | Buried with soil and gravel | Defect Type: | Drainage tray has no drainage pipe |

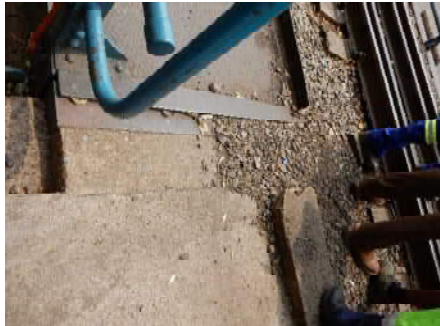
| Defect Type | Buried with soil and gravel | Defect Type | Damage to the adjacent pavement | Defect Type: | Corrosion |
| Description: | The tops of the joints need to be cleaned. | Description: | Need to repair the joint and the adjacent pavement. | Description: | The troughs on the underside of the roadway are corroding due to leakage from gaps (1 cm) between the troughs along the entire length. |

| Date: | | Contractor Name: | | | Contract Ref. No. : | | Province: | | |
|---|---|---|---|---|---|---|---|---|---|
| 3 | Expansion joint/ Zambia side | Footway | Covered with soil & gravel | Fair | Cleaning | RM Repair | Existing | April 2022 | Photo: 2-1 |

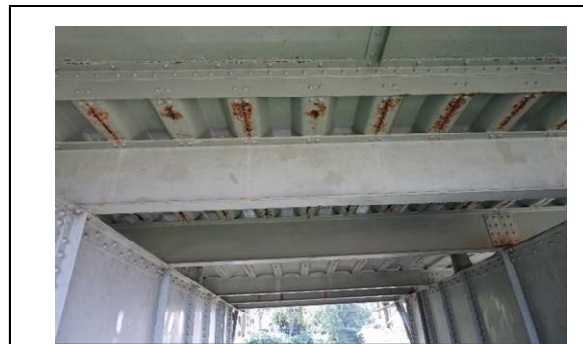
| No.: | 4 |

| Defect Type | Corrosion |
| Description: | The troughs on the underside of the railway are corroding due to leakage from gaps (1 cm) between the troughs along the entire length. |

| Date: | | Contractor Name: | | | Contract Ref. No. : | | Province: | | |
|---|---|---|---|---|---|---|---|---|---|
| 6 | Deck/ Steel troughing | Railway | Corrosion | Bad | Entire railway | MM Repair | Existing | April 2022 | Partially replace the troughs and track materials sequentially. Photo: 4 |

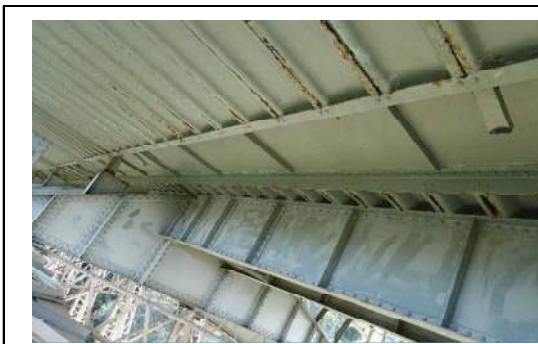
| No.: | 5 |

| Defect Type | Corrosion |
| Description: | The troughs on the underside of the footway are corroding due to leakage from gaps (1 cm) between the troughs along the entire length. |

| Date: | | Contractor Name: | | | Contract Ref. No. : | | Province: | | |
|---|---|---|---|---|---|---|---|---|---|
| 7 | Deck/ Steel troughing | Footway | Corrosion | Fair | Entire footway | MM Repair | Existing | April 2022 | Repainting (with Pavement repair) Photo: 5 |

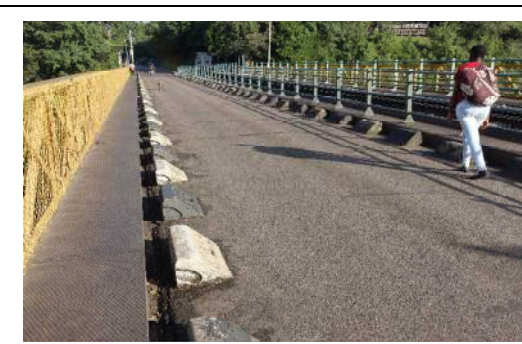
| No.: | 6-1 |

| Defect Type | Cracks (or Construction joints) |
| Description: | Transverse cracks (or construction joints) in the roadway pavement at 7 to 8 m intervals are suspected to be leaking from these cracks. |

| Date: | | Contractor Name: | | | Contract Ref. No. : | | Province: | | |
|---|---|---|---|---|---|---|---|---|---|
| 8 | Pavement | Roadway | Cracks (or Construction joints) | Fair | Entire roadway | MM Repair | Existing | April 2022 | Replacement of pavement and installation of waterproof layer Photo: 6-1, 6-2 |

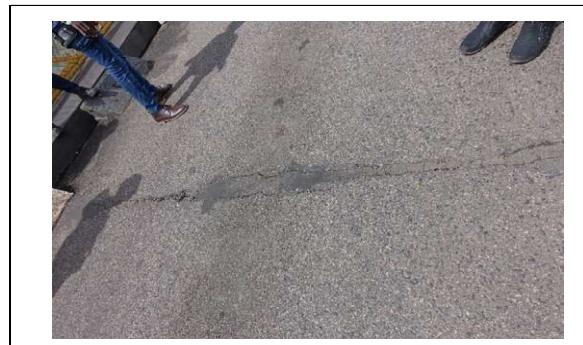
| No.: | 6-2 |

| Defect Type | Cracks (or Construction joints) |
| Description: | Transverse cracks (or construction joints) in the roadway pavement at 7 to 8 m intervals are suspected to be leaking from these cracks. |

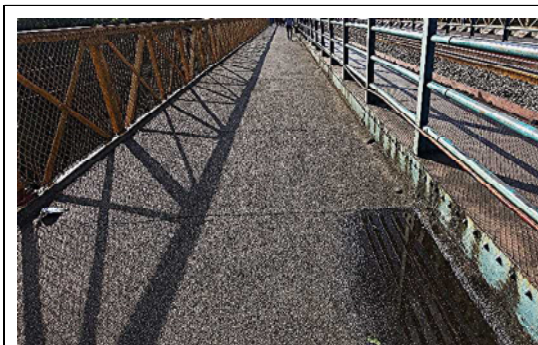
| No.: | 7 |

| Defect Type | Cracks (or Construction joints) |
| Description: | Transverse cracks (or construction joints) in the footway pavement at 2 m intervals are suspected to be leaking from these cracks. |

| Date: | | Contractor Name: | | | Contract Ref. No. : | | Province: | | |
|---|---|---|---|---|---|---|---|---|---|
| 9 | Pavement | Footway | Cracks (or Construction joints) | Fair | Entire footway | MM Repair | Existing | April 2022 | Replacement of pavement and installation of waterproof layer Photo: 7 |

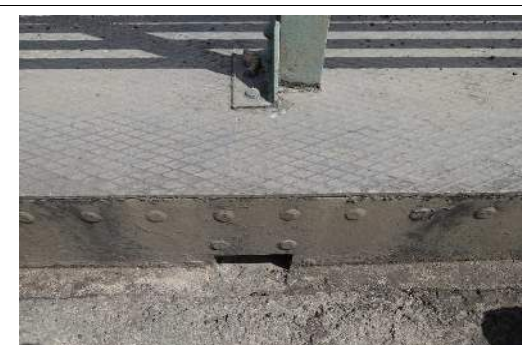
| No.: | 8-1 |

| Description: | Scupper in the roadway. |

| 10 | Drainage | Roadway | Insufficient pipes | Poor | Entire bridge | MM Repair | Existing | April 2022 | The pipe should extend to the outside of the bridge. Photo: 8-1 to 8-3 |

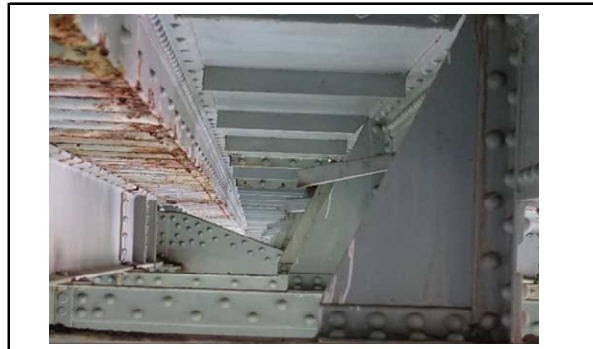
| No.: | 8-2 |

| Defect Type: | The outlets of pipes are in the extent of the bridge. |
| Description: | The pipes are short and those outlets are extent of the bridge. The drainage pipes should be lead to the outside of the bridge. |

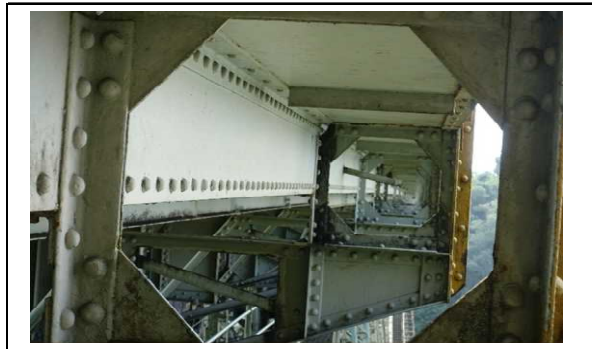
| No.: | 8-3 |

| Defect Type: | Same as left column. |
| Description: | Same as left column. |

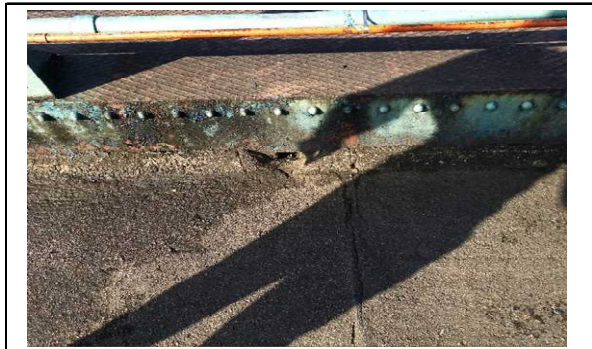
| No.: | 9-1 |

| Description: | Scupper in the footway. |

| 11 | Drainage | Footway | Insufficient pipes | Poor | Entire bridge | MM Repair | Existing | April 2022 | The pipe should extend to the outside of the bridge. Photo: 9-1, 9-2 |

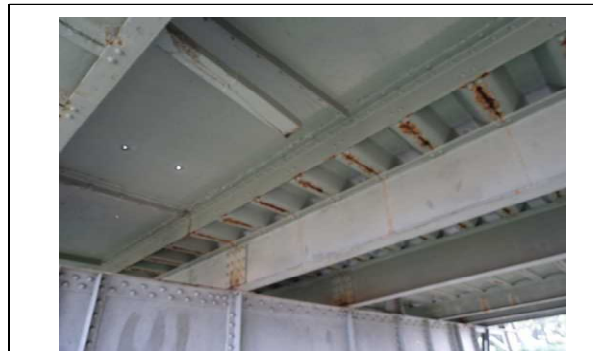
| No.: | 9-2 |

| Defect Type: | The outlets of pipes are in the extent of the bridge. |
| Description: | The pipes are short and those outlets are extent of the bridge. The drainage pipes should be lead to the outside of the bridge. |

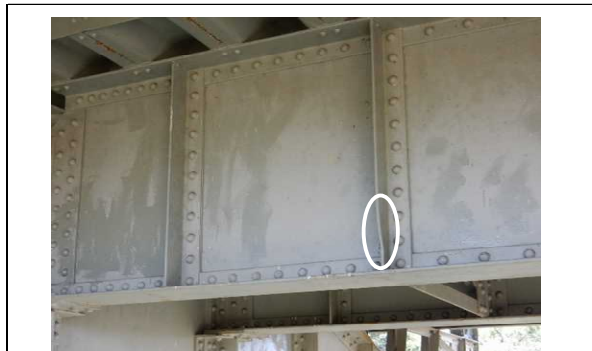
| No.: | 10-1 |

| Defect Type: | Deformation (Buckling) |
| Description: | Vertical stiffener of the girder is deformed. (bay 10) |

| 12 | Superstructure | Longitudinal girder | Deformed (Buckling) | Fair | 2 locations | MM Repair | Existing | Nov. 2021 | Vertical stiffener of the girder is deformed. (bay 10 & 11) Photo: 10-1, 10-2 |

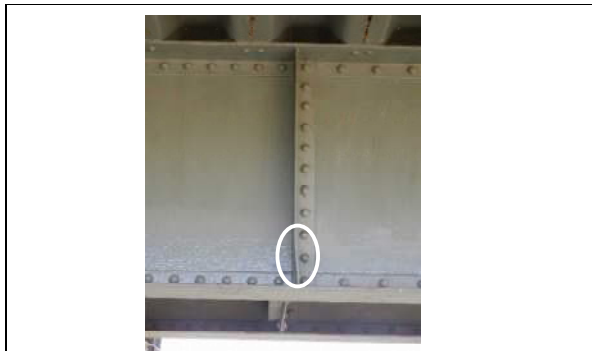
| No.: | 10-2 |

| Defect Type: | Deformation (Buckling) |
| Description: | Vertical stiffener of the girder is deformed. (bay 11) |

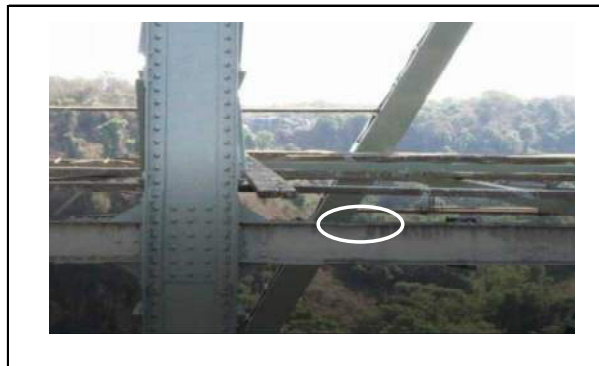
| No.: | 11-1 |

| Defect Type: | Deformation (Buckling) |
| Description: | The flange of the horizontal member is deformed. |

| 13 | Arch | Horizontal member | Deformation (Buckling) | Fair | 2 locations | MM Repair | Existing | Nov. 2021 | The flanges of the horizontal members are deformed (bay 25, 27). Photo: 11-1, 11-2 |

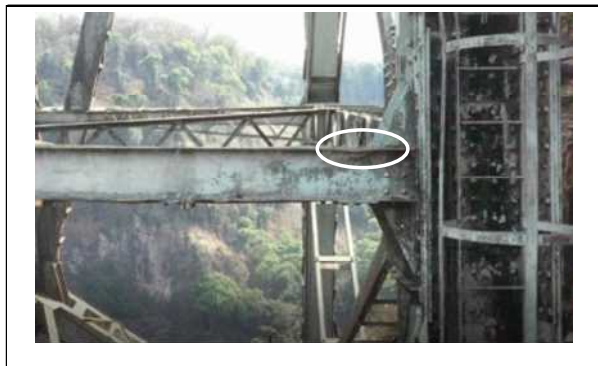
| No.: | 11-2 |

| Defect Type: | Deformation (Buckling) |
| Description: | The flange of the horizontal member is deformed. |

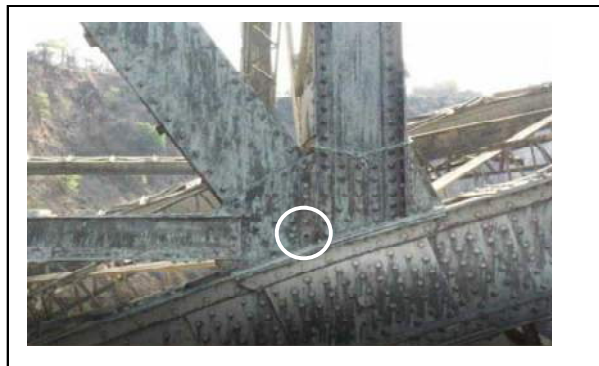
| No.: | 12 |

| Defect Type: | Missing ribet |
| Description: | 1 ribet is missing on the splice plate. |

| 14 | Arch | Grid point | Missing ribet | Fair | 1 location | MM Repair | Existing | Nov. 2021 | Installation of a bolt is necessary. Photo: 12 |

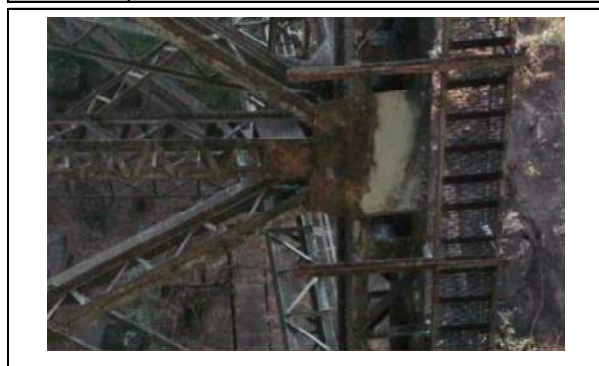
| No.: | 13-1 |

| Defect Type: | Corrosion |
| Description: | Rusting has occurred on many of the members inside the arch main structure. By the drone survey, the underside of the Arch Liv has areas of rusting. |

| 15 | Arch | Grid points | Corrosion | Poor | Many of arch members | MM Repair | Existing | Nov. 2021 | Rusting has occurred on many of the members inside the arch main structure. By the drone survey, the underside of the Arch Liv has areas of rusting. Repainting is necessary. Photo: 13-1 to 13-3 |

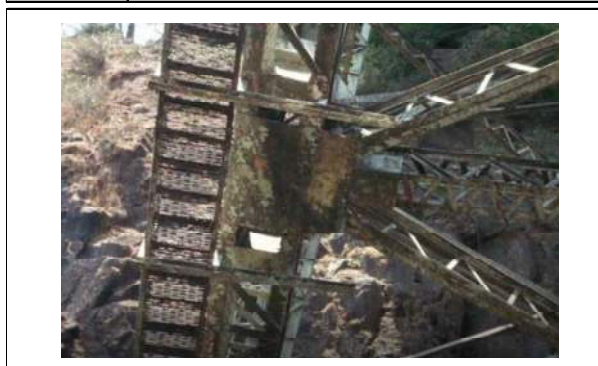
| No.: | 13-2 |

| Defect Type: | Corrosion |
| Description: | Same as left column. |

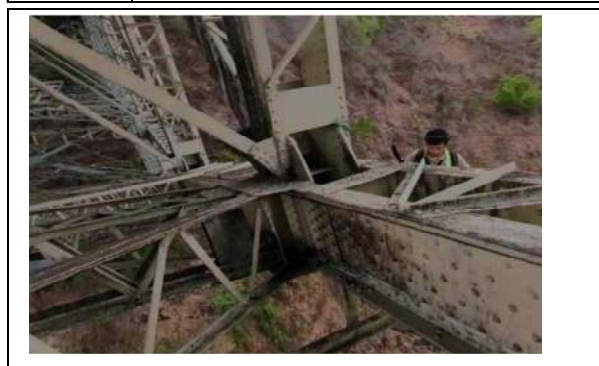
| No.: | 13-3 |

| Defect Type: | Corrosion |
| Description: | Same as left column. |

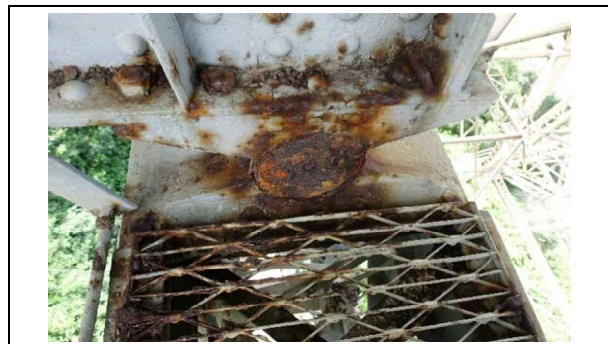
| No.: | 14-1 |

| Defect Type | Corrosion |
| Description: | Fixed bearings of truss span at the arch side are corroded. |

| 16 | Bearing (Truss span) | Fixed bearing | Corrosion | Bad | 4 bearings | In-depth inspection & MM Repair | Existing | April 2022 | Fixed bearings of truss span at the arch side are corroded. Repair or replacement is needed. Photo: 14-1, 14-2 |

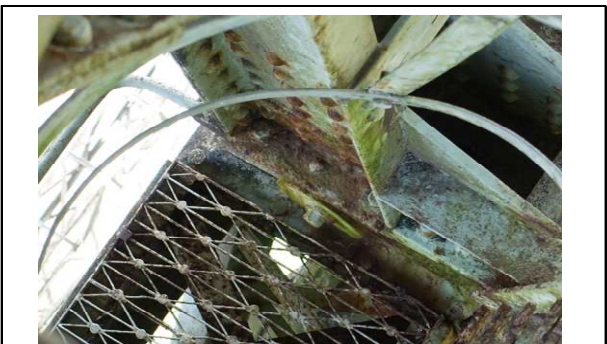
| No.: | 14-2 |

| Defect Type | Corrosion |
| Description: | Same as left column. |
