BRIDGE MAINTENANCE CAPACITY BUILDING IN ZAMBIA

BRIDGE ROUTINE MAINTENANCE GUIDELINES

2024

**Road Development Agency
Japan International Cooperation Agency**

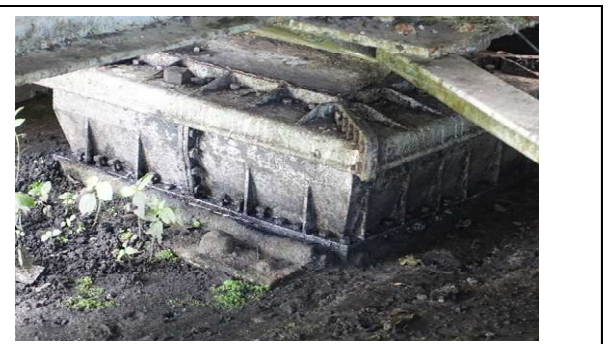
| No.: | 14-3 |

| Description: | Movable bearings of truss span are covered with the boxes. Condition inside boxes is unknown. |

| 17 | Bearing (Truss span) | Movable bearing | | | 4 bearings | In-depth Inspection | Existing | April 2022 | Movable bearings of truss span are covered with the boxes. Condition inside boxes is unknown. Photo: 14-3 |

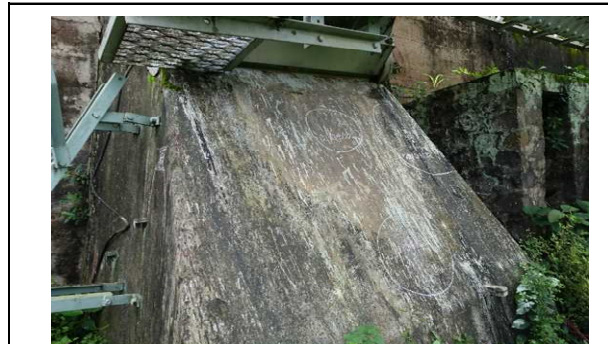
| No.: | 15-1 |

| Defect Type | Lower shoe is buried |
| Description: | The bearing of the springing of the main arch has the lower shoe buried in the concrete base unlike the drawing. |

| 18 | Bearing (Arch) | Zimbabwe side | Lower shoes buried Mortar cover detached | Fair | 4 bearings | In-depth inspection RM Repair | Existing | April 2022 | The bearing of the springing of the main arch has the lower shoe buried in the concrete base unlike the drawing. The mortar cover on the concrete foundation is detached and partially peeling. Photo: 15-1 to 15-4 |

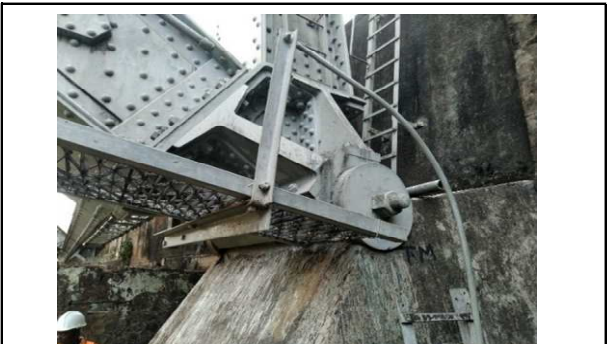
| No.: | 15-2 |

| Defect Type | Lower shoe is buried |
| Description: | Same as left column. |

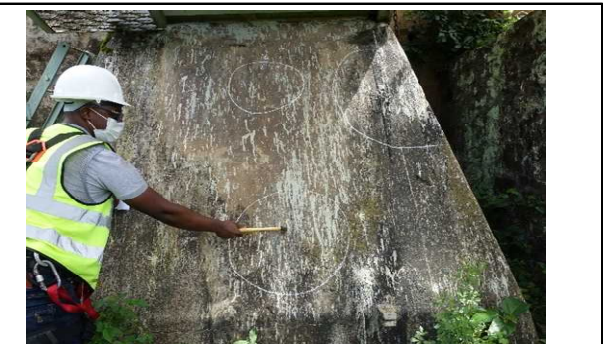
| No.: | 15-3 |

| Defect Type: | Mortar cover detached |
| Description: | The mortar cover on the concrete foundation is detached and partially peeling. |

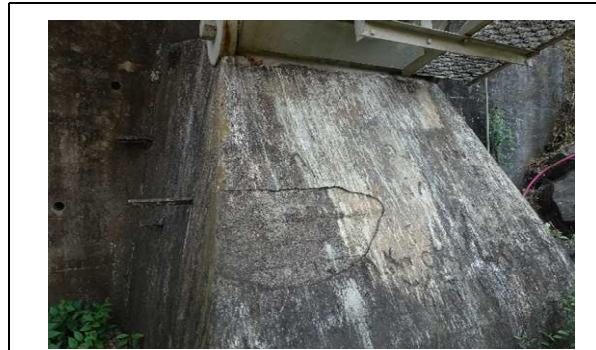
| No.: | 15-4 |

| Defect Type: | Mortar cover detached |
| Description: | The mortar cover on the concrete foundation is detached and partially peeling. |

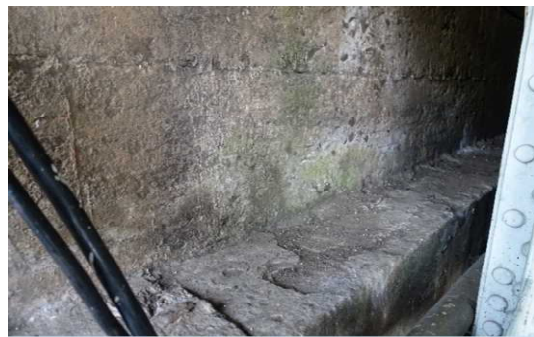
| No.: | 17-2 |

| Defect Type: | Cracks, Loose Concrete, Surface weathering |
| Description: | Same as the above |

| 20 | Abutment | Zimbabwe side | Cracks | Poor | Several locations | RM Repair | Existing | April 2022 | Cracks, loose concrete, and other damage have occurred on the front and top surfaces of the abutment. Photo: 17-1, 17-2 |

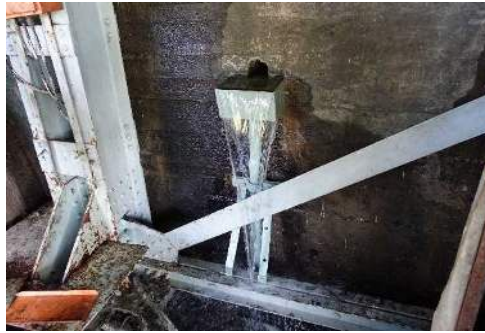
| No.: | 16 |

| Defect Type: | Overflow of drainage system |
| Description: | The drainage system installed in the abutment wall is overflowing. |

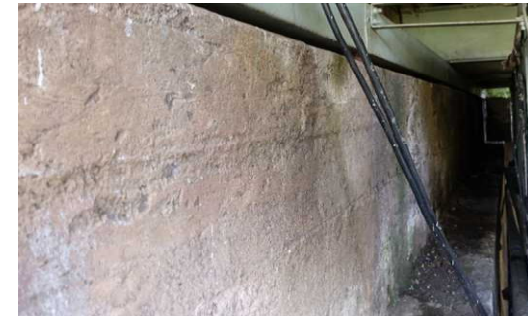
| No.: | 17-1 |

| Defect Type: | Cracks, Loose Concrete, Surface weathering |
| Description: | Cracks, loose concrete, and other damage have occurred on the front and top surfaces of the abutment. |

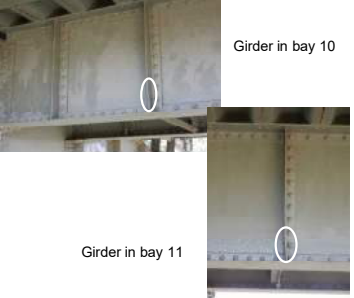
| Location | Defects | Photography | Probable Causes |
|---|---|--|---|
| Superstructure/ Longitudinal Girder | Deformation of vertical stiffness | <p>Girder in bay 10</p> <p>Girder in bay 11</p> | <p>Temporarily large forces (bending moment and shear force) acted on the steel girder web, causing some of the vertical stiffeners to buckle.</p> <p>Or, external forces acted on the vertical stiffeners.</p> <p>The steel girder seems to maintain its load-bearing capacity thereafter.</p> |

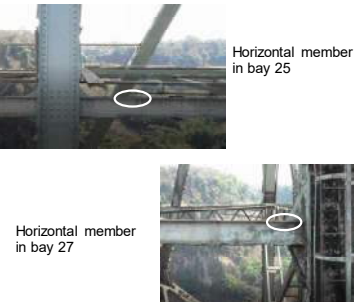
| Location | Defects | Photography | Probable Causes |
|---|---|--|---|
| Arch/ Horizontal member | Deformation (Buckling) | <p>Horizontal member in bay 25</p> <p>Horizontal member in bay 27</p> | <p>Some force acted on the horizontal member and buckled the flange in that area.</p> |

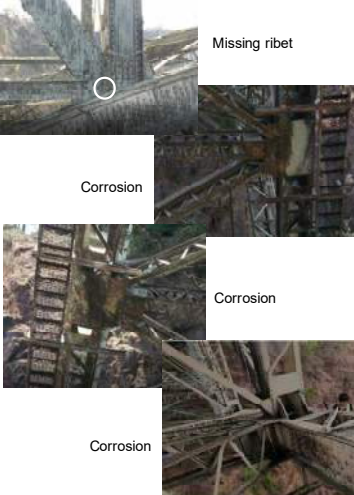
| Location | Defects | Photography | Probable Causes |
|---|---|--|---|
| Arch/ Grid points | Missing Ribets & Corrosion | <p>Missing ribet</p> <p>Corrosion</p> <p>Corrosion</p> <p>Corrosion</p> | <ul style="list-style-type: none"> •Missing bolts --- Ribet broken or loosened •Corrosion --- This may be due to rainwater and water from Victoria Falls spraying on the bridge and stagnating along the arch ribs. •For arch structures, the Arch Main Structure (Arch Riv, Upper Cord Members, Vertical Members, Diagonal Members and Horizontal Members) has been repaired with timely painting. But the underside of the Arch Riv has areas of rusting (Drone survey results). <p>And, rusting has occurred on many of the members inside the Arch Main Structure (Horizontal Members perpendicular to the bridge axis, Sway Bracings, Transverse members and other supporting members).</p> |

However, corrosion is ongoing in the Deck steel troughs, Steel members and those grid points of the Arch structure, and Bearings of trusses which are on the arch ends. The concrete foundations of the arch bearings have different shapes from the original design drawing, and the lower portions of the shoes are buried in the foundations.

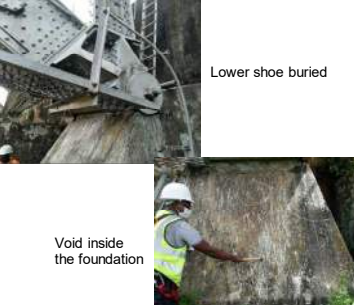
| Location | Defects | Photography | Probable Causes |
|---|---|--|---|
| Bearing of Arch (Springing) | Zimbabwe side downstream bearing --- Internal void noise (percussion inspection) All Bearings --- the lower shoes are buried in the concrete bases. (different from the original drawings) | <p>Lower shoe buried</p> <p>Void inside the foundation</p> | <ul style="list-style-type: none"> •Inside void --- The mortar cover on the concrete foundation is detached and partially peeling. •Lower shoes buried in concrete foundation --- May have been changed during construction. |

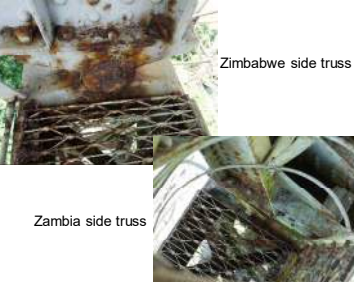
| Location | Defects | Photography | Probable Causes |
|---|---|--|---|
| Bearing of Truss/ Arch side | Corrosion | <p>Zimbabwe side truss</p> <p>Zambia side truss</p> | <p>This may be due to rainwater and water from Victoria Falls spraying on the bridge and stagnating at the bearings.</p> |

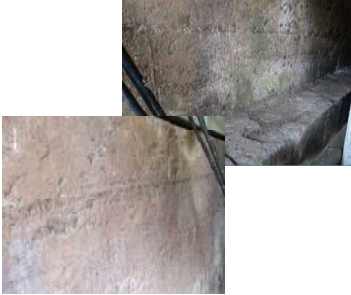
| Location | Defects | Photography | Probable Causes |
|---|--|---|--|
| Abutment/ Zimbabwe side | Cracks, Loose Concrete, Surface weathering | | Over the long years (117 years), the concrete surface has weathered and cracks and other damage have occurred. |

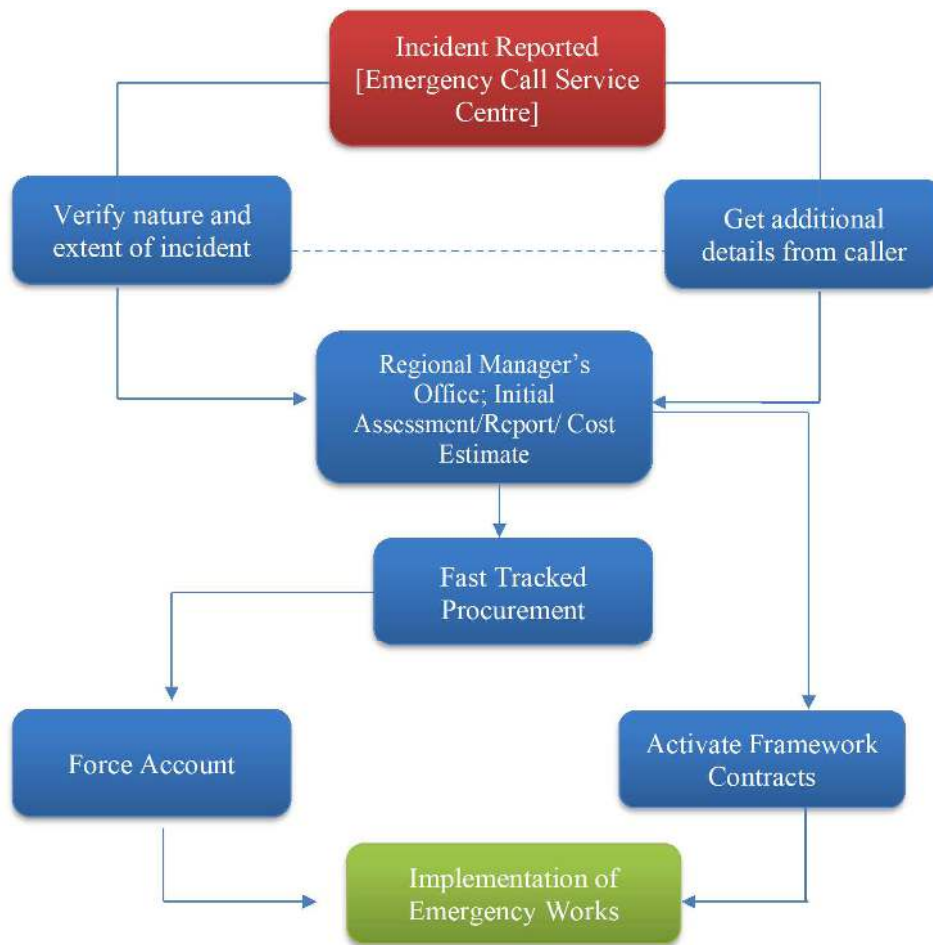
Figure 6-1 Emergency Response Flow Chart

Figure 6-1 shows the emergency response flow chart through either Force Account or Framework Contract approach. The RDA will maintain to a limited extent Force Account works for emergencies while at the same time use Framework and Supply Contracts to deal with all major emergency works in the regions.

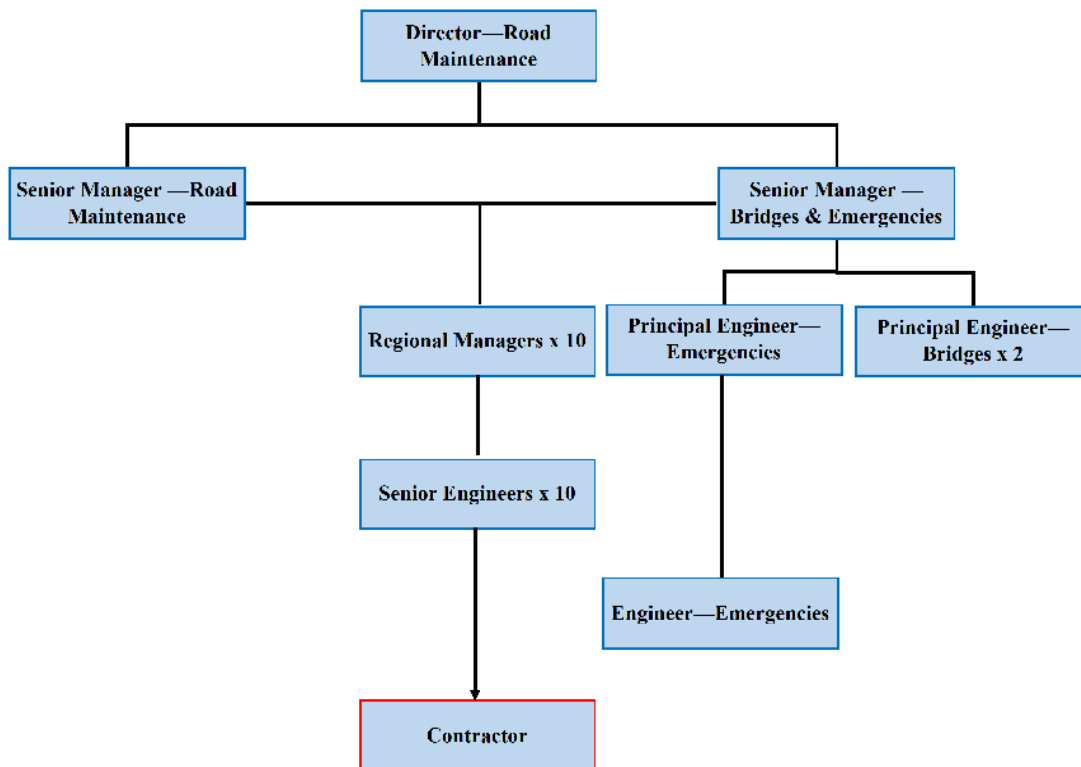
Figure 6-2 The RDA Emergencies Organization Chart

Figure 6-2 shows the RDA Emergencies Organization Chart

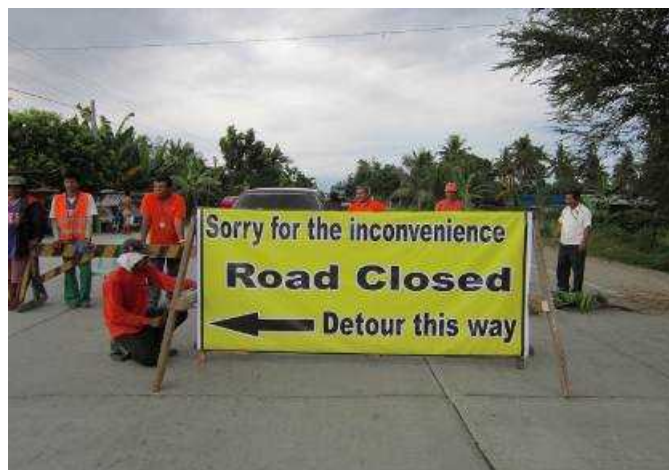
Photo 6-1 Warning signs and Barricades

- Install appropriate warning signs and barricades

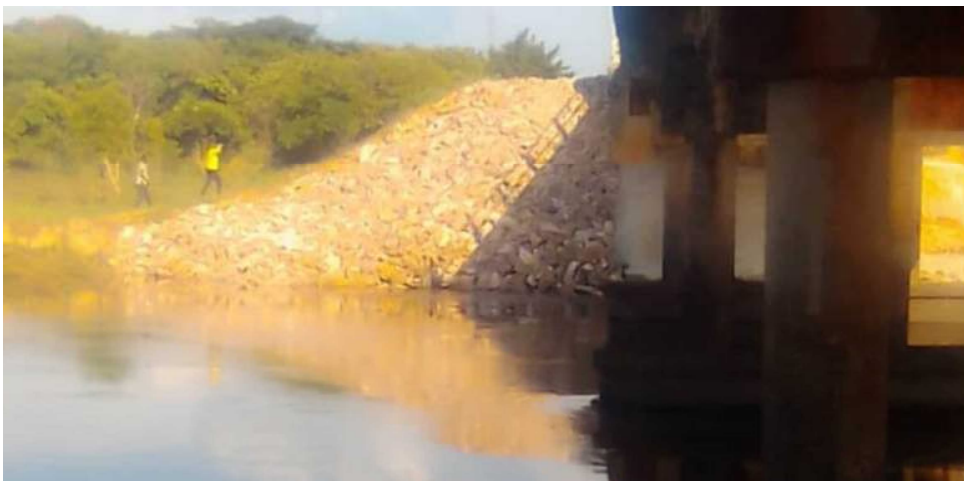
Photo 6-3 Repair around abutments

- Immediate repair of damaged portion of bridge to ensure safety and stability of structure.

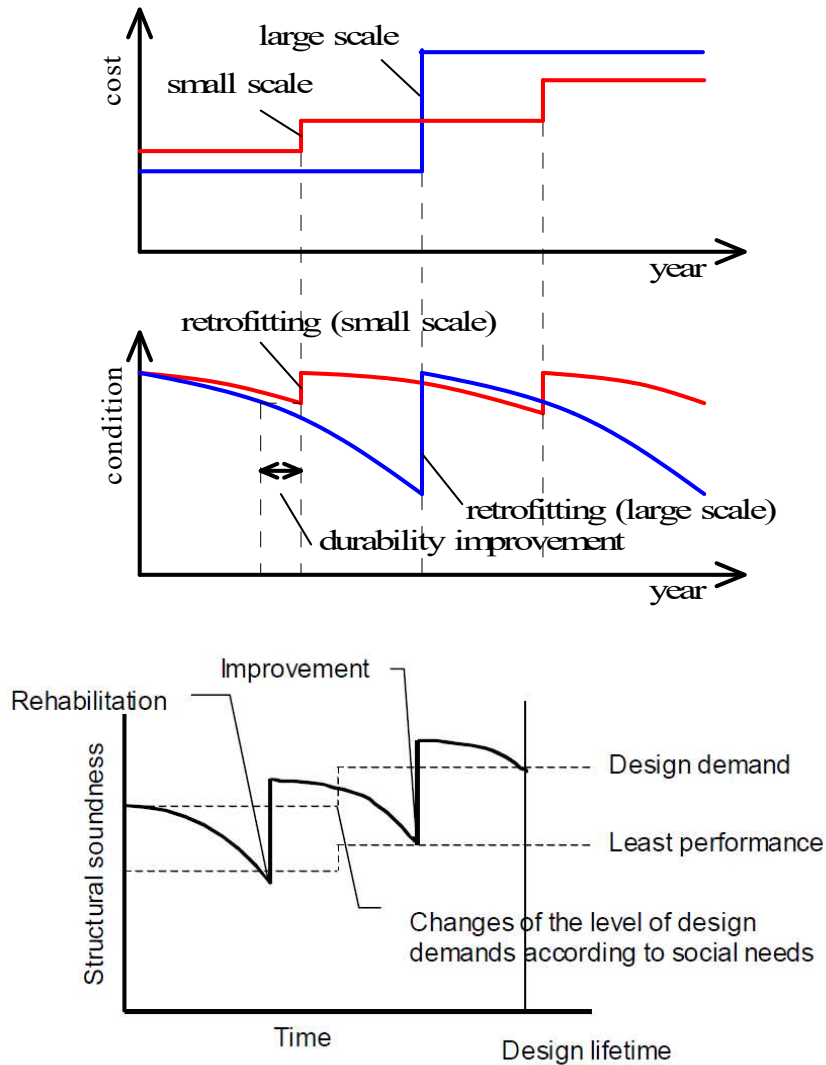
Figure 1-2 Concept of LCC Minimization

Most important key word is “Early inspection and Early maintenance”. JICA Team recommends RDA to implement Preventive maintenance in the near future, so that bridge life can be prolonged.

$$\text{LCC (Life Cycle Cost)} = \text{I} + \text{M} + \text{R}$$

(I : Initial Cost, M : Maintenance Cost, R : Renewal Cost)
