BRIDGE MAINTENANCE CAPACITY BUILDING IN ZAMBIA

BRIDGE INSPECTION GUIDEBOOK

2024

**Road Development Agency
Japan International Cooperation Agency**

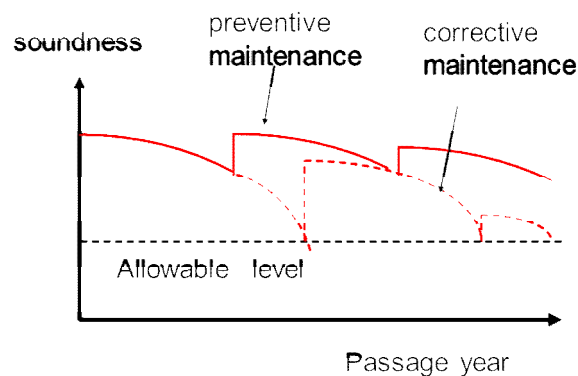
Figure 1-1 Comparison of Maintenance Method

Bridge maintenance is classified into two types, Preventive Maintenance or Corrective maintenance. Preventive Maintenance minimizes the LCC by implementing the countermeasures at the initial stage before the damage gets worse.

In case of Corrective Maintenance, if the bridge condition become serious due to damage, then an immediate replacement of the bridge will be necessary. Preventive maintenance is more preferable than corrective maintenance because of the LCC, small-scale repairs will cost less than large-scale repairs. In order to carry out preventive maintenance, early detection of damage is important. Therefore, a periodic inspection is necessary.

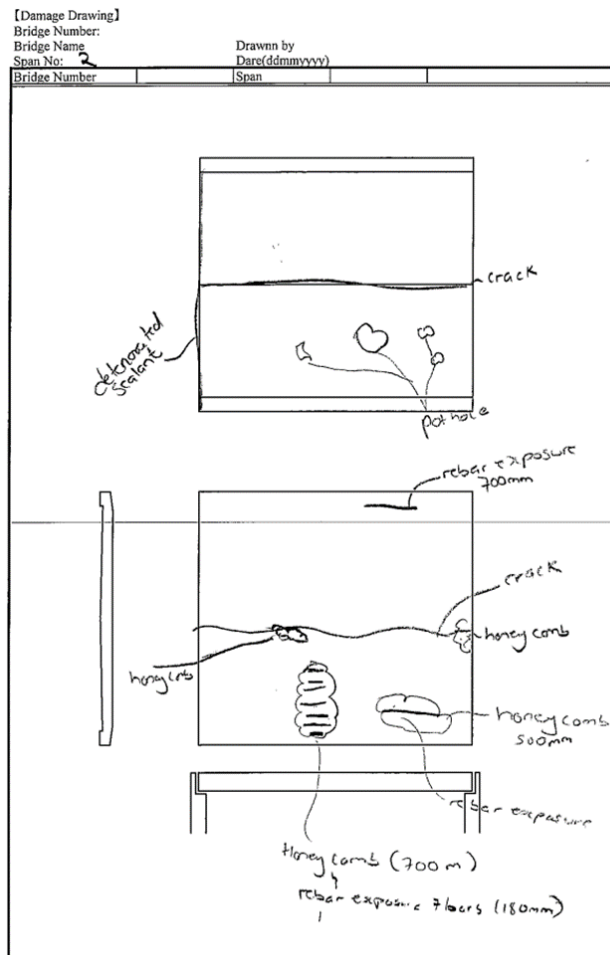
Figure 2-1 Sketch of Damage

Sketches of damage can be made on forms. The sketch should show the necessary plan and elevation views of the attribute to which they pertain. All damages should be located on the sketches by dimensioning their location in reference to the beginning or end of each attribute. For each damage the accredited bridge inspector should indicate dimensions showing its length, width, and depth (if applicable).

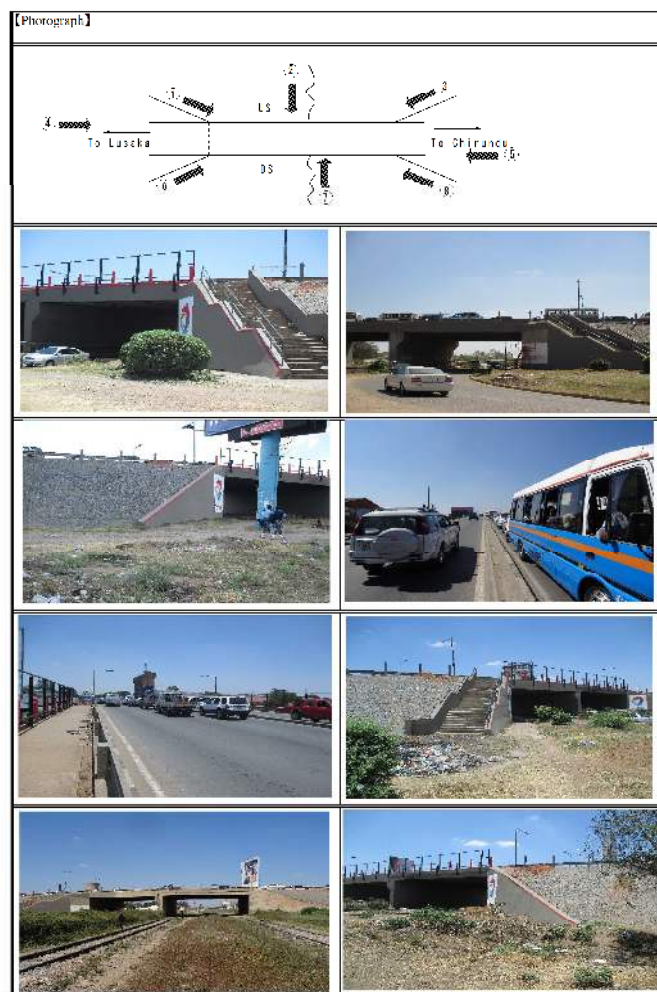
Figure 2-2 Photograph Record (1)

1. Photographic Record
2. Front View from traffic origin: One general photograph from top of deck showing alignment, width, kerbs and barriers.
3. Side View (Each span) from upstream: One photograph from side of bridge showing piers, abutments and waterway or roadway.
4. Under the bridge (Each Span) from upstream: One photograph from under of bridge showing piers, abutments and waterway or roadway.
5. Representative photographs of main superstructure components(i.e. girders), from underneath or side of the structure, used in:
 - The original structure
 - Any modifications (i.e. widening, lengthening, etc.)

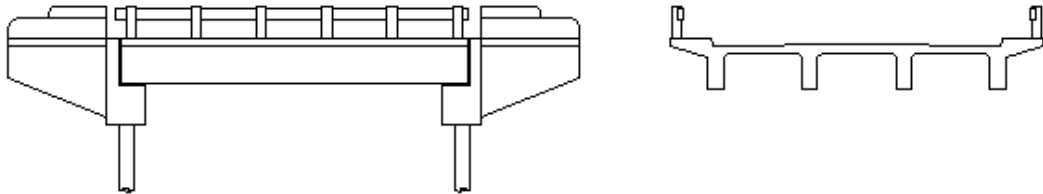
Figure 3-1 Girder

Simple Girder	A girder is supported on two points.
Continuous Girder	A girder is supported on three points or more.
Cantilever Bridge	Continuous girder with hinged support in the middle of span

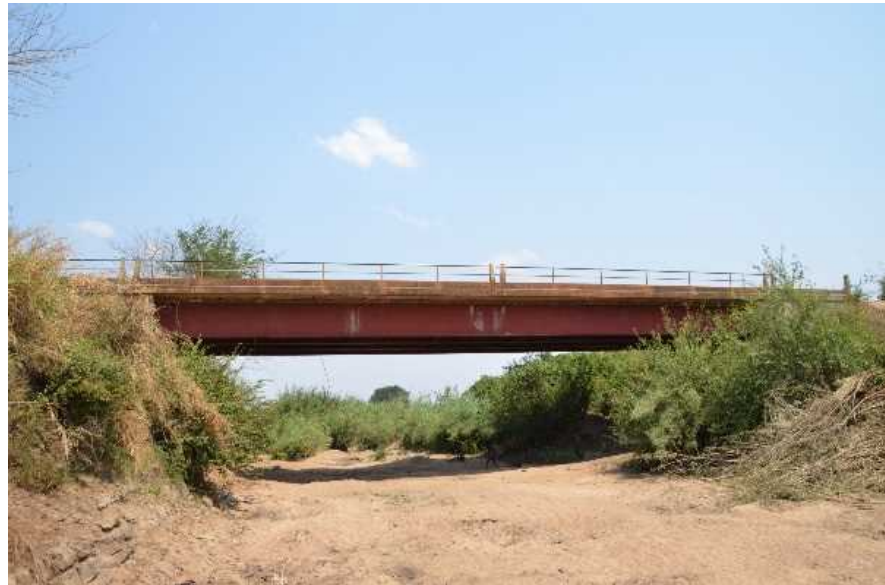
Figure 3-3 Steel Bridge

Steel has greater strength in both tension and compression than concrete. Steel used in bridge is most commonly in the form of rolled beam, welded or riveted plate girders and truss.

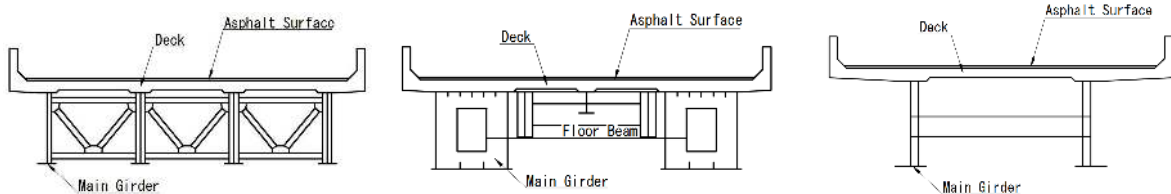
Figure 3-4 Type of Steel Bridge

Steel box girders are used for long spans, where the self-weight of the bridge needs to be minimized, and for situations where their excellent high torsional stiffness is of particular benefit.

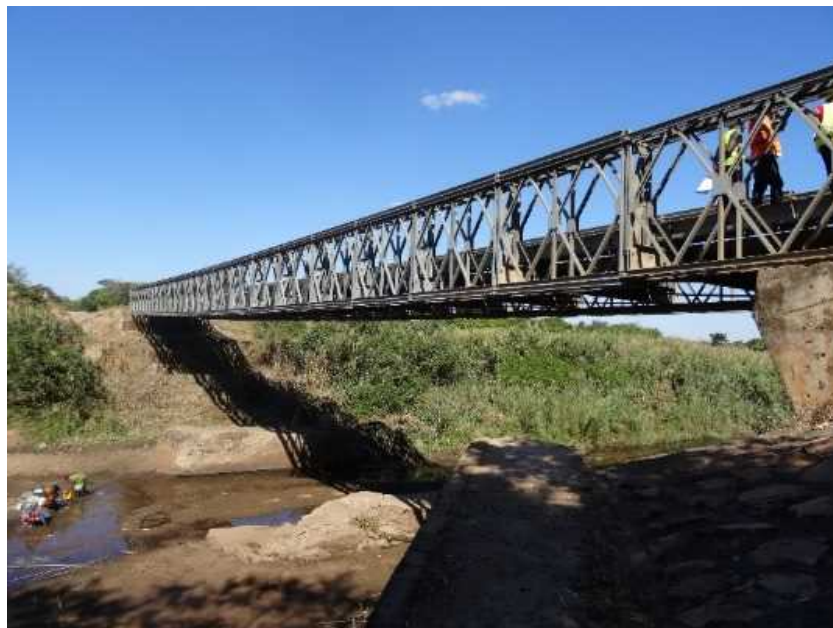
Figure 3-6 Bailey Bridge

There are some bailey bridges in Zambia. The bailey bridges are military truss firstly developed in England during World War II. For the light weight and small members, each members can be carry along by the track. Generally they are used temporary bridges. As for the merits, election of girder have no need of heavy equipment.

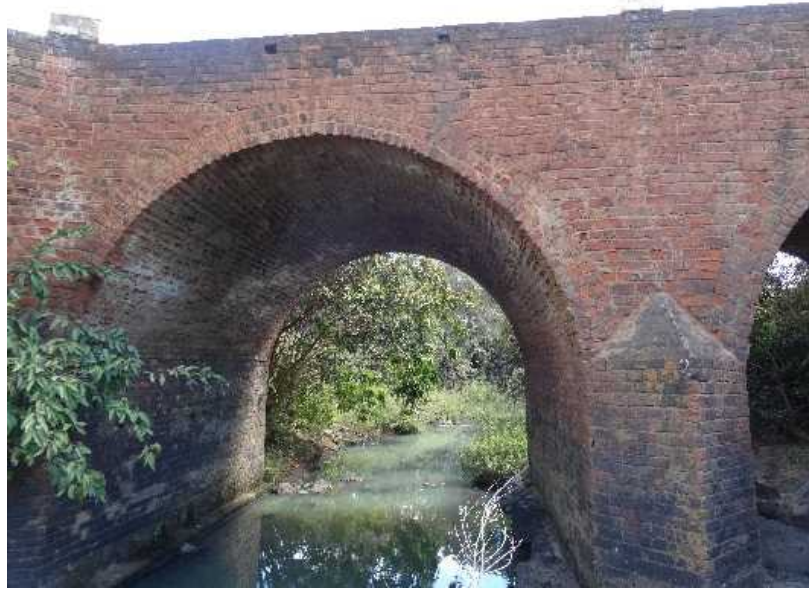
Figure 3-7 Masonry Bridge

Masonry consists of bricks or stones with sand and cement mortar in joints between them. It is strong in compression and weak in tension, like mass concrete. Masonry is used for constructing masonry arches, abutment, piers and retaining walls.

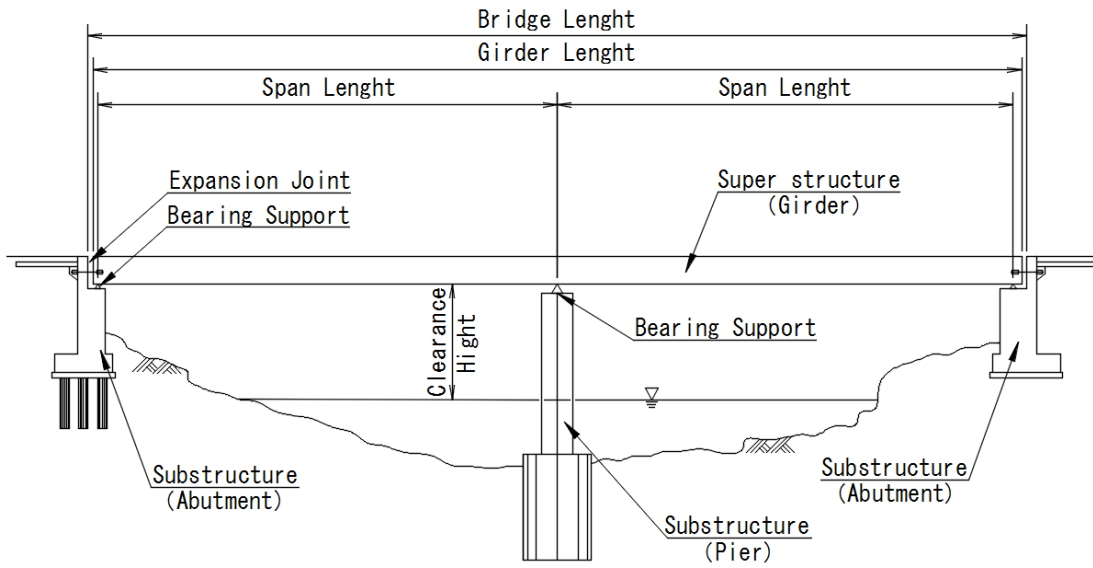
Figure 3-13 Bridge Component (1)

A Bridge is basically divided into two components namely superstructure(s) which extend to cover entire bridge length to support the road surface and substructure(s) which support the superstructure(s). Other important components of a bridge are bearing support(s) which connects superstructure(s) and substructure(s), and expansion joints which allow movement of superstructure(s) at the end of superstructure(s). Substructures are divided into two type of structures, abutments and piers.

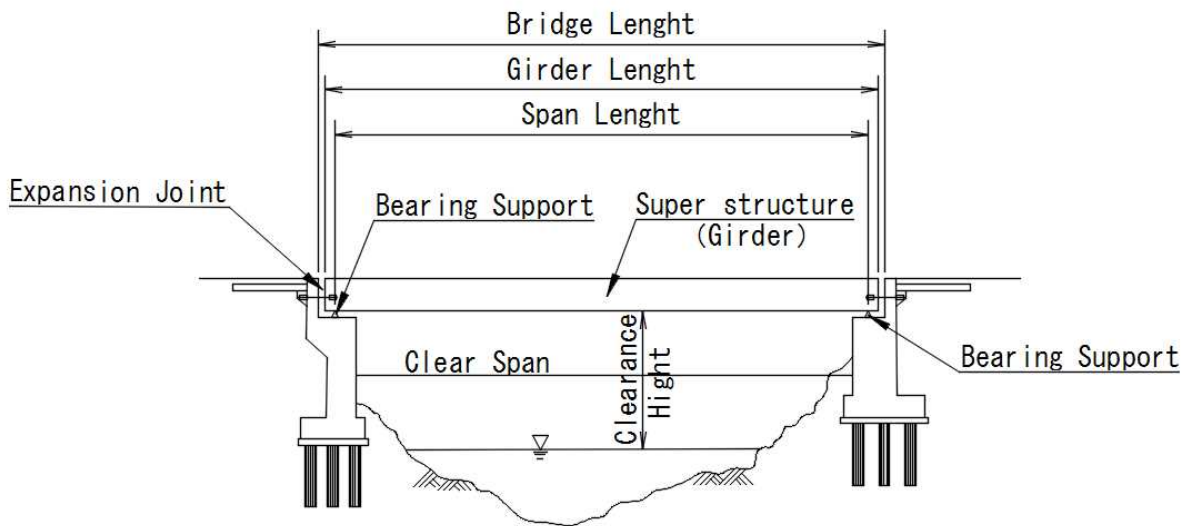
Figure 3-14 Bridge Component (2)

Bridge consists of various kinds of components with different durable years. Component (A) with short durable years, which usually affect traffic safety and component (B) with long durable years, which affect stability strength and durability of the bridge structures themselves, shall be separately judged. Routine inspection mainly targets component A and Periodic inspection targets both component A and B.

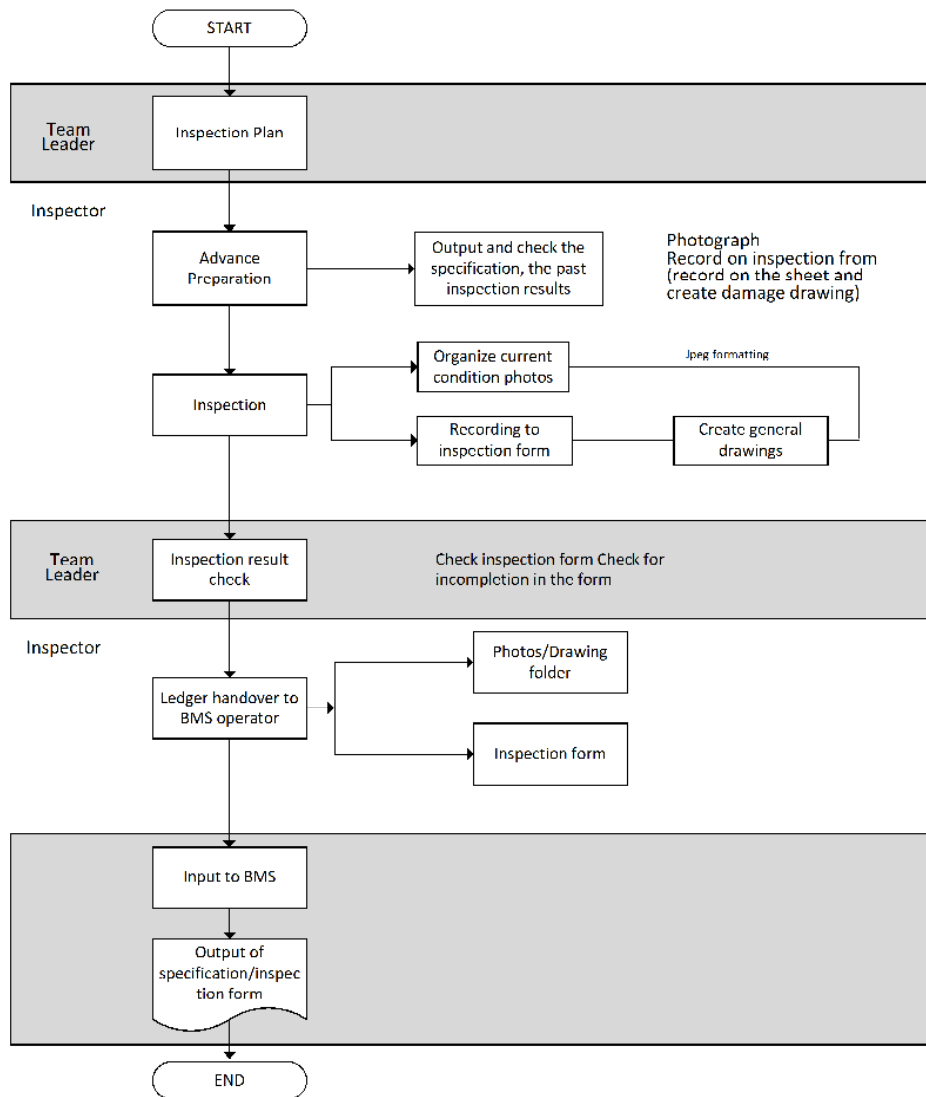
Figure 4-1 Work Flow

The inventory inspection results shall be input in BMS.

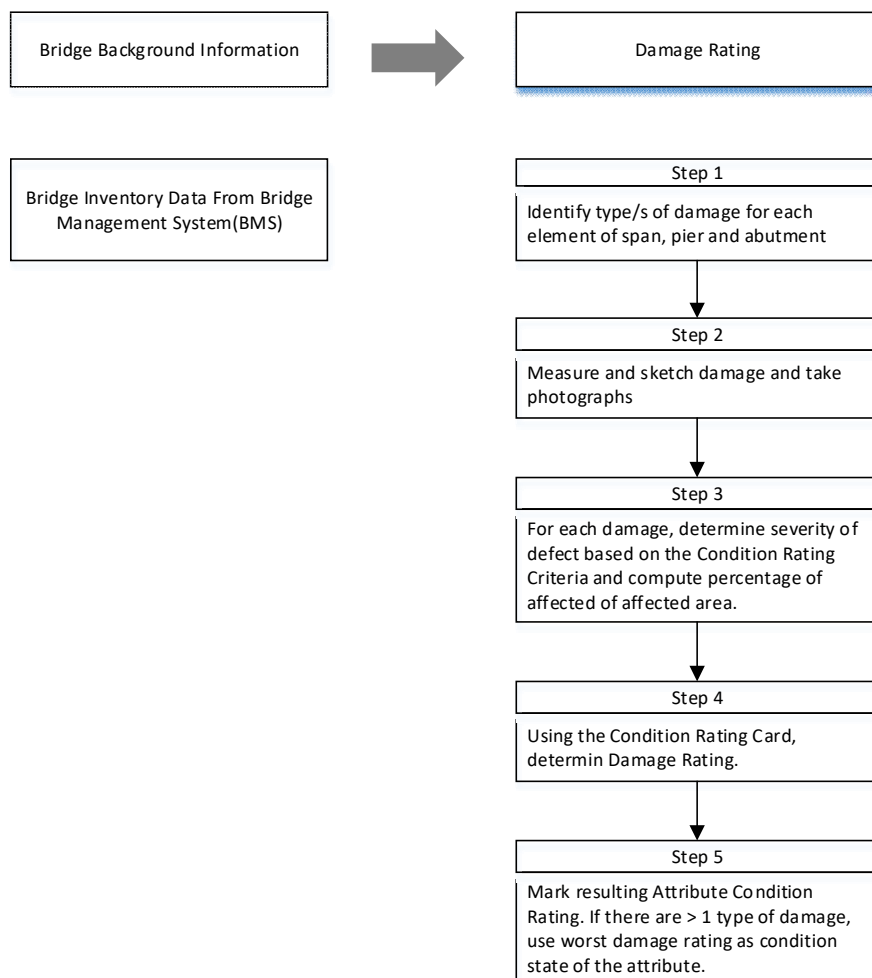
Figure 5-1 Process of Inspection

The process for undertaking condition survey is illustrated in Figure5-1.

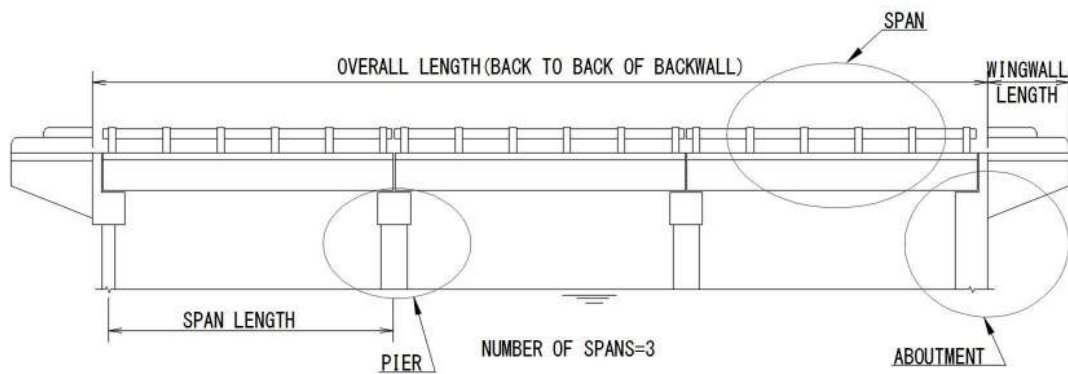
Figure 5-2 Bridge Elements

Bridges are composed of span, pier and abutment elements as shown in Figure 5-2. Each element has a standard set of defined component that cover all the features of the element in general terms.

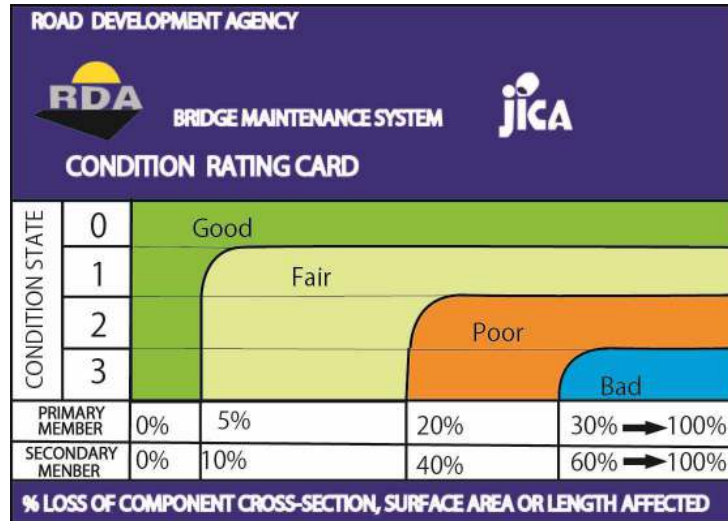
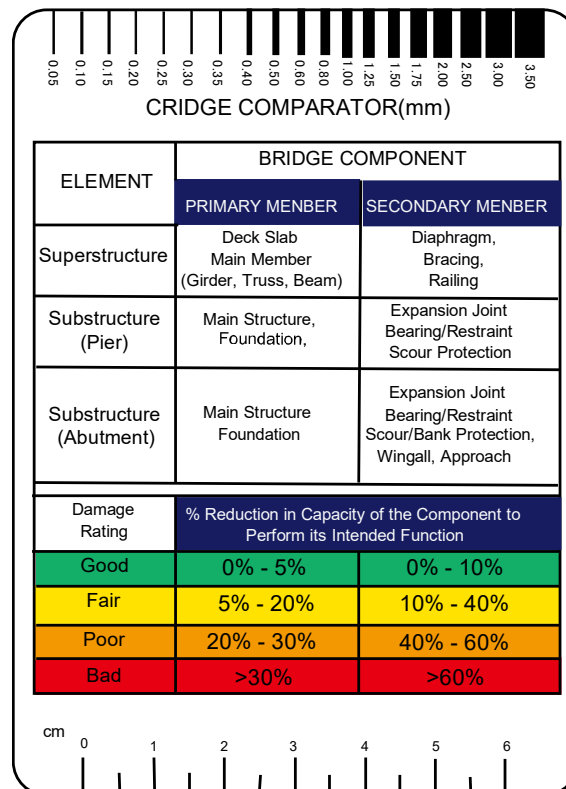
Figure 5-3 Condition Rating Card

Type of Material	Type of Damage		Severity of Defect	Affected		Damage Rating	Overall Rating
				Unit	%		
DECK							
Concrete Slab	×	Cracking	3	-	-	Bad	3
		Spalling/Scalling/Disintegration					
		Rebar exposure/corrosion					
		Honeycomb					
	×	Water leakage	2	Area	26	Poor

The bridge is a concrete girder bridge with a RC deck slab supported directly on the main members consisting of beams. In this case, there are no secondary members component for Span 1 therefore the box for “Not Applicable” will be marked.

The bridge engineer will estimate the condition state of each bridge component shown in the CIF based on a detailed visual inspection each component. The affected area, length or number of components will then be roughly estimated which will be the basis in assessing the severity of defects using the Condition Rating Card (Figure 5-3) and eventually deciding the condition.

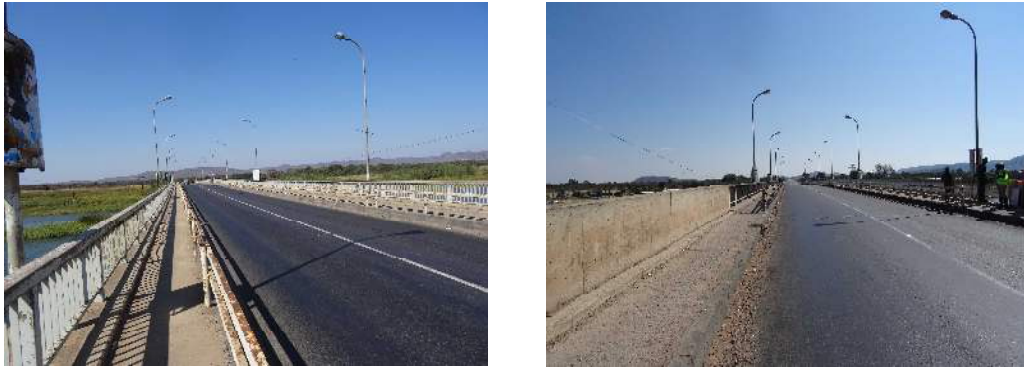
Figure 5-4 Approach Road

(1) Observe the Entire Bridge from the Approach Road

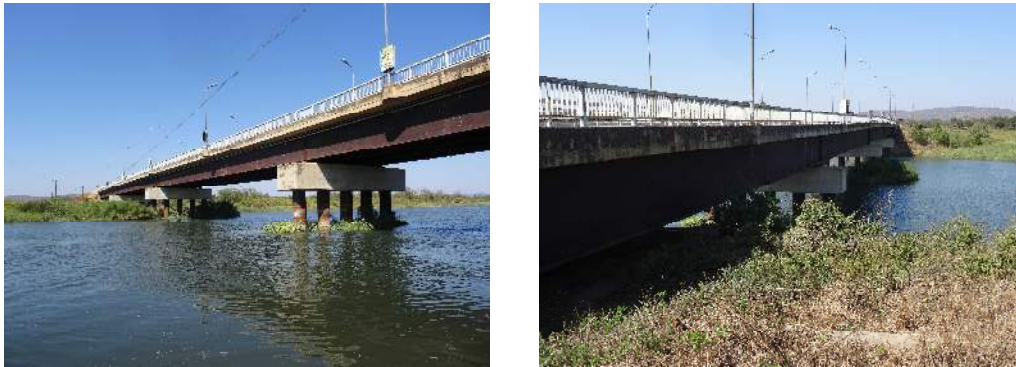
Figure 5-5 Inspection Side View

- Observe if there is a problem through the girder, railing, fellow guard.
- Detecting settlement, incline, move in substructure.

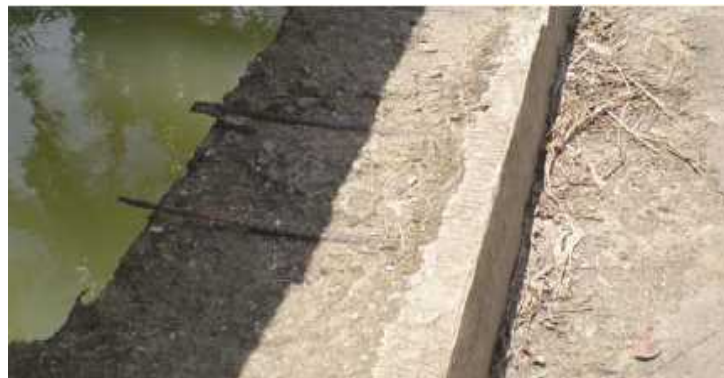
Figure 5-6 Inspection the Curb

Look at the kerb. Observe if there are defects. In photo below, rebars are already exposed.

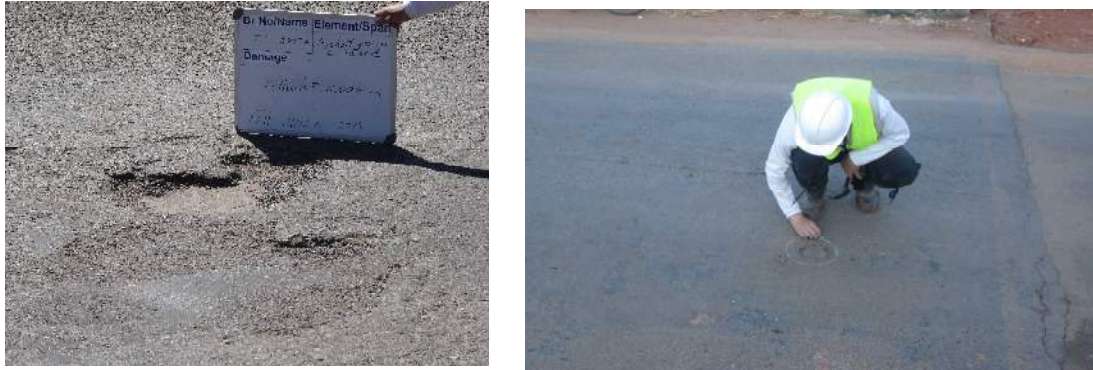
Figure 5-7 Inspect of the Pavement

Observe if there are potholes or dent, alligator cracks, large crack in the direction of the bridge axis and in a bridge axis orthogonal direction.

Detecting potholes or alligator cracks, its sign for damage of the deck slab.

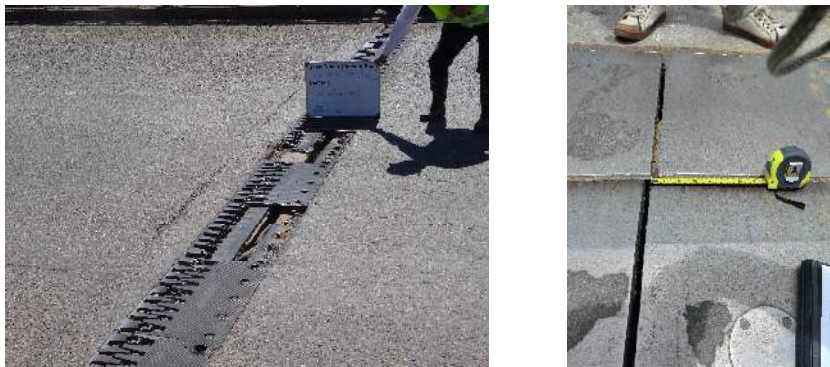
Figure 5-8 Inspect Expansion Joint

Observe if there is difference in elevation or abnormal space, whether it's broken.

Damage of the expansion joint cause traffic accident.

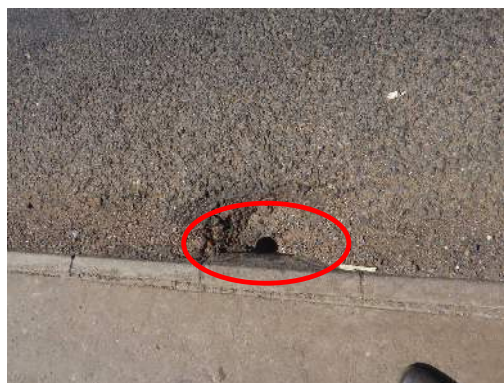
Figure 5-9 Inspect Drainage

Look at inside the drainage. If there is much debris, clean it as soon as possible

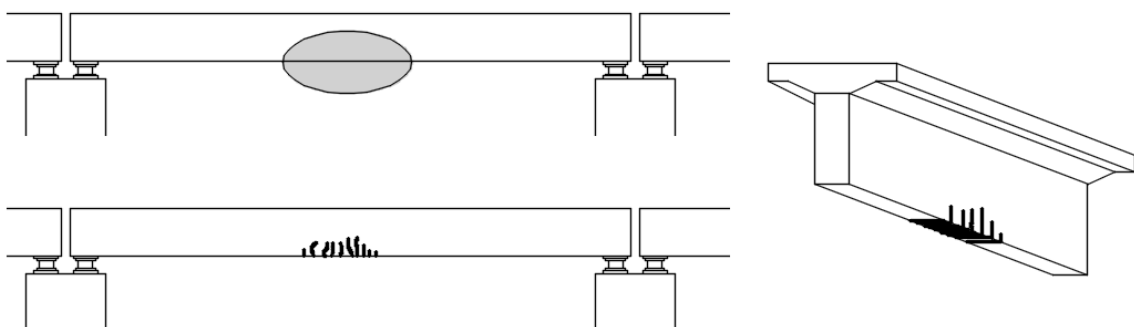
Figure 5-12 Flexural Cracks of Concrete Girder

Look for the transverse direction's cracks at bottom of concrete girder. These are flexural cracks.

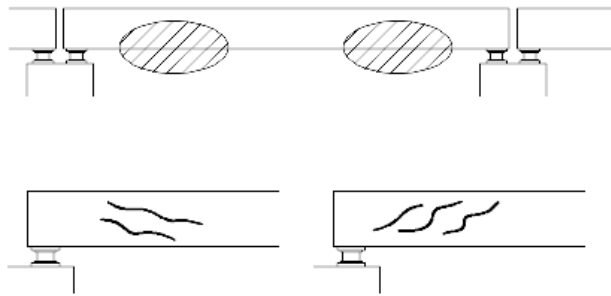
Figure 5-14 Shear cracks in Concrete Girder at 1/4 Point of Span

Look for the inclined crack line on the web near 1/4 point of span. These are shear cracks.

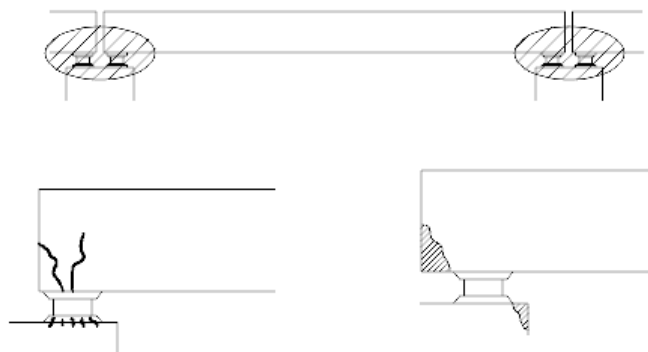
Figure 5-16 Shear Cracks in Supporting

Look for shear cracks near the bearing up to edge

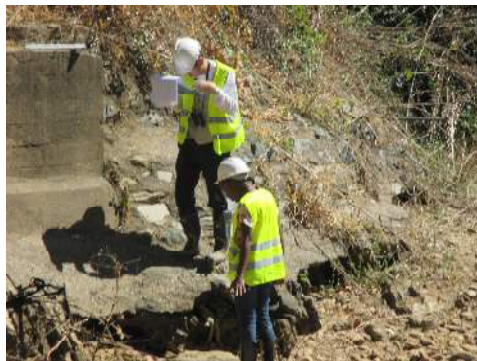
Figure 5-18 Inspect Foundation

Observe if there are incline or move or settlement, if scouring at the riverbed.

If foundation is under the water, inspection should carry out the dry season.

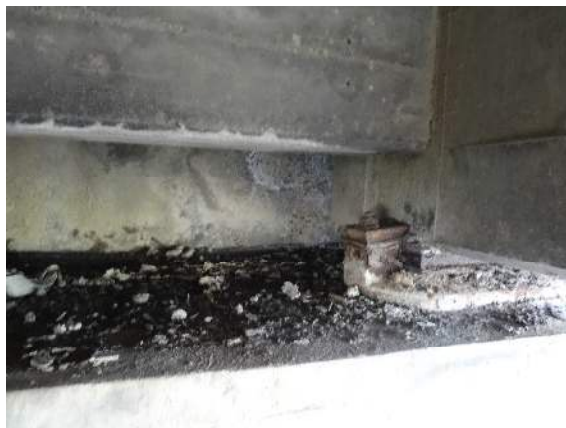
Figure 5-28 Inspect Anchor Bolts of Bearings

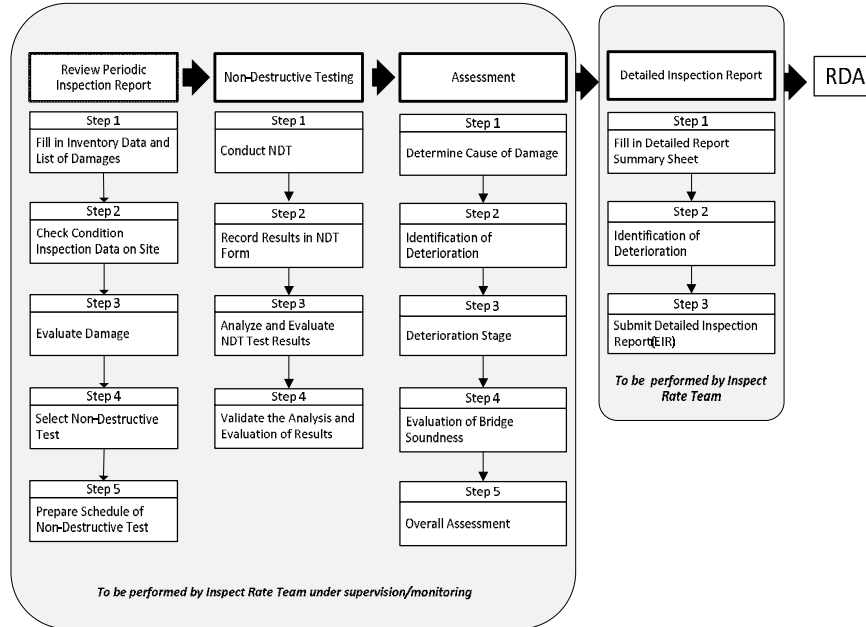
Figure 6-1 Process of Inspection

The general process for a bridge detailed inspection is shown in Figure 6-1.

This is a generic inspection model as the scope and extent of the detailed inspection will vary depending on the nature, extent, magnitude and severity of the observed defects. This type of inspection would be undertaken by the Detailed Inspect Rate team who would develop the appropriate scope necessary to address the identified defects and any particular bridge requirements.

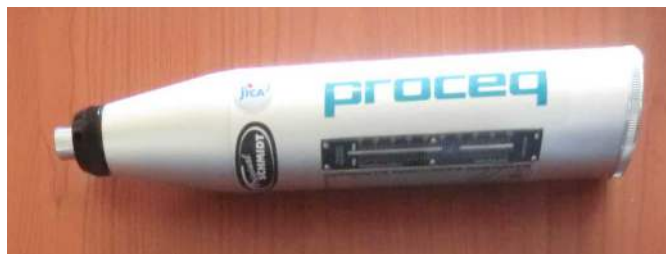
Figure 6-3 Manual Type Concrete Test Hammer

- i) Rest the plunger head at right angles to the concrete surface.
- ii) Press the hammer until it strikes the surface(Note: Do not press push-button under any circumstances when taking reading)
- iii) The hammer rebounds moving a reference pointer with it
- iv) By pushing the button, the pointer is held at its maximum position.
- v) Repeat procedures for next measurements until a total of 20 readings (Cells A1 to D5) are taken.
- vi) The hammer can be used to test surfaces

The hammer can be used to test surfaces at any inclination but only readings at any inclination but only readings at the same inclination (horizontal, up, down, etc.) shall be compared. Test inclination shall be recorded on the test sheet.

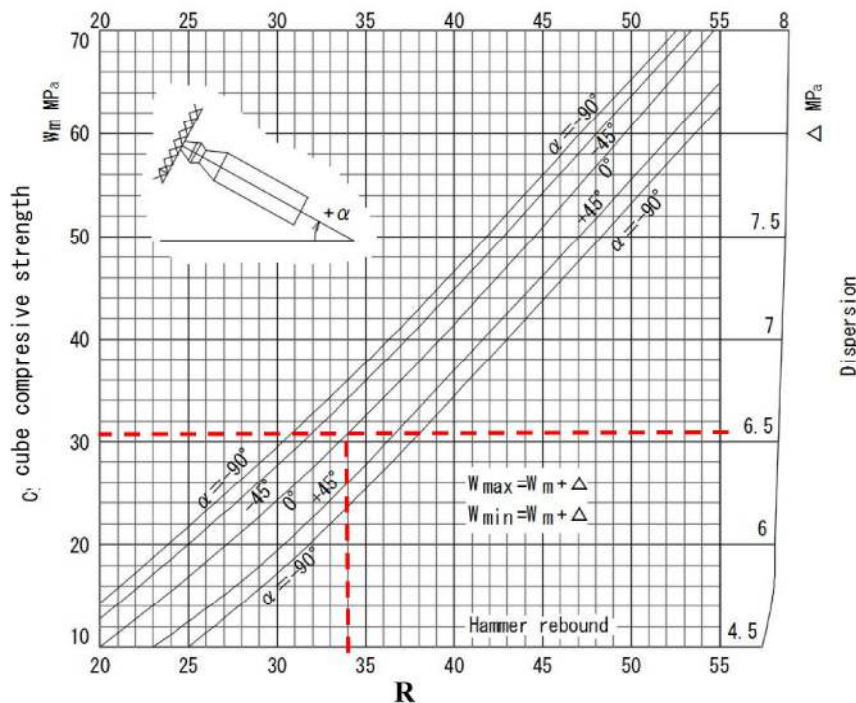
Figure 6-4 Rebound Value and Cube Compressive Strength Chart

The “R” values of rebound have been defined in such a way that they can be converted by means of diagrams, in terms of resistance to compression for tests carried out on a cube or cylinder. In the diagrams below, 5 different curves have been reproduced for cube compressive strength, which take into account the angle of inclination of the hammer. The curves take into account the effect of gravity acting upon the impact shock. Thus the test can be carried out on floors, walls, ceilings and any other inclined surface.

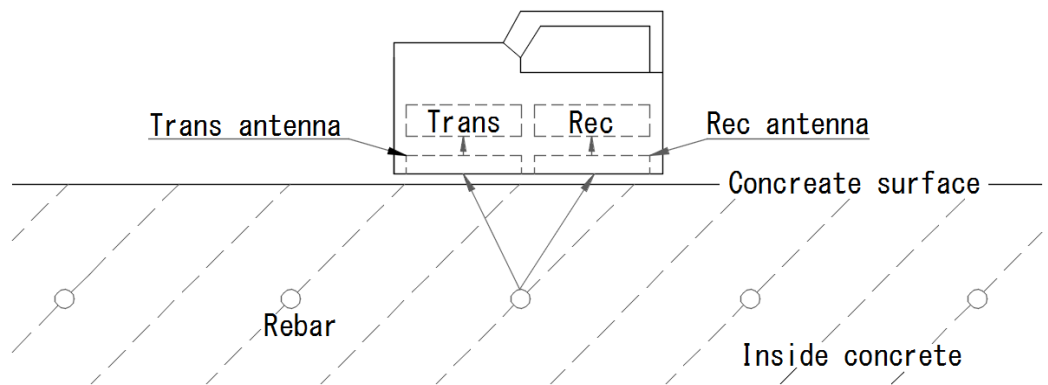
Figure 6-5 Diagram of Reflected Wave Form

Electromagnetic waves are transmitted from the antenna toward the concrete as shown in diagram below. The electromagnetic waves are reflected by an interface with the reflective objects (e.g., reinforcing steel bars or cavities) whose electrical property is different from that of concrete. The waves are reflected back into the surface of concrete and received by the receiving antenna placed near the concrete surface. The distance to the reflecting objects can be calculated from the time the waves need to reach the receiving antenna. The horizontal locations of the objects can be detected by moving the main unit on the surface of concrete.

Since this radar is designed to probe objects with high resolution that are near from the surface of concrete, it transmits pulse waves having a width of about one nanosecond(one-billionth of a second) or less.

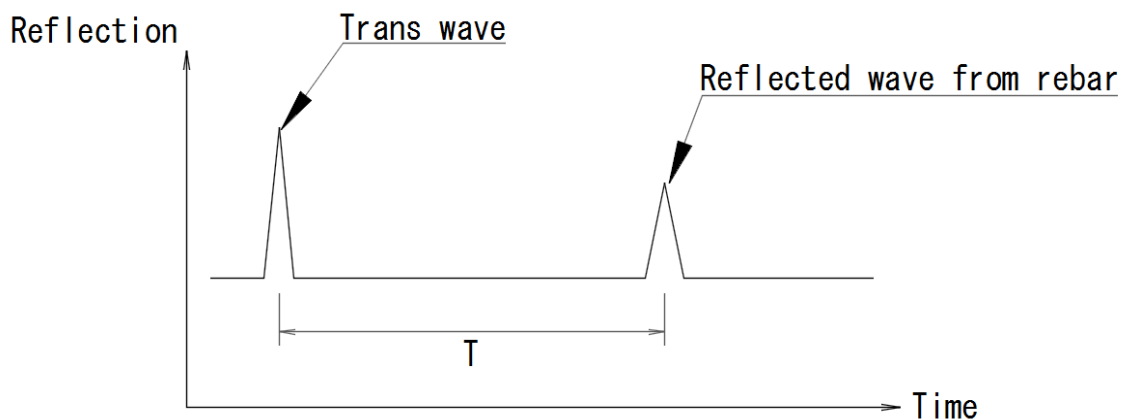
Figure 6-6 Diagram of Reflected Wave Form

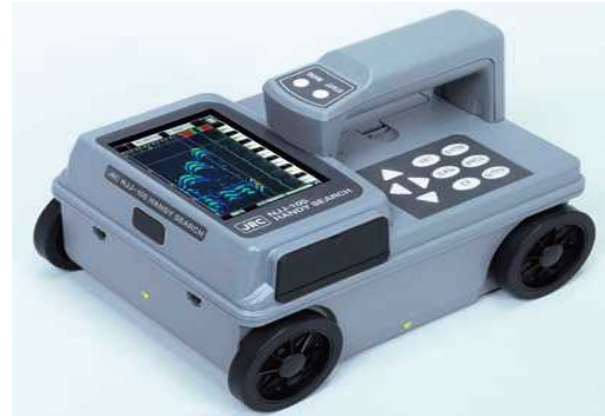
Figure 6-7
Radar Type Rebar Detector

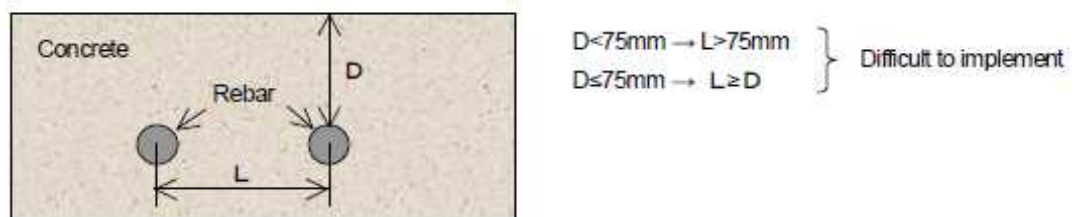
(Depth less than 75 mm with spacing between rebar less than 75 mm

Depth greater than 75 mm with spacing between rebar less than depth)

Figure 6-8 Inapplicable Measuring Conditions

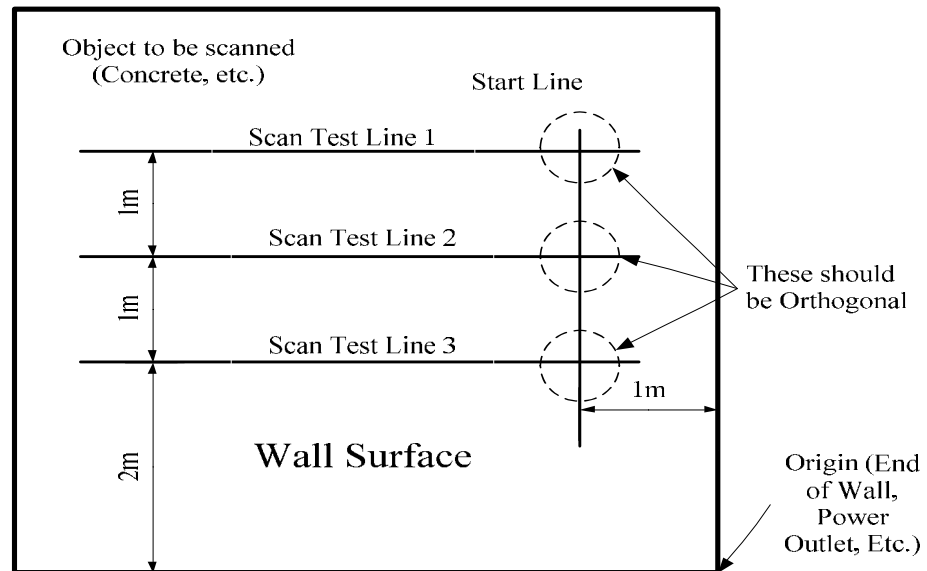
Figure 6-9 Example of Scan Test Set-up

- a) Using chalk(or similar tool) make markings on the concrete surface to indicate where to start testing(stating line) and where to scan(scan test line)
- b) Make sure the start line and the scan test line are orthogonal (Perpendicular to each other). (As necessary, in other to perform a retest, use an endpoint of the wall as a reference standard for the start line and scan test line).
- c) A scan test applicable set up example is shown in Figure 6-9

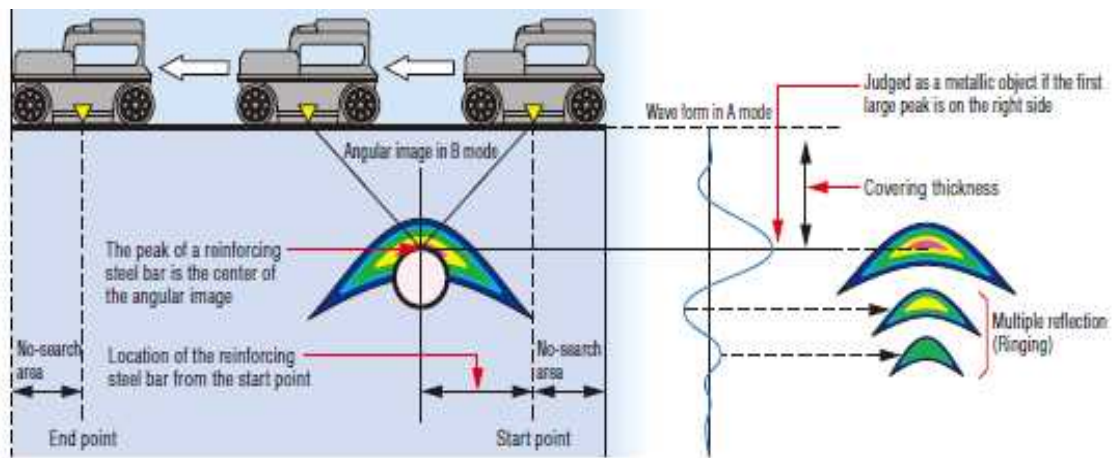
Figure 6-10 Scanning Diagram

- Place the unit over the intersection of start line and the scan test line.
- After about one second after pressing START, a short single buzzer sound is generated, the fixed cursor is displayed at a position of about 10cm of the movement distance scale on the screen, and then scan test preparation is complete.
- Move the unit on top of the scan test line at a speed of less than 40 cm/s by rotating the wheels.
- Press START again to finish. A double buzzer sound is generated and the scan test is stopped.

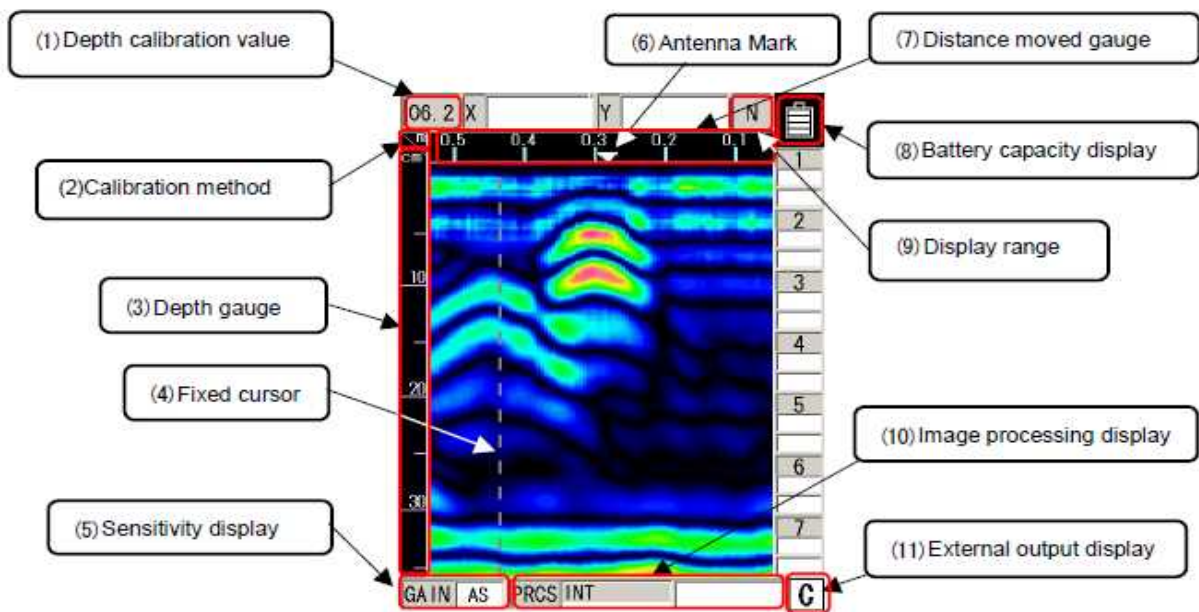
Figure 6-11 Example of a Test Scan

- The reflected waves shown in the scan test example in figure above are reflections of rebar. (↓ position)
- The position of the object to be probed (e.g., reinforcing steel bar) in the traveling direction is determined as the peak of the reflected wave.
- An approximate depth (covering depth) of the object to be probed (e.g., reinforcing steel bar) is determined as the center of the reflected wave.

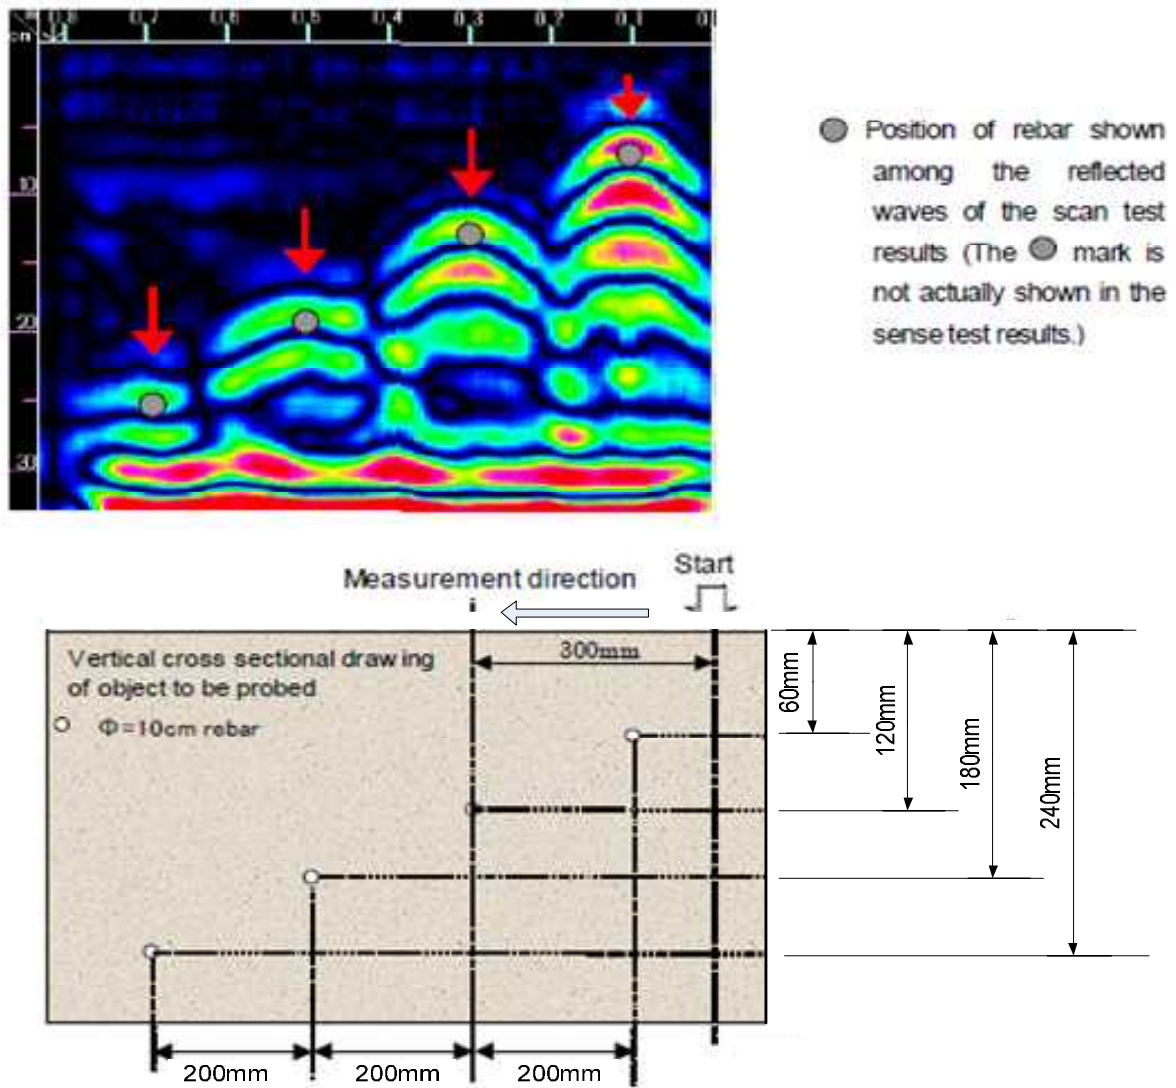
Figure 6-12 Example Data Analysis

- Perform depth calibration to reduce the error in the depth (covering depth) of the object being probed (such as rebar). The position of the object to be probed (such as rebar) is shown by the peak on the right side of the A mode waveform.
- Match the cursor to the peak position to determine the depth.
- Refer to Figure 6-12 for example of data analysis

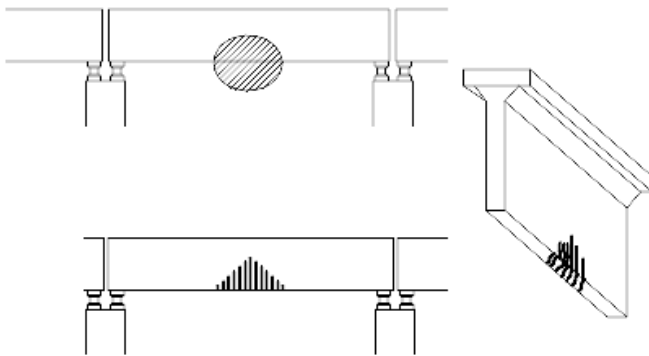
Figure 8-1 Flexural Cracking at Center Span of Span

Typical cracking patterns observed in RC structures and the typical cause of each type of cracking is illustrated in the following figures.

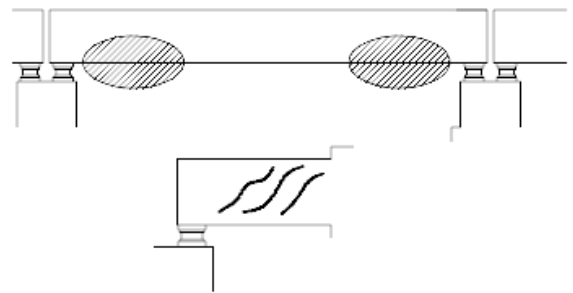
Figure 8-2 Shear Cracking at 1/4 of Span

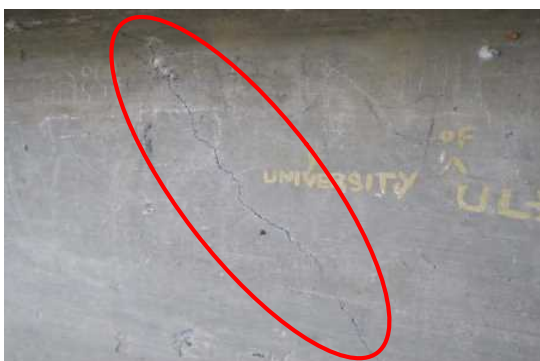
Figure 8-3 Shear Crack in a Concrete Girder

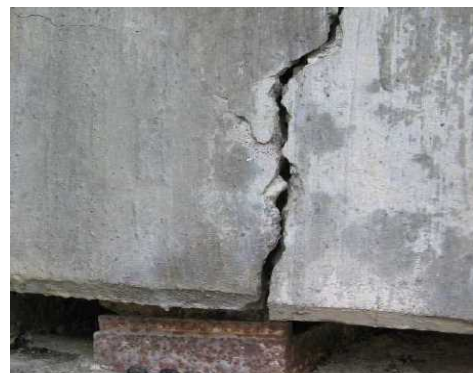
Figure 8-4 Shear Crack near the Bearing

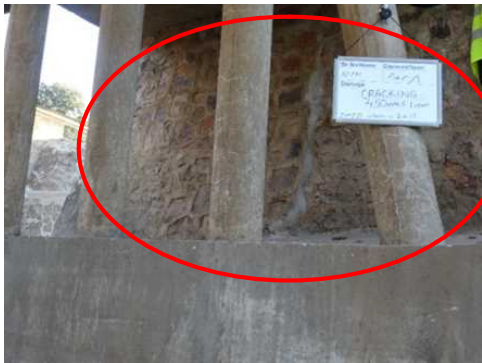
Horizontal cracking could indicate reverse bending due possibly to compaction of the soil by traffic on the approach to the abutment.

Figure 8-5 Horizontal Crack in Pier Abutment

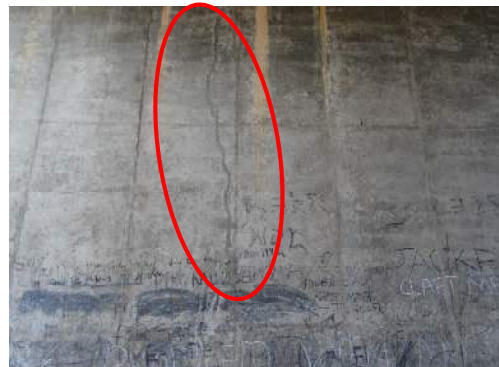
Vertical cracking near the top of abutments could indicate that there is insufficient reinforcement to contain the local bursting stresses at bearing positions.

Figure 8-6 Vertical Cracks in Abutment Wall

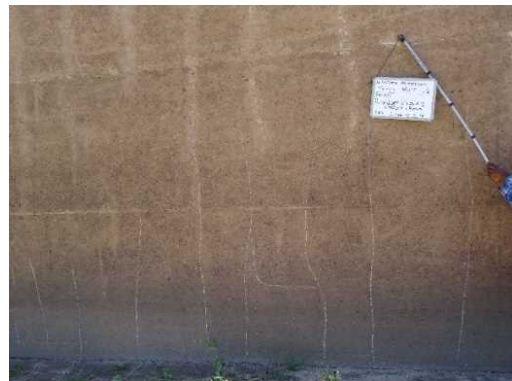
Differential settlements can produce serious distress. These cracks are caused by settlement of the ground.

Figure 8-7 Vertical Cracking by Differential Settlement

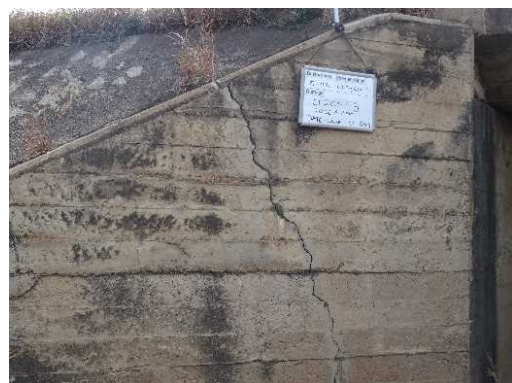
Severe crack caused by earth pressure.
Maximum crack width is 2mm.

Figure 8-8 Crack in Wing Wall

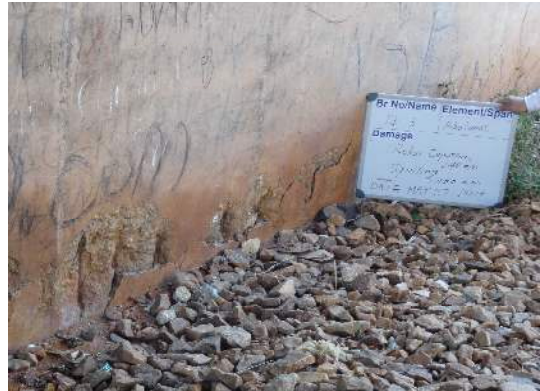
A spall is a fragment, which has been detached from a larger concrete mass. Spalling is a continuation of the corrosion process whereby the actions of external loads or pressure exerted by the corrosion of reinforcement results in breaking off the delaminated concrete. The spalled area left behind is characterized by sharp edges. Spalling may also be caused by overloading of the concrete in compression. This results in the breaking off of the concrete cover to the depth of the outer layer of reinforcement. Spalling may also occur in areas of localized high compressive load concentrations, such as at structure supports, or at anchorage zones in PC.

Figure 8-9 Spalling on Abutment

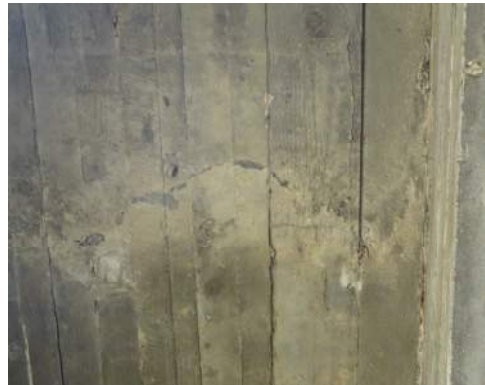
Delamination is defined as a discontinuity in the surface concrete which is substantially separated but not completely detached from concrete below or above it. Visibly, it may appear as a solid surface but can be identified as a hollow sound by tapping. Delamination begins with corrosion of reinforcement and subsequent cracking of the concrete.

Figure 8-10 Delamination in Deck Slab

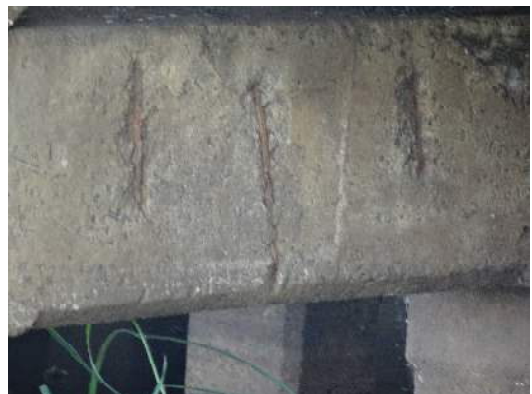
Corrosion is the deterioration of reinforcement by electrolysis. The alkali content in concrete protects the reinforcement from corrosion but when moisture, air/or chloride ions are dissolved in water and penetrate through the concrete to reinforcement this protection breaks down and corrosion starts. In the initial stages, corrosion may appear as rust stain on the concrete surface. In the advanced stages, the surface concrete above the reinforcement cracks, delaminates and spalls off exposing heavily rusted reinforcement.

Figure 8-11 Rebar Exposure in the Girder
