BRIDGE MAINTENANCE CAPACITY BUILDING IN ZAMBIA

BRIDGE INSPECTION GUIDEBOOK

2024

**Road Development Agency
Japan International Cooperation Agency**

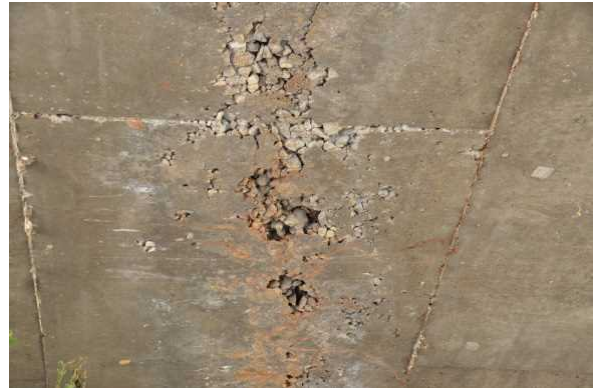
Honeycombing is caused by the improper or incomplete vibration of the concrete that results in voids being left in the poured concrete where the cement mortar failed to completely fill the spaces between the coarse aggregate particles.

Figure 8-12 Honeycomb in Deck Slab

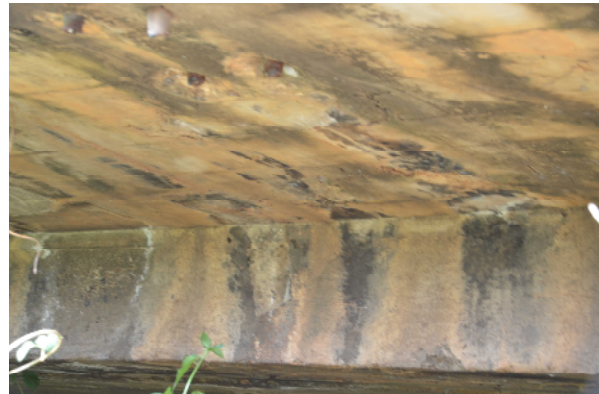
As a result of continuous progress of cracking, cracks penetrate slab thickness, then water leakage starts. The phenomenon is due to water passing through the concrete and dissolving constituent material such as calcium hydroxide at clacking location. The result is very unsightly causing staining, efflorescence, encrustation or at its very worst stalactites. It causes loss of alkalinity of the concrete which could lead to corrosion of the embedded reinforcement or prestressing cables.

Figure 8-13 Water Leakage from Some Holes for the Anchor Bolt

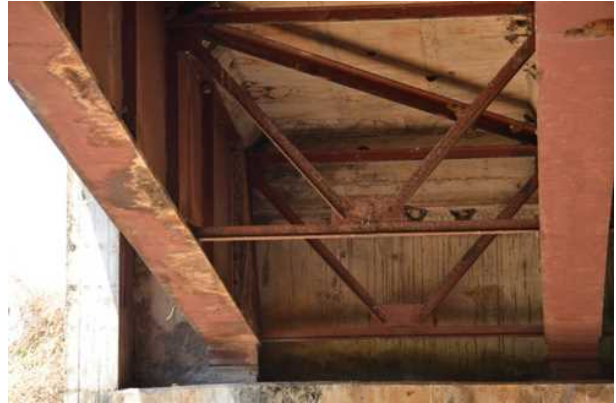
Rust on carbon steel is initially fine grained, but as rusting progresses it becomes flaky and delaminates exposing a pitted surface. The process thus continues with progressive loss of section. Corrosion is very severe near sea shore due to wind-borne sea water spray.

Figure 8-14 Corrosion of Steel Member

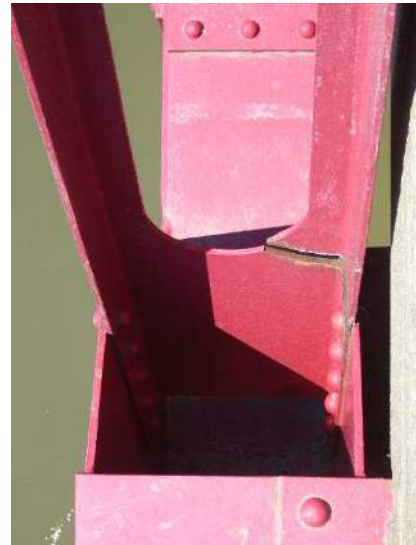
A fatigue crack at bottom flange progresses to the web plate of the cross beam. It is caused by traffic load.

Figure 8-15 Cracking of Steel Member

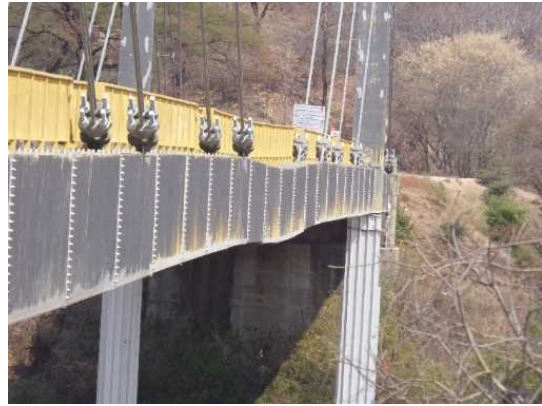
Permanent deformation of steel members can take the form of bending, buckling, twisting or elongation, or any combination of these. Permanent deformations may be caused by overloading, vehicular impact or damaged intermediate lateral supports or bracing.

Figure 8-16 Deformation of Steel Member

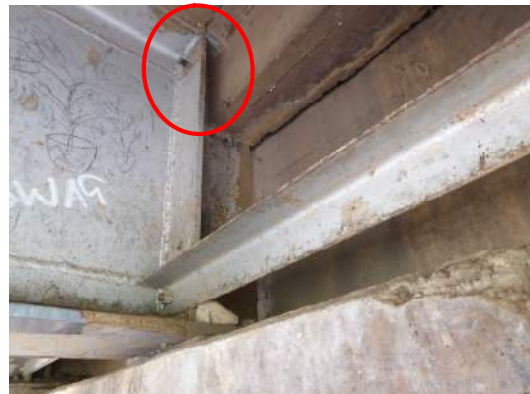
Loose connections can occur in bolted or riveted connections; and, may be caused by corrosion of the connector plates or fasteners, excessive vibration, overstressing, cracking, or the failure of individual fasteners.

Figure 8-17 Loose Connection of Steel Member

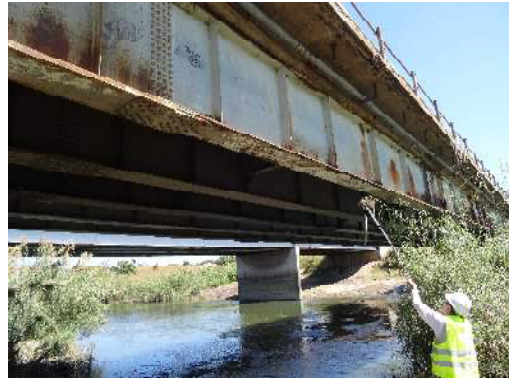
Condition of the protective system is the most common form of deterioration in structural steelwork. Both paint systems and galvanizing eventually deteriorate and areas of breakdown should not only record, but immediate action should be taken to prevent problem spreading.

Figure 8-18 Paint Peel Off of Steel Member

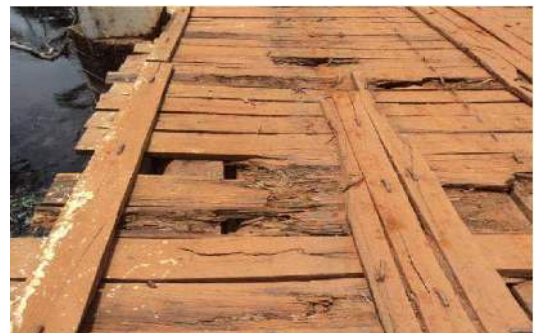
Fungal attack is characterized by discoloration or staining when mild but wood becoming soft and spongy when decay is more advanced. Decay can be found at locations where water could penetrate the members or where high moisture levels are encountered.

Figure 8-19 Decay of Timber Deck Slab

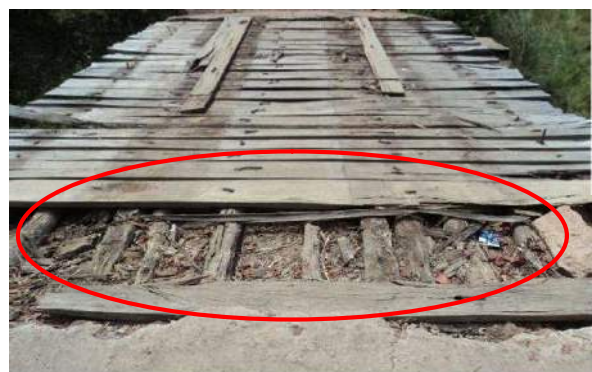
The timber deck is structurally very weak after decay, splitting and cracking. Disconnection in timber deck will occur due to traffic load.

Figure 8-20 Disconnection of Timber Deck

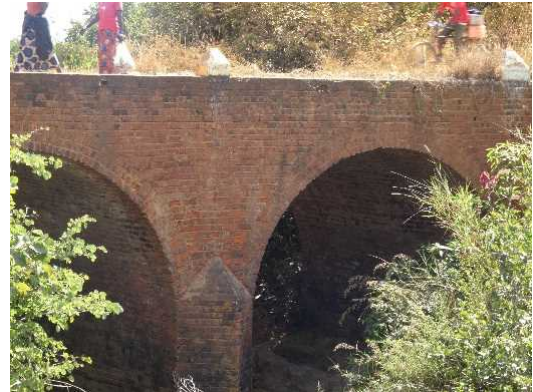
Constant daily variations of temperature and the seasonal variations of ambient temperature, rain and wind can seriously weaken the structure by gradual erosion of the masonry. Arches constructed of ‘soft’ rock such as sandstone and jointed with lime mortar, can suffer to such a degree that often an outside layer of rock has eroded leaving the hard lime mortar joints still in place. Fretting or abrasion occurs at the side of arch wall.

Figure 8-21 Fretting/Abrasion of an Arch Bridge

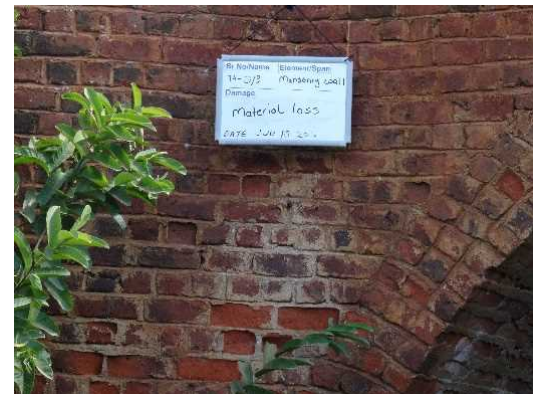
The masonry arch material is detached due to compressive stress.

Figure 8-22 Material loss of an Arch Bridge

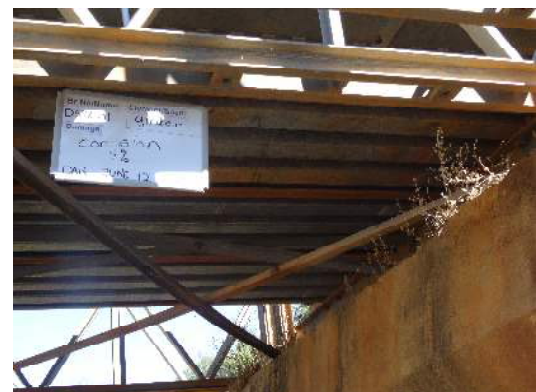
The paint of the lower chord is severely peeled off. Total repainting should be done as soon as possible so that the bridge’ service life can be extended to another decade.

Figure 8-23 Corrosion of a Bailey Bridge

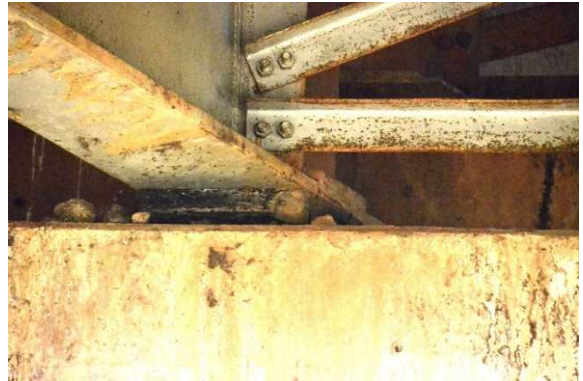
Neoprene bearings are subject to tearing, bulging and cracking, particularly in hot climates which affect the properties of the elastomers and, in extreme situations, this can cause complete failure of the bearing. Bulging occur due to aging and contamination.

Figure 8-24 Bulging Bearing

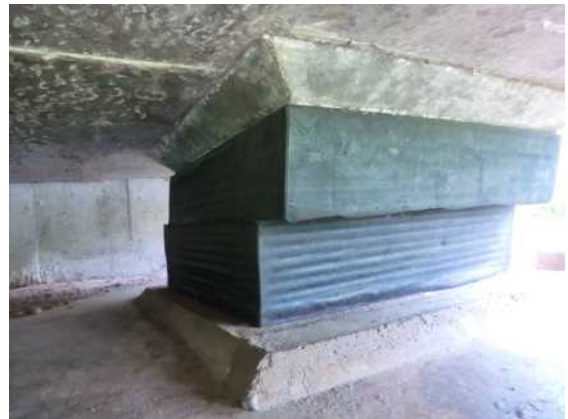
Abnormal displacement may indicate overloading or unevenness of loading.

Sometimes creep or drying shrinkage provokes to tear the rubber pad.

Figure 8-25 Abnormal Displacement of Bearing

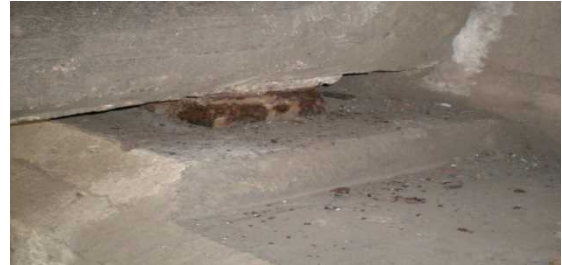
Photograph shows heavy rust of steel bearing.

Figure 8-26 Corrosion of Steel Bearing

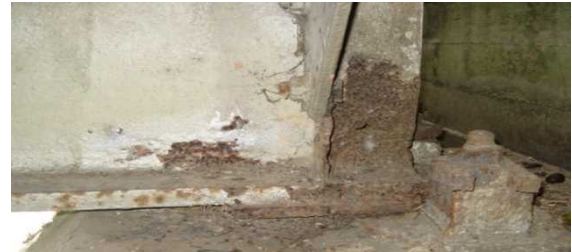
Incorrect installation procedures lead to failure of bearing. Photograph shows the girder end is not resting on the bearing anymore.

Figure 8-27 Abnormal Displacement at a Support

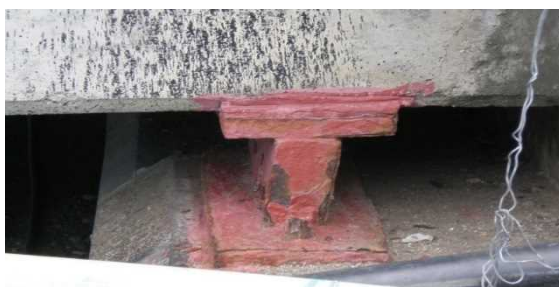
This red color paint is primer only. Original paint had already peeled off.

Figure 8-28 Paint Deterioration of Bearing

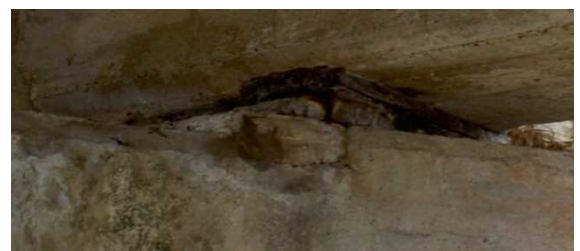
Figure 8-29 Bed Damage

Bed Damage may occur subsidence of bearing and frequently accompanied by other damage of the main part such as crack, subsidence, and anchor-bolt. Once crack occur at the support, leakage cause to rust. (See 8.6.2 (5)).

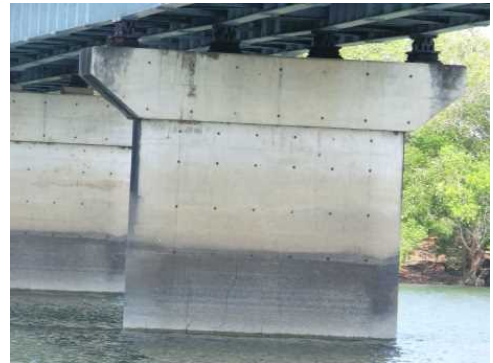
Figure 8-30 Tilt of Pier

Pile has settled due to impact force. Abutment settled due to earth pressure.

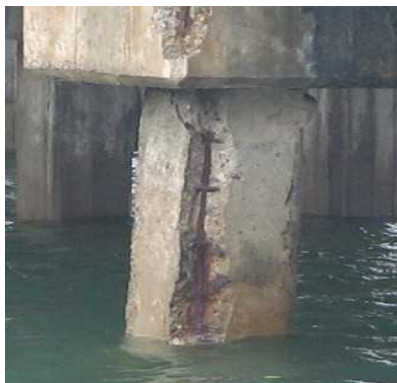
Figure 8-31 Tilt of Pier Due to Collision

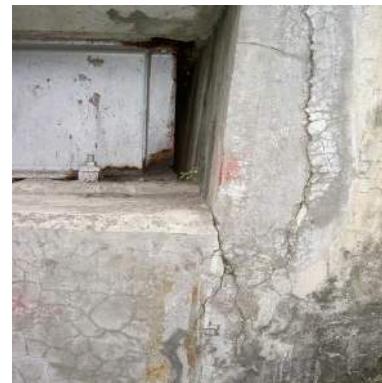
Figure 8-32 Settlement of Abutment

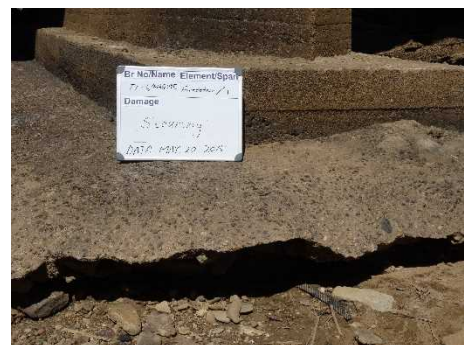
Scour is the single most common form of bridge failure. The failure was due to scour around the central pier which subsided and initiated progressive collapse of the complete bridge. Pile foundation is severely scoured.

Figure 8-33 Scouring at Abutment

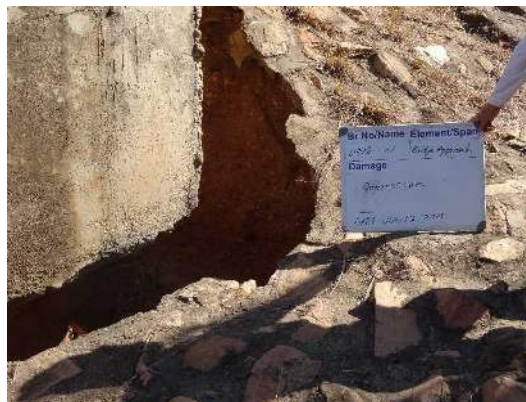
The soil materials are completely washed out by flood.

Figure 8-34 Bank Erosion

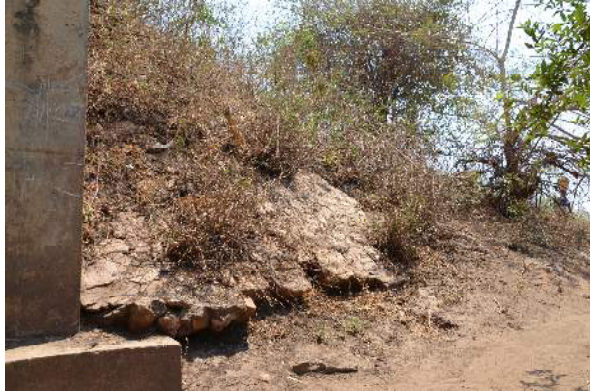
Slope protection is completely eroded by flood.

Figure 8-35 Cracking in Slope Protection

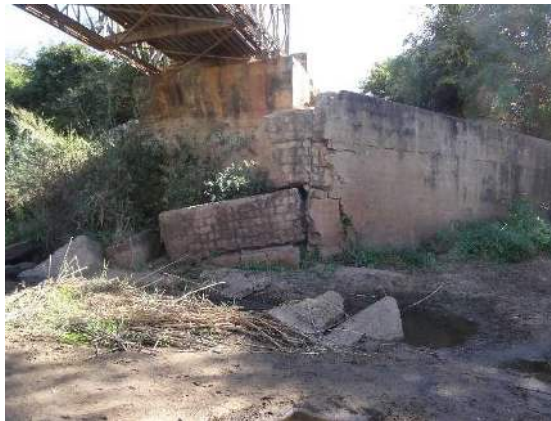
The soil materials are washed out from back of parapet.

Figure 8-36 Slope Protection Erosion

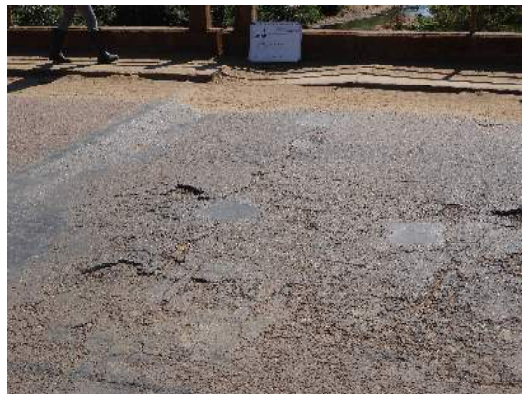
Depression occurred due to sinking of approach road.

Figure 8-37 Approach Depression

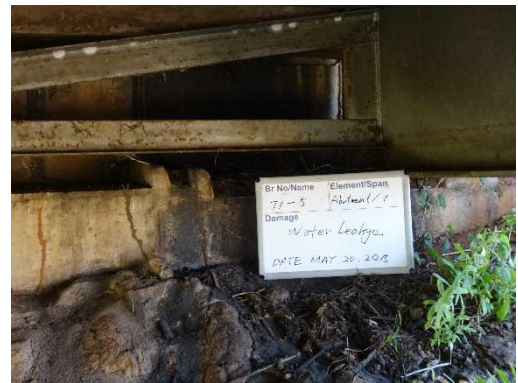
Leakage tends to be localized, and this is borne out by the many unsightly streaks and stains down abutments and piers.

Figure 8-38 Water leakage from Expansion Joint

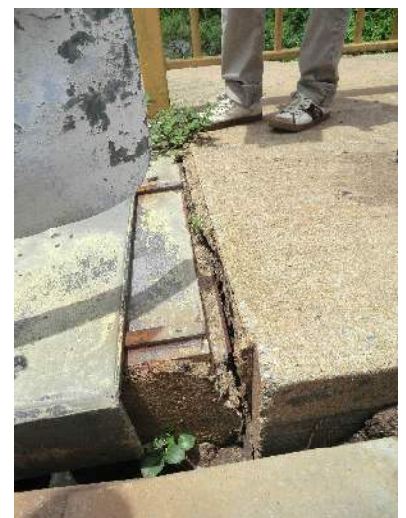
If the joints have been incorrectly set at the construction stage, then they may over stretch in cold weather (causing cracking and/or tearing, and constituting a hazard to traffic) or jam tight in hot weather (causing crushing of the surfacing and deck).

Figure 8-39 Abnormal Space

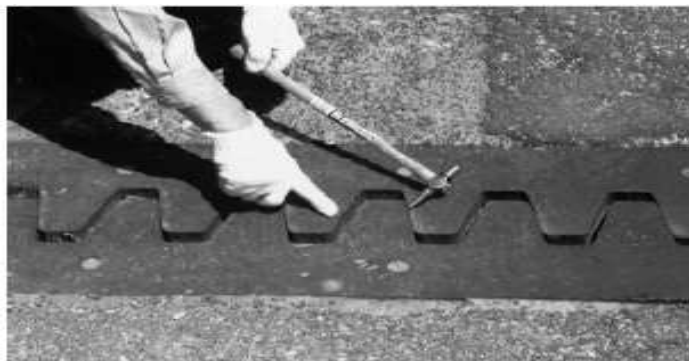
Difference in elevation at expansion joint due to bearing problems.

Figure 8-40 Difference in Elevation

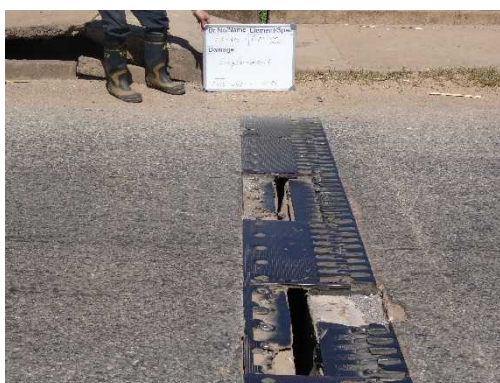
Displacement due to direct impact loads from traffic. It cause to accident.

Figure 8-41 Displacement of Cover Plates

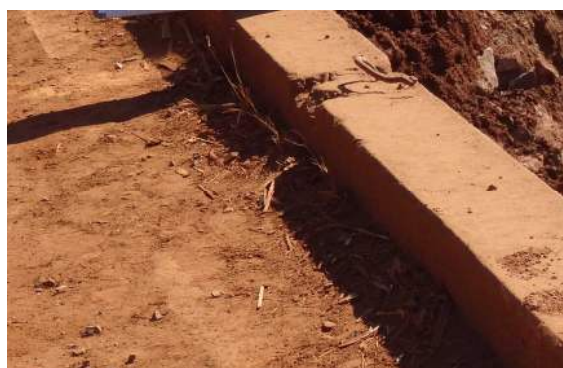
Cracking and spalling at kerb.

Figure 8-42 Cracking at Kerb

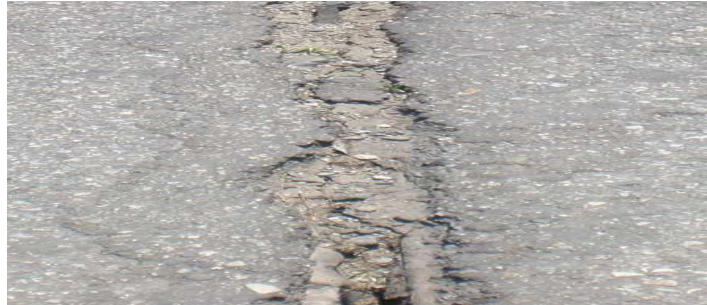
Deteriorated rubber sealant cause leakage just like a steel type. (See 7.10.1 (1).)

Figure 8-43 Water leakage Due to Deteriorated Rubber Sealant

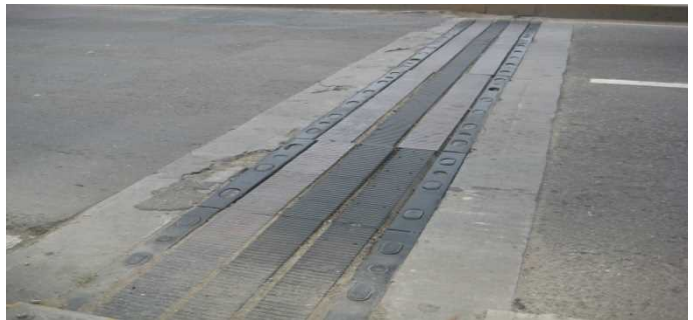
As the amount of expansion becomes longer, rubber is apt to swell in summer when the girder is extended.

Figure 8-44 Difference in Elevation

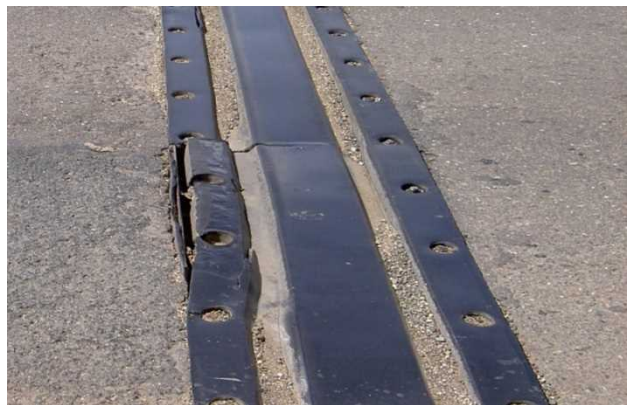
The demerit of the rubber surface type is the wear and the rubber cuts. Generally speaking, the rubber surface type is less durable than the metal surface type. Rubber joint is severely deteriorated and has ruptured in some places.

Figure 8-45 Rupture

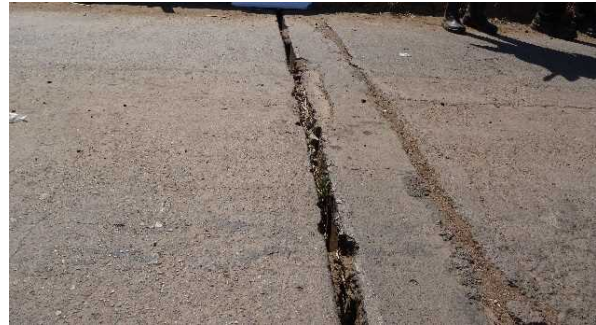
Asphalt sealant is intact to prevent water leakage, and is used to short span.

And seals are intended to keep out sand, dirt, and stones.

Figure 8-46 Missing Sealant (Cause of Water Leakage)

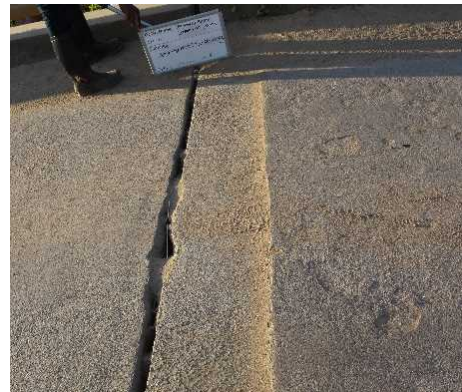
Concrete gap is too wide. Edge of concrete is broken due traffic load,

Figure 8-47 Abnormal Space

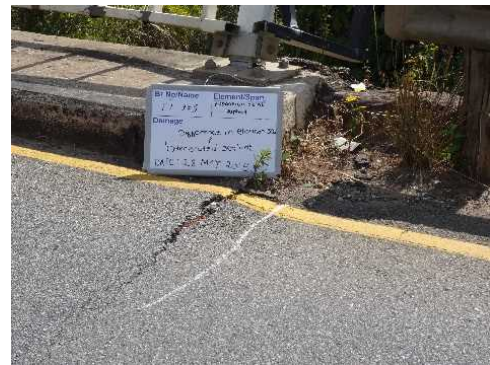
The expansion joint is designed for horizontal movement, but it moved in vertical direction which is abnormal.

Figure 8-48 Difference in Elevation

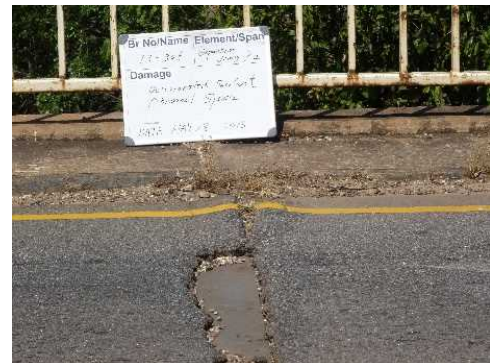
This is where the joint material separates from the adjacent surfacing, and is closely associated with cracking. In severe cases where there is substantial cracking it is possible for the joint to separate from the substrate posing a danger to users.

Figure 8-49 Deteriorated Sealant

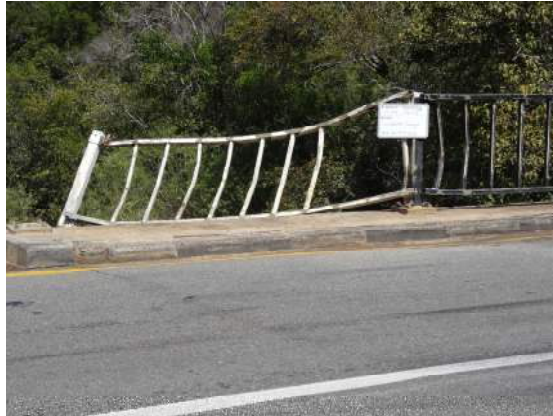
Sometimes accidental damage of the railing occurs.

Make a note if a part of the bridge next to the railing is also damaged. For steel railings, look at holding down bolts at post bases, joints in rails, and joints between rails and posts

Figure 8-50 Accidental Damage of Railing

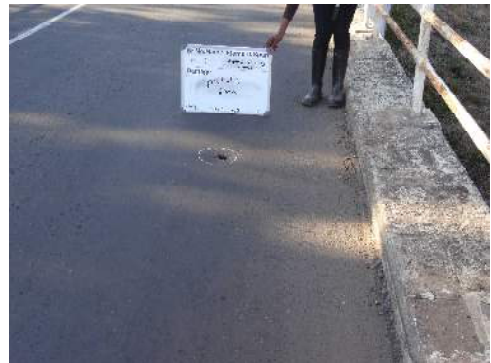
Potholes occur for several reasons, shortage of asphalt material, excessive heating, deficient mixture, penetration of water, deficient compaction, impact for traffic load.

Figure 8-51 Potholes of Asphalt Surface

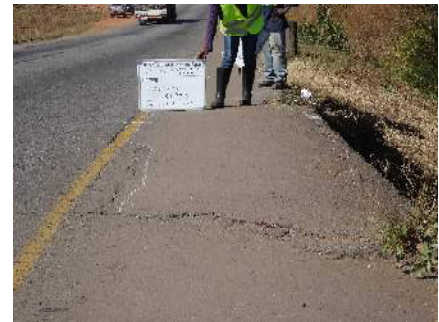
Crack occurs for several reasons such as temperature stress, defective construction work.

Figure 8-52 Cracking of Asphalt Surface

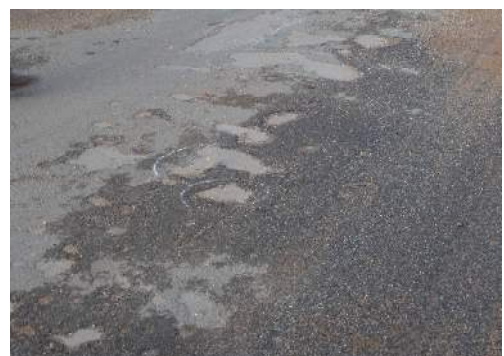
Aggregate leave asphalt surface and become wasting surface for the separation of mortar.

Figure 8-53 Ravelling of Asphalt Surface

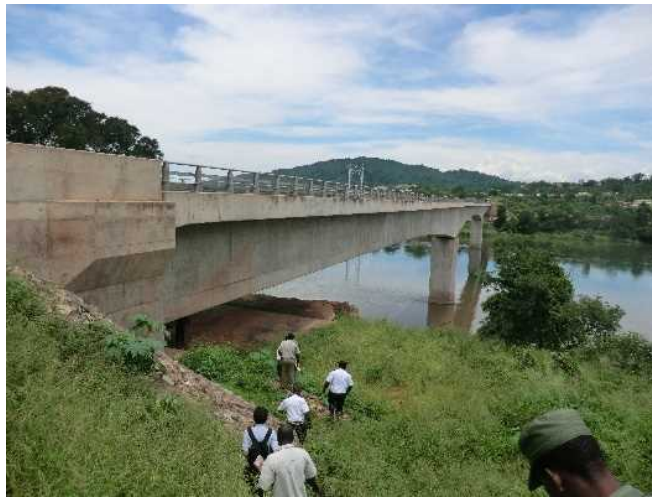
Pre-stressing method is used in the concrete structure to counteract tensile stress by introduction of compressive force/stress. In the case of pre-stressed concrete, pre-stressing cables are used to provide compressive stress that balances the tensile stress in concrete members to overcome natural weakness in tension of concrete. PC bridge type is appropriate for long spans due to this attribute. Tension in cable and compression in concrete are the most important forces to keep a structure in a stable condition.

Figure 1-1-1 PC BOX Bridge

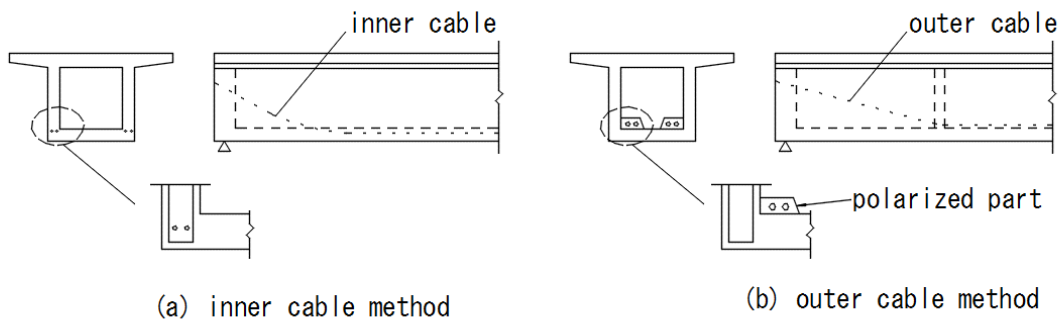
PC bridges are appropriate for long spans. Tension in cable and compression in concrete are the most important forces to keep a structure at a stable condition.

PC bridges classify method into two types, inner cable or outer cable. Inner cable method is common and Chirundu Bridge is only inner cable.

Figure 1-1-2 Bridge Component (PC Box)

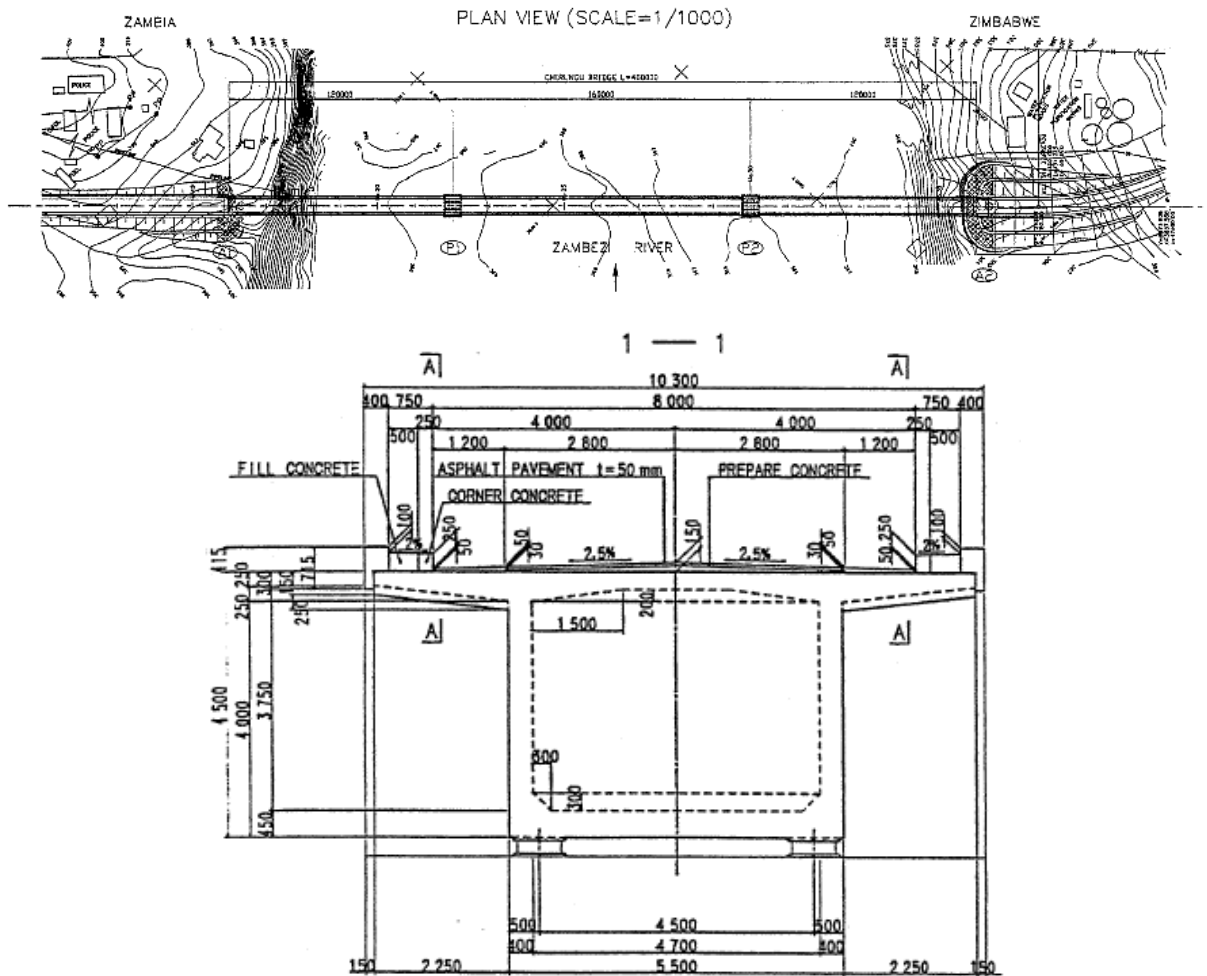
Figure 1-1-3 Bridge Geometry Definition

The bridge is assessed in the direction of increasing chainage. Refer to Figure 1-1-3

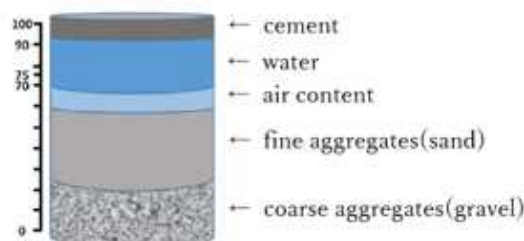
Constituents of Concrete

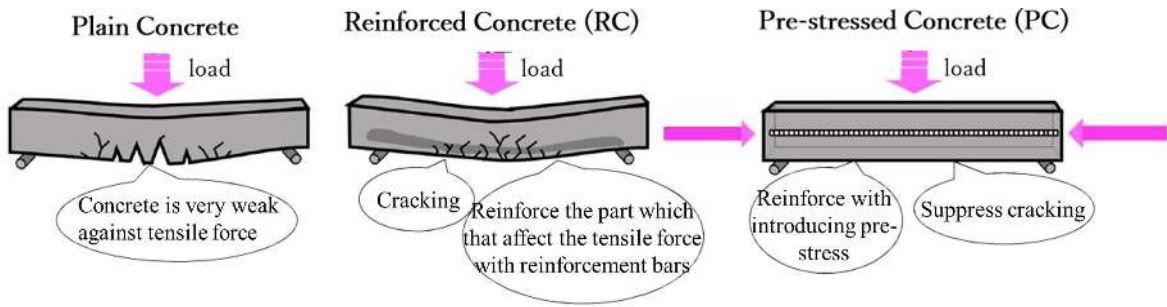
On the other side, PC stands for “Pre-stressed Concrete” . In general, the weakness of concrete, which is vulnerable to tension, can be strengthened by the compressive force exerted by PC steel.

Figure 1-1-4 PC structure

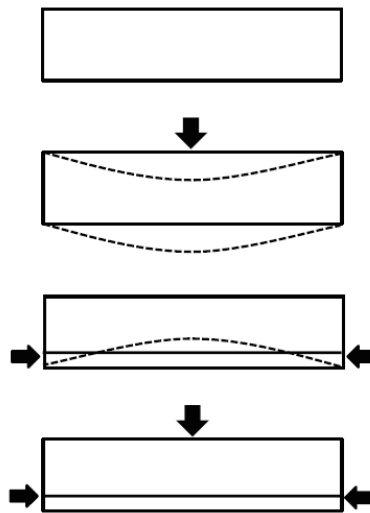
Pre-stressing method is used in the concrete structure to counteract a tensile stress by introducing compressive. In the case of pre-stressed concrete, pre-stressing cable is used to provide compressive stress that balances the tensile stress in concrete members to overcome the natural weakness in tension of concrete. Tension in the cables and compression in concrete are the most important forces to keep a structure at a stable condition.

Figure 1-1-5 Function of Pre-stressed Concrete

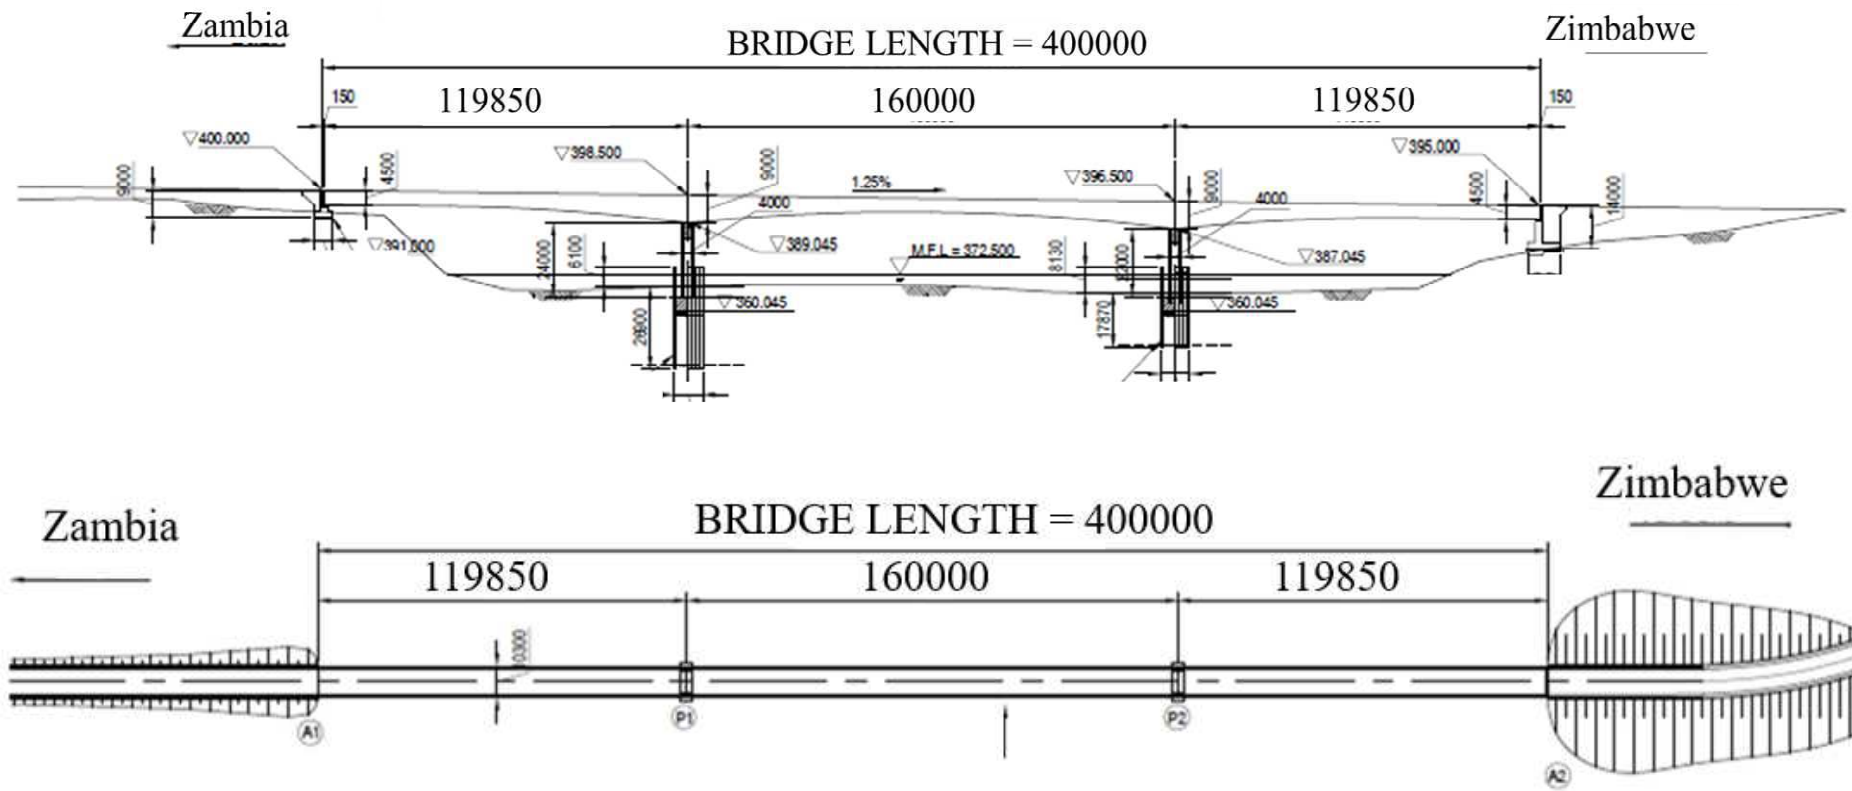
Figure 1-1-6 General View of Chirundu Bridge (1 of 3)

Shown in Figure 1-1-6, 1-1-7 and 1-1-8 are the General Views of Chirundu Bridge.

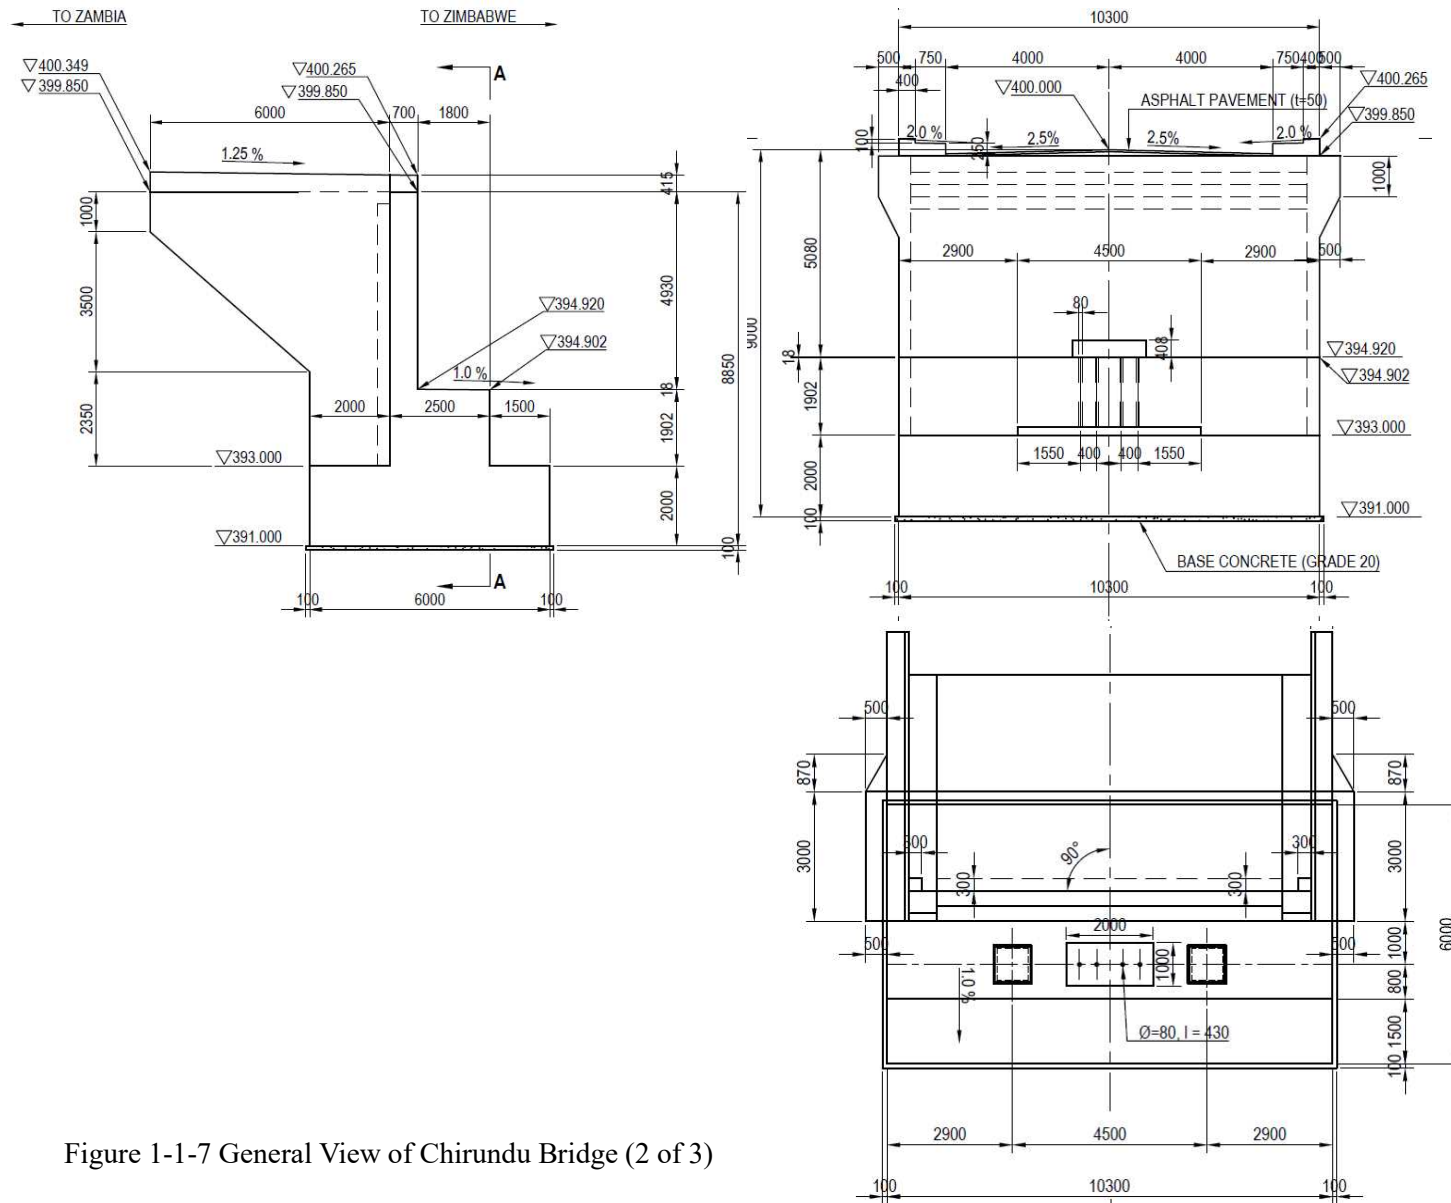
Figure 1-1-7 General View of Chirundu Bridge (2 of 3)

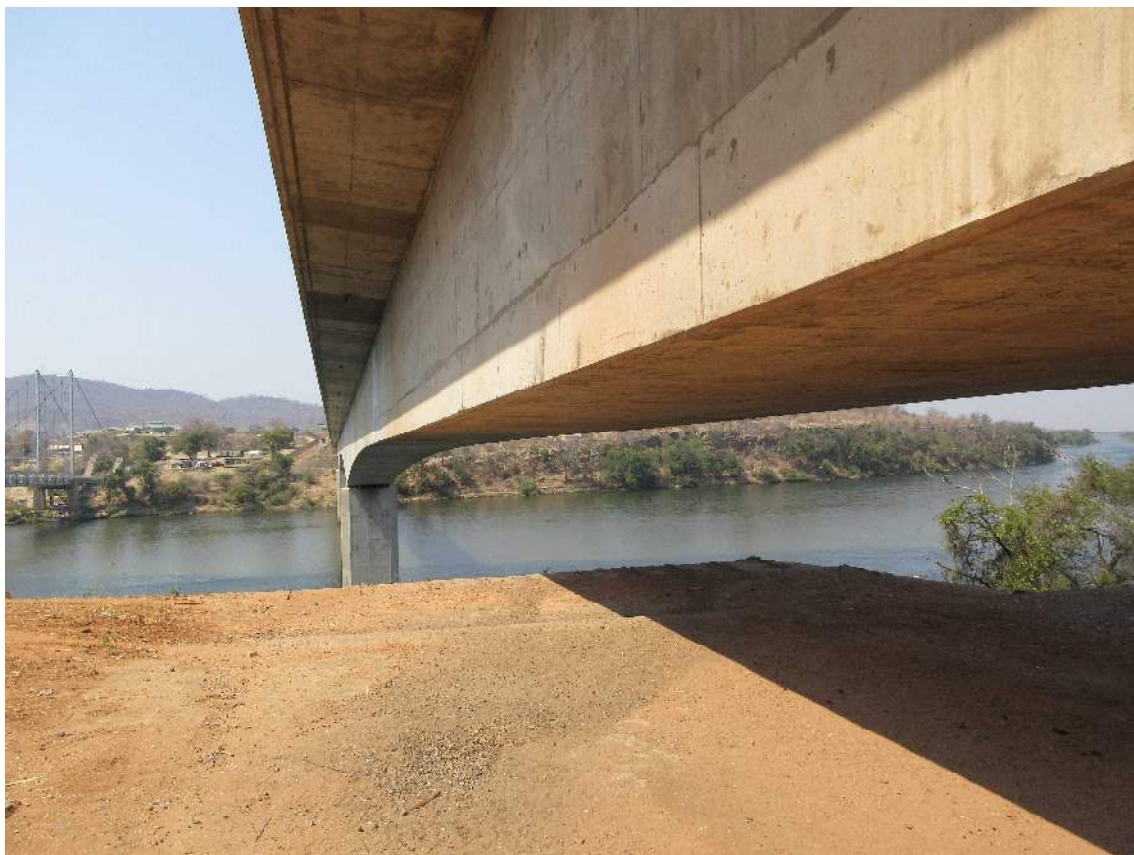
Figure 1-2-1 Photo of Chirundu Bridge

The Chirundu Bridge is located between Zambia and Zimbabwe across the Zambezi River, and it is along the one of the biggest economic corridors, which passes through South Africa, Mozambique, Zimbabwe and Zambia. The bridge, which is 40 meters long and 10.3 meters wide, was funded and constructed by the Japanese government in 2002. It is a three-span, continuous, pre-stressed box girder bridge and has two lanes.

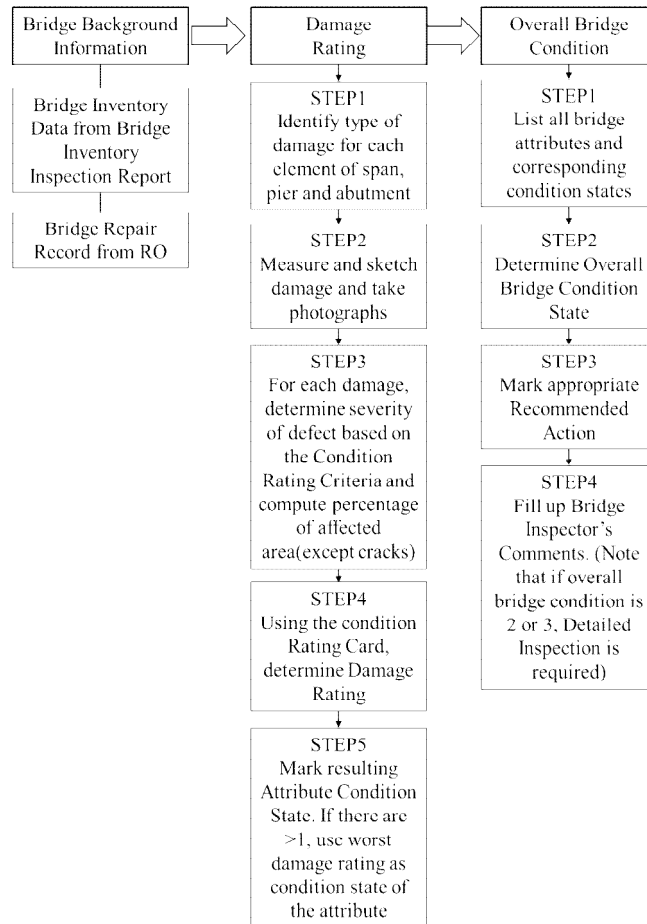
Figure 1-3-1 Flowchart of Bridge Periodic Inspection

The step-by step procedure for conducting the Periodic Inspection is illustrated in the following flowchart.

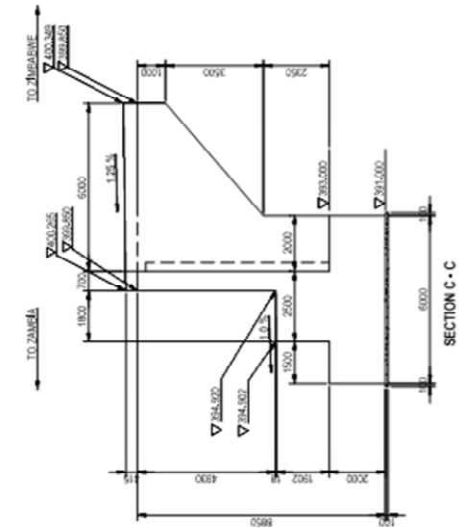
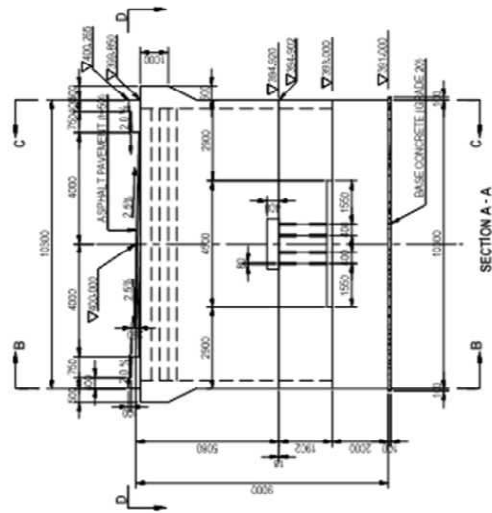
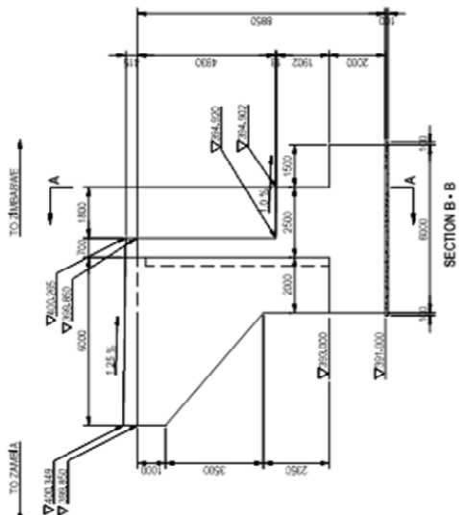
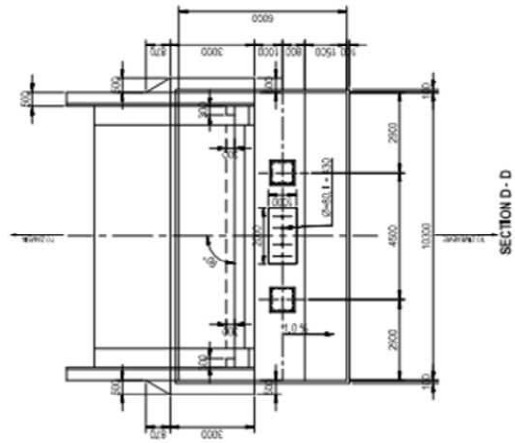
Figure 1-3-6 Check point of the periodic inspection (2of 2)

Abutment
 Cracking, Spalling / Disintegration,
 Delamination, Re-bar Exposure / Corrosion,
 Honey comb, Tilt / Settlement, Water Leakage

The bridge Periodic Inspection Routes of Chirundu Bridge are shown in Figure 1-3-2, 1-3-3 and 1-3-4, and the Check Points of the Periodic Inspection are shown in Figure 1-3-5 and 1-3-6.

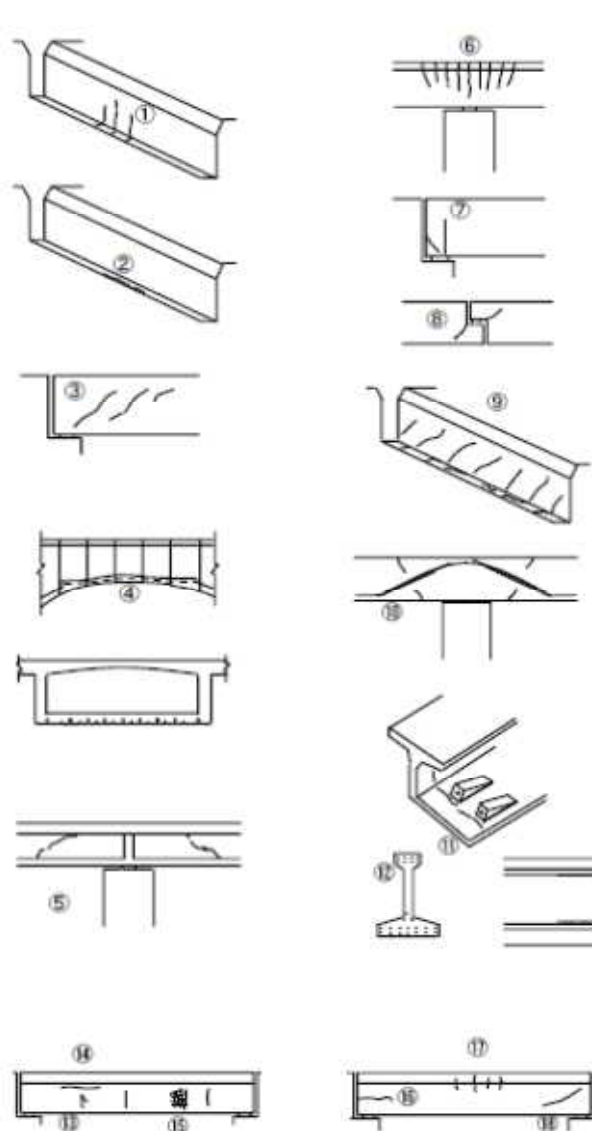
Figure 1-3-7 General Patterns of Defects (1of 4)

General Patterns of Crack Defects on Pre-stressed Concrete Bridge

Number	Location	Pattern
1	Span center	Vertical bending crack on bottom and side girder
2	Span center	Longitudinal crack on bottom of girder
3	Supporting point	Diagonal shear crack on around supporting point
4	Span center	Crack on lower flange along to Sheath or PC cable
5	Changing point of bending moment	Crack on web along to Sheath or PC cable
6	Supporting point	Crack on upper flange on continuous girder
7	Supporting point	Vertical or diagonal bearing crack on supporting point
8	Supporting point	Crack on the corner point of cantilever hinge
9	-	Diagonal crack on the whole of girder
10	Changing point of bending moment	Right angled crack against PC steel
11	Connecting point of PC Steel	Crack around connecting point of PC cable
12	High density point of PC steel	Crack around PC cable
13	-	Crack on web by regular interval
14	-	Vertical crack on the point between girder and web
15	-	Crack like mesh
16	Supporting point	Horizontal crack on supporting point

17	Span center	Horizontal crack on span center
18	Along to Sheath	Crack along to Sheath or PC cable

As a reference, some special attributes of Chirundu Bridge are listed in Table 1-3-2. All other applicable descriptions in the BMS Manual for standard bridge are adopted in this Manual. General pattern of defects in bridges are shown in Figure 1-3-7, 1-3-8, 1-3-9 and 1-3-10.

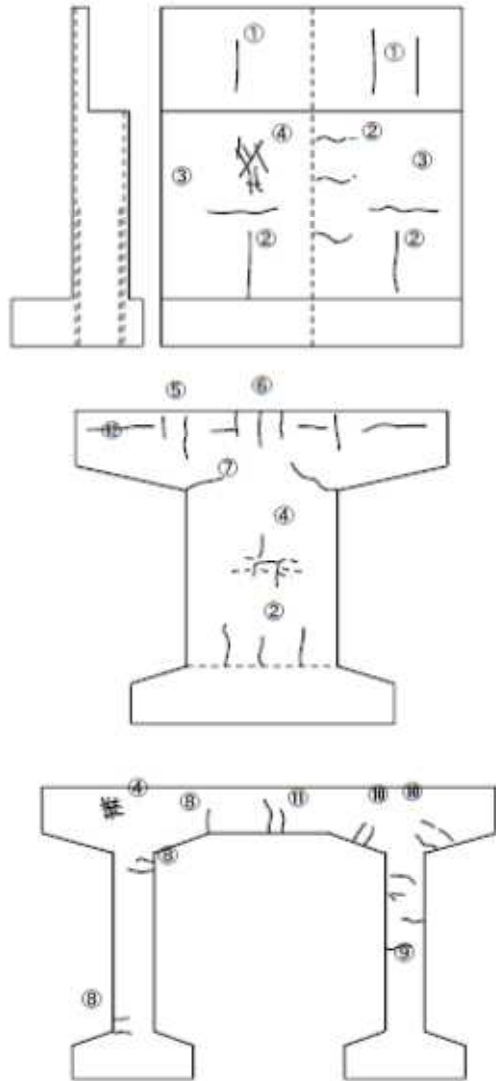
Figure 1-3-8 General Patterns of Defects (2of 4)

General Patterns of Crack Defects on Abutment and Pier

Number	Pattern
1	Crack with regular interval
2	Crack on the concrete casting joint
3	Crack around the changing point of density of reinforcement bar
4	Crack like mesh
5	Crack on topside of overhang beam (coping)
6	Vertical crack on pier center
7	Crack on bottom side of overhang beam (coping)
8	Crack on upper and bottom part of column
9	Crack on column
10	Crack on haunch
11	Bending crack on the span center or beam
12	Horizontal crack on beam

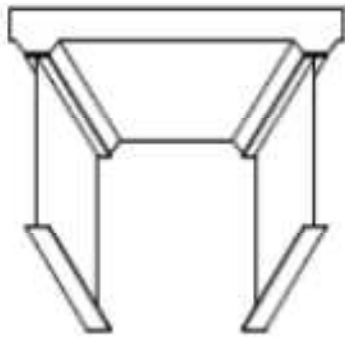
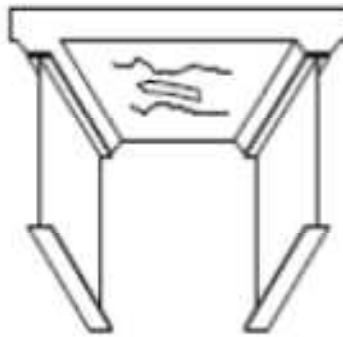
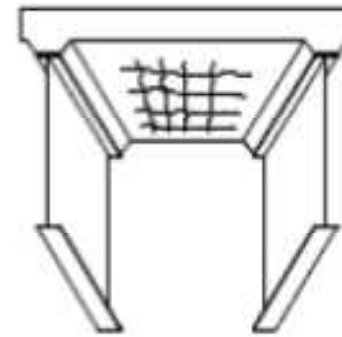
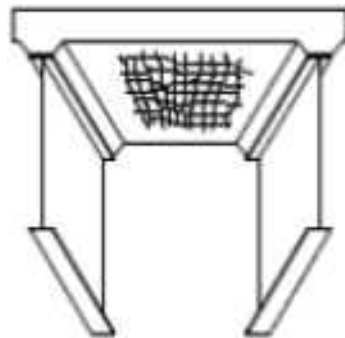
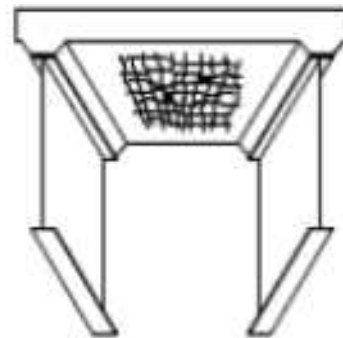
Figure 1-3-9 General Patterns of Defects (3of 4)

General Patterns of Crack Defects on Concrete Deck

Stage 0
Sound condition

Stage 1
Development of cracks in one direction

Stage 2
Development of cracks in two direction

Stage 3
Cracks develop like a mesh

Stage 4
Water penetrates cracks, spalling
