BRIDGE MAINTENANCE CAPACITY BUILDING IN ZAMBIA

BRIDGE INSPECTION GUIDEBOOK

2024

**Road Development Agency
Japan International Cooperation Agency**

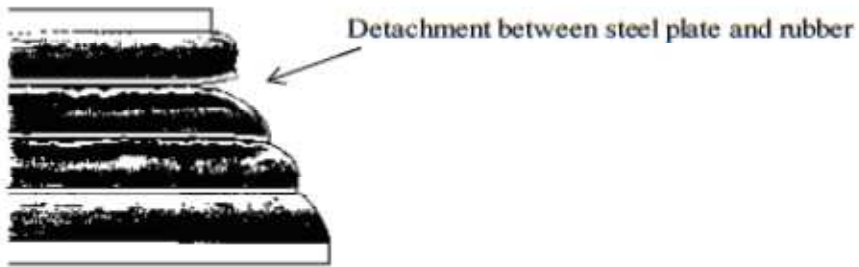
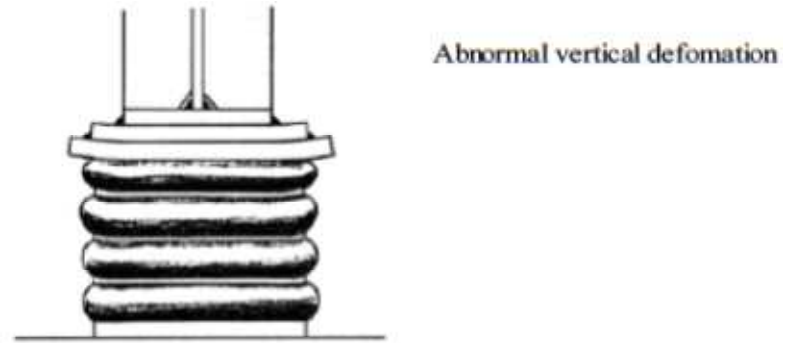
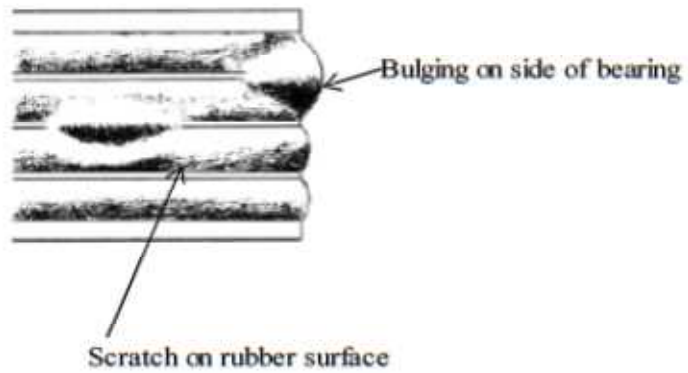
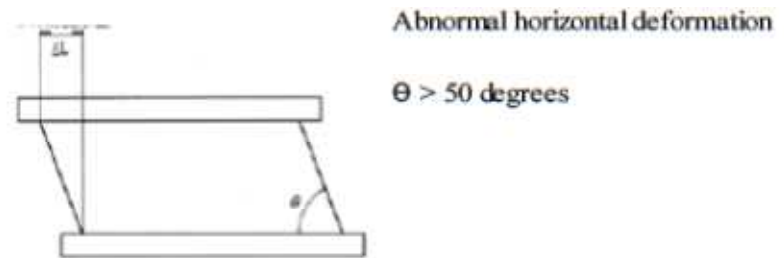
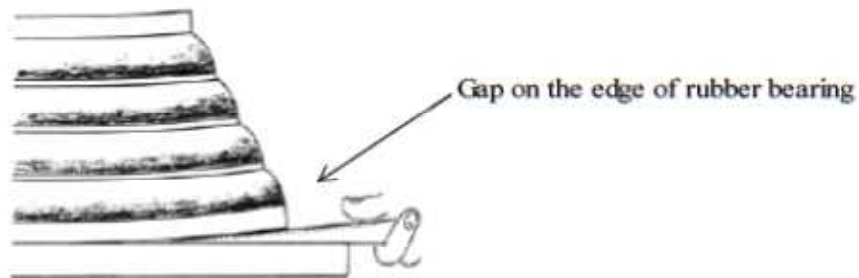
Figure 1-3-10 General Patterns of Defects (4of 4)

General Patterns of Crack Defects on Rubber Bearing

As a reference, some special attributes of Chirundu Bridge are listed in Table 1-3-2. All other applicable descriptions in the BMS Manual for standard bridge are adopted in this Manual. General pattern of defects in bridges are shown in Figure 1-3-7, 1-3-8, 1-3-9 and 1-3-10.

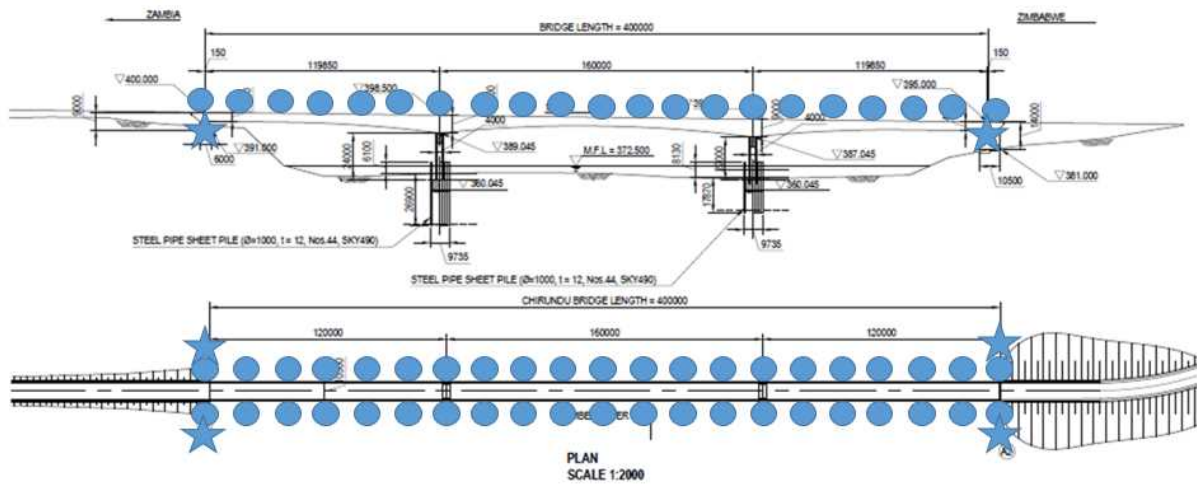
Figure 1-5-1 Geometrical Inspection:
Leveling of Abutments and longitudinal alignment of deck surface

- Leveling measure point for deck surface
- ★ Leveling measure point for abutment surface

Geometrical Inspection methods are shown in Figure 1-5-1, 1-5-2 and 1-5-3. As a reference, Geometrical Inspection form (GIF) of Chirundu Bridge are shown in Appendix A-1-3.

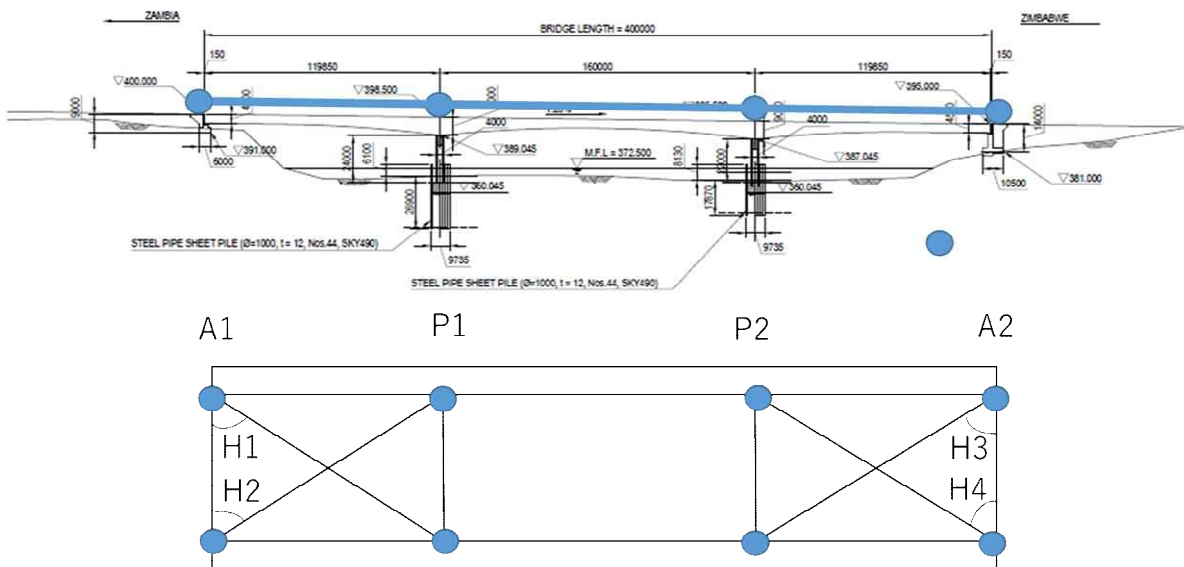
Figure 1-5-2 Geometrical Inspection:
Slope of PC Box Girder

Measure: Angle(Horizontal): H1', H2', H3', H4'

Slope: H1'
H2'
H3'
H4'

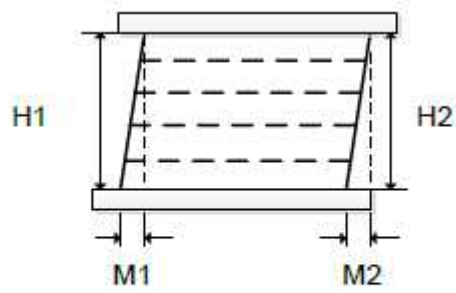
Figure 1-5-3 Geometrical Inspection:
Movement of Bearings and Expansion Joints

Bearing

Measure every bearing (everytime use same marking point)

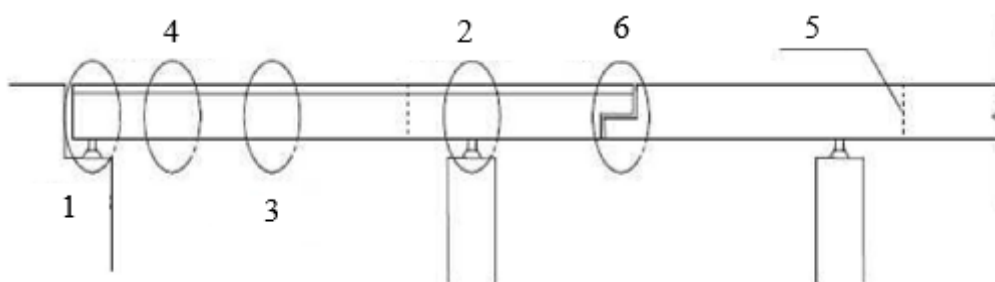
Damage occurring point	the points to be focused
① Edge supporting area	This point is susceptible to deformation due to water leakage from the expansion and contraction system, bearing reaction forces, and horizontal forces caused by earthquakes, temperature changes, etc.
② Intermediate supporting area	Prone to cracking in the area where the stress state is complex because the negative bending moment and the shear force is maximum and intensive bearing counterforce is generated.
③ central section of girder	Bending moment at the span center is at its maximum and bending cracks are likely to occur.
④ One quarter from the edge supporting areas	Susceptible to cracking due to shearing forces and disorder of bearings in the members with less reinforcing bars.
⑤ construction joints	Prone to cracking, delamination, or water leakage due to drying shrinkage or poor construction.
⑥ cutout section	Susceptible to cracking due to stress concentration in the area where the cross-section of main girder changes suddenly such as Gerber hinge or girder cutout section. The corrosion of steel member is caused by water leakage from expansion joints.

⑦ segment joints	Cracking along the segment joints sometimes occur due to the decrease in the amount of pre-stress. Cracking, scaling (floating), and water leakage are likely to occur due to drying shrinkage and poor construction.
⑧ fixed parts	Susceptible to cracks due to the concentration of tensile stress in areas where PC steel is anchored by projections on the web or flange. In addition, the anchorage area is covered with post-cast concrete, which allows rainwater to penetrate through the construction joints and easily corrode the anchorage apparatus.
⑨ PC steel anchorage	Corrosion of steel is likely to occur due to water penetration caused by insufficient grout filling.
⑩ water drainage	Susceptible to corrosion of steel members due to the loss or dropout of drainage system.

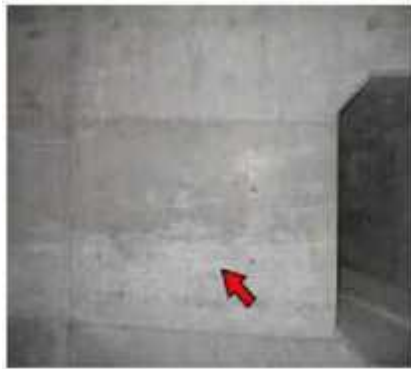
crack occurring point	crack pattern	presumed major causes
Intermediate supporting area	Cracks in the cross girder of the central support	Thermal stress or drying shrinkage

cracks in the cross girder

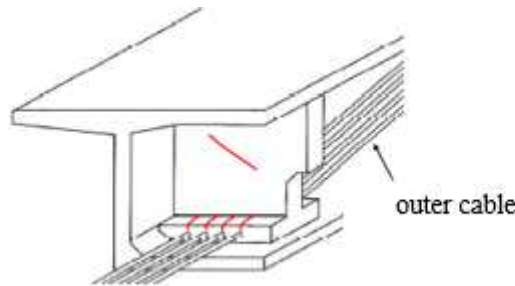
cracks near the deviation of the outer cable

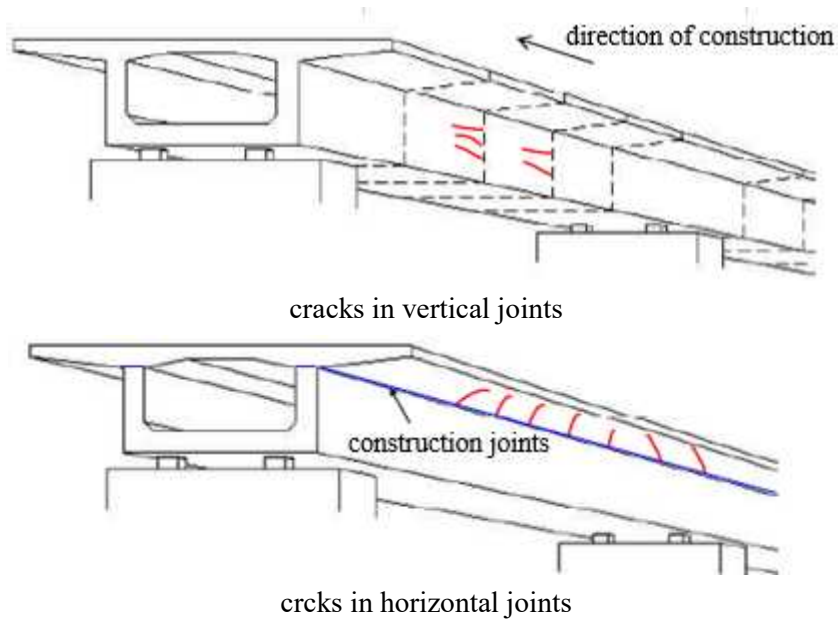
Cracks by thermol stress and shrinkage occur easily at concrete joint of new concrete.

crack occurring point	crack pattern	presumed major causes
construction joints	cracks at girder joints and floor-slab joints	difference in shrinkage between existing and newly post-casted concrete (heat of hydration, drying shrinkage), poor joint processing

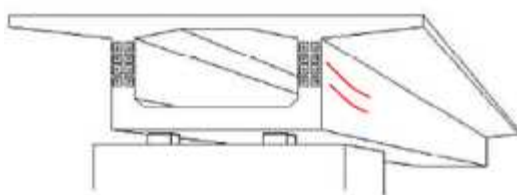
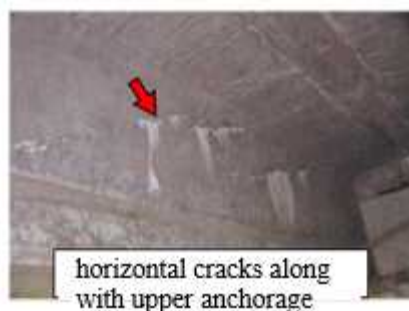
We pay attention to along to PC cable. Cracks along to PC cable are caused to insufficient grout filling.

crack occurring point	crack pattern	presumed major causes
edge supporting area	cracks along with the PC steel	cracks due to water penetration into the sheath from the fixed parts and expansion by alkali-silica reaction

Horizontal cracks along with PC steel

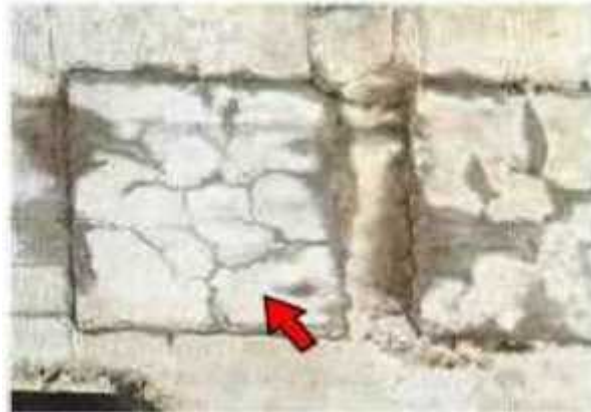
We have to pay attention to crack, delamination or efflorescence at post casting part or side of ground cover. Rain floods to concrete joint of post casting part and anchorage of PC cable corrodes.

crack occurring point	crack pattern	presumed major causes
fixed parts of PC steel	Cracks on the post-casted area	cracks due to drying shrinkage of post-casting concrete

cracks in the post-filling concrete

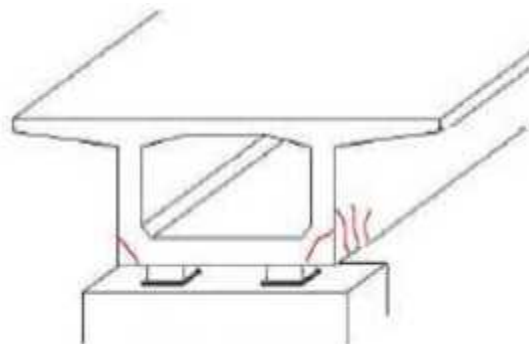
crack occurring point	crack pattern	presumed major causes
edge supporting area	vertical cracks on the underside and sides of the girder above the bearing	excessive local stress on the support, loss of bearing function, earthquake
	diagonal cracks in the web near the bearing	excessive shear force, insufficient shear reinforcing steel, and decreased amount of pre-stress

cracks near the end of girder

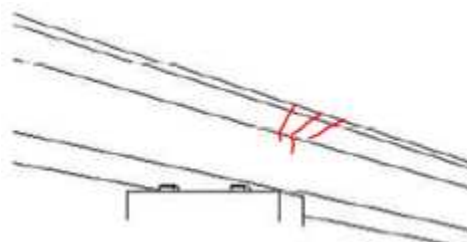
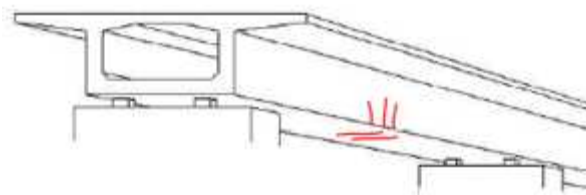
In intermediate support, negative moment and shear force is maximum, and condition of stress is complex, so crack should occur. Especially, we have to pay attention to top of overhang deck at continuous girder bridge and joint girder.

crack occurring point	crack pattern	presumed major causes
intermediate supporting area	vertical cracks occurring on the upper side of the main girder at the intermediate support of the continuous girder	insufficient reinforcing steel for negative bending moment at the top flange of the intermediate support, decreased amount of pre-stress
central section of girder	cracks occurring in the vertical direction on the underside and sides of the girder in the direction perpendicular to the main girder	excessive bending moment, decreased amount of pre-stress

cracks on the intermediate support

cracks on the central section

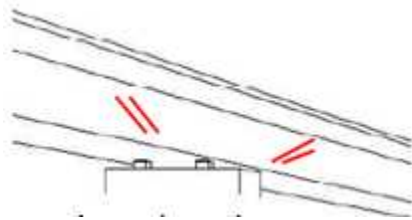
In one forth span, shear force is big. We pay attention to diagonal crack in thin web girder bridge.

crack occurring point	crack pattern	presumed major causes
one quarter from the edge supporting area	cracks occurring in the vertical direction on the underside and sides of the girder in the direction perpendicular to the main girder	insufficient amount of reinforcing bar or pre-stress

shear cracks near the support

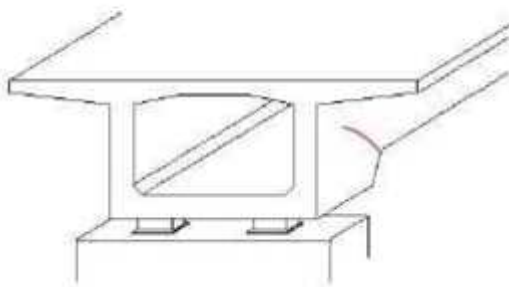
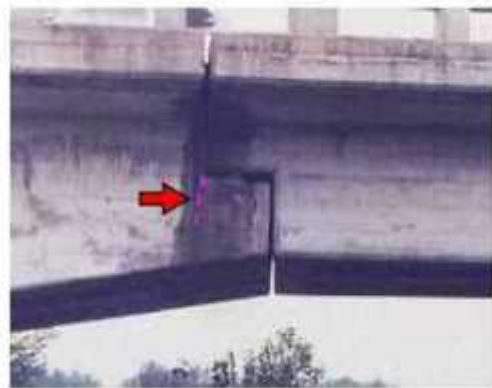
In cross section change part (gerber hinge, supporting point), crack occurs by stress concentration.

crack occurring point	crack pattern	presumed major causes
cross-sectional changing part	cracks in cross-sectional changing parts	stress concentration due to abrupt cross-sectional change

cracks in abrupt cross-sectional changing parts

cracks in Gerber hinge

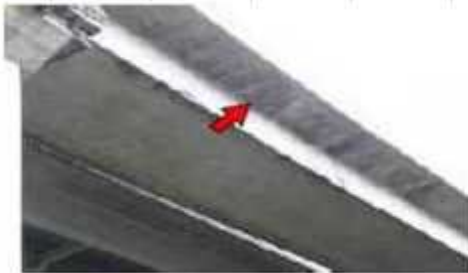
water stain point	water stain pattern	presumed major causes
underneath the overhanging floor slab	water stains on the underneath of the overhanging floor slab	poor compaction of concrete on the underneath of lateral sheaths, trickle-down water around bundled grout hoses, stagnant water in mortar areas directly under curbs, stagnant water in hand holes, and around drainage basins

water stains shaped like worm crawling, perpendicular to the bridge axis

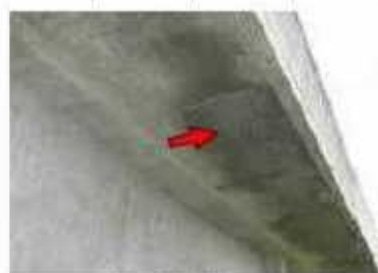
streaked water stains

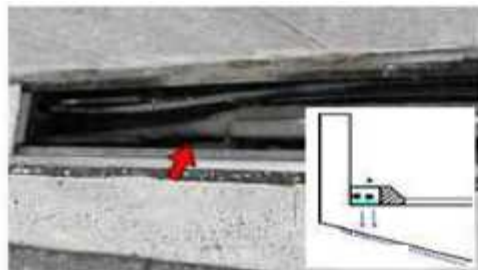
stagnant water in the hand hole

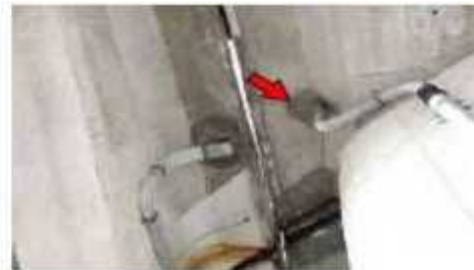
water stains around the drainage

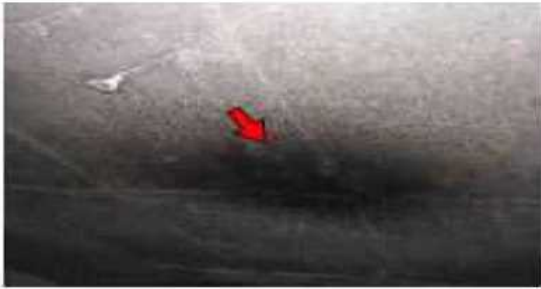
Water stains around central parts

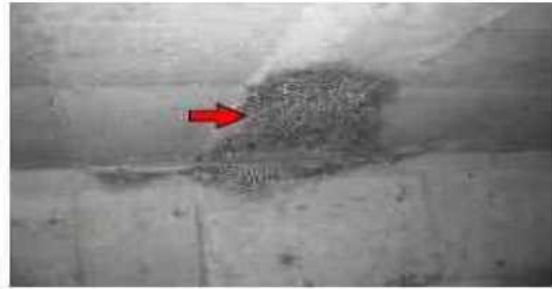
water stains around construction joints

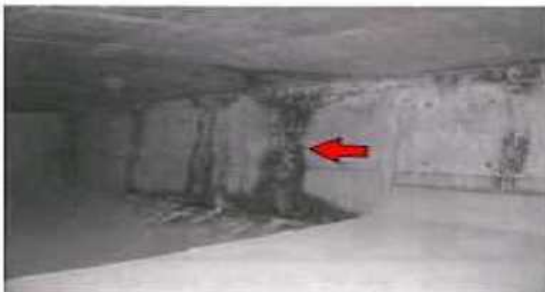
vertical water stain on the inner surface

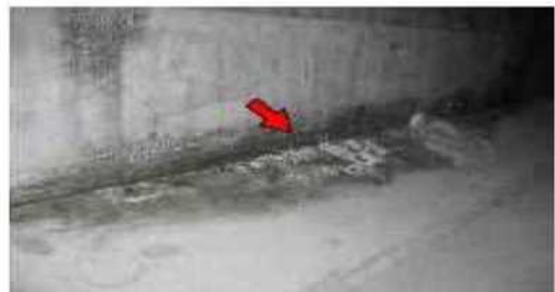
water stains around the lower floor slab haunches

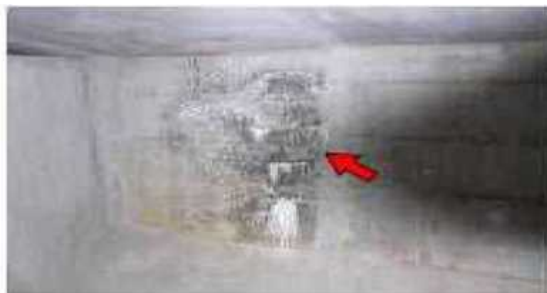
water stain along PC steel

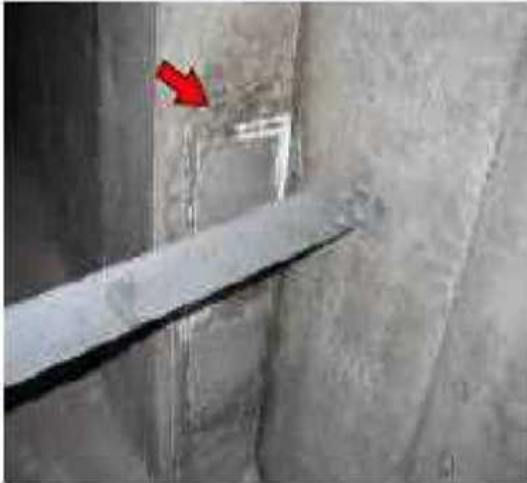
water stain on the postcasted area

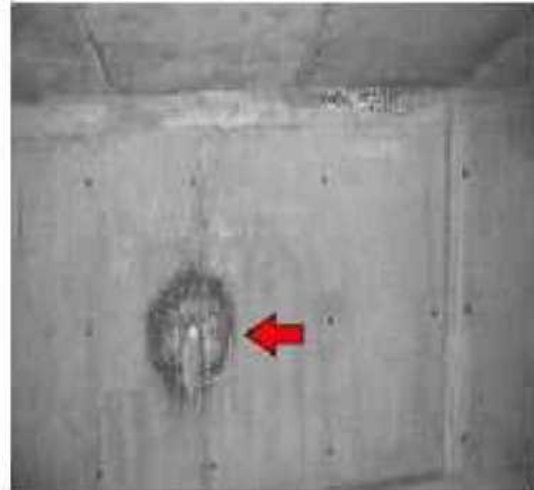
water stain on the postcasted P-con

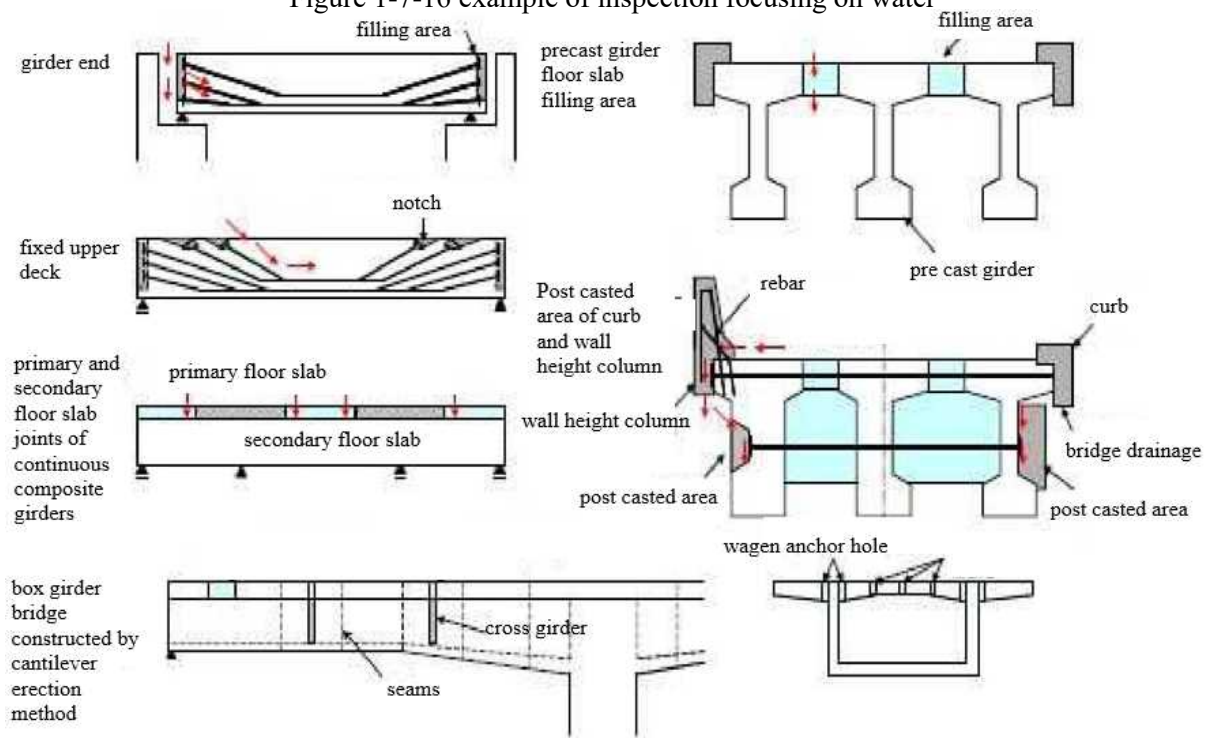
When we find leakage from pre stressed concrete bridge itself, we have to confirm the location of crack, concrete joint and aperture, whether upper anchorage of PC cable is or not, whether drainage system is or not. And we have to inspect where water floods.

Figure 1-7-16 example of inspection focusing on water

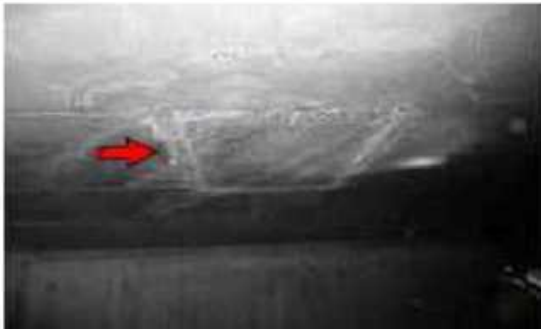
leakage from work aperture

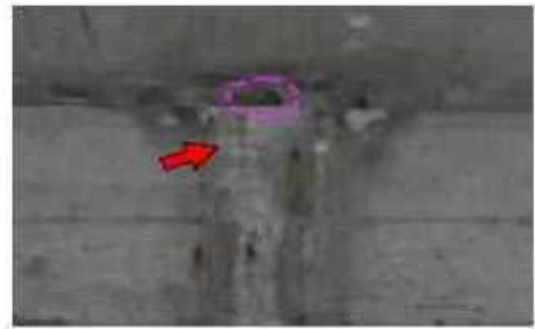
leakage from casting aperture

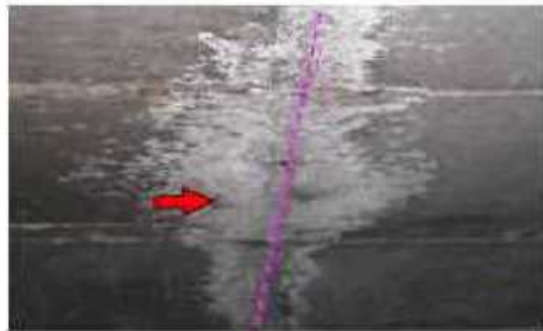
leakage from construction joint

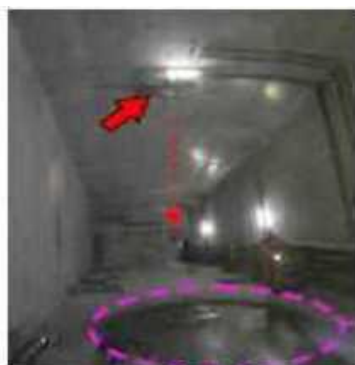
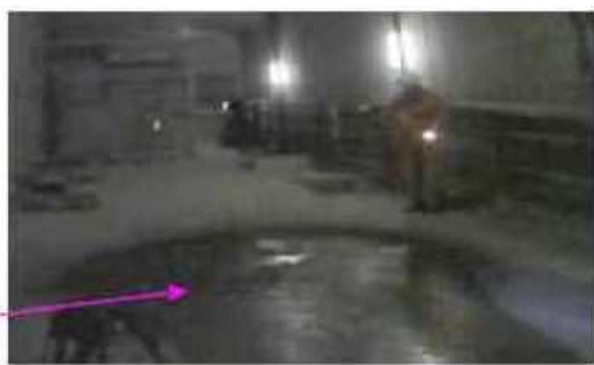
leakage from the upper slab and dripping-down to the lower slab

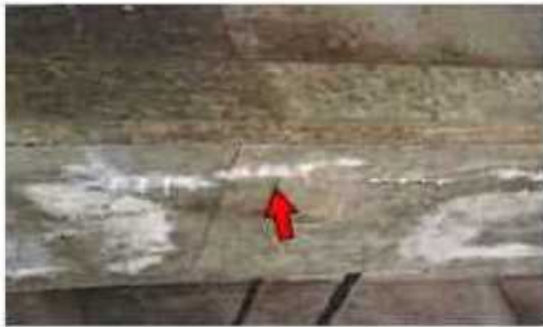
leakage from underneath the main girder

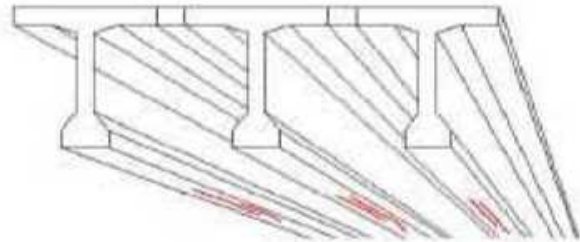
leakage points

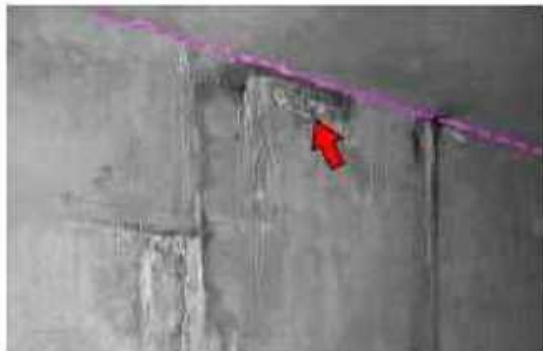
leakage from joints

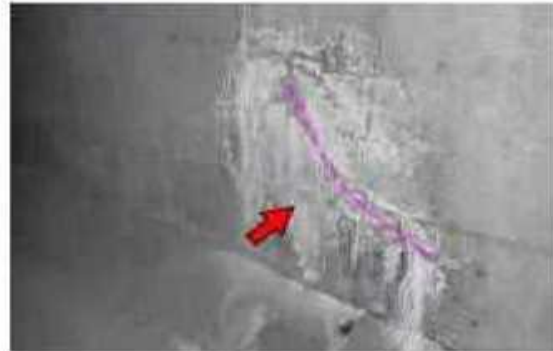
leakage along the PC steel

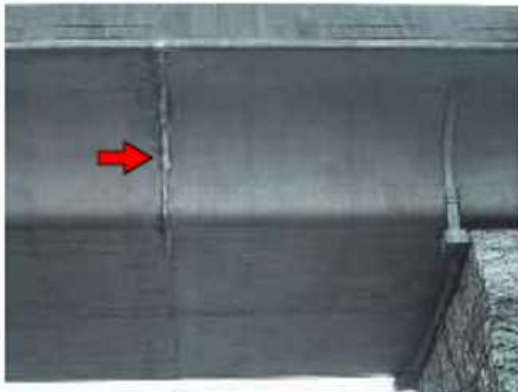
leakage from joints of segmental girders

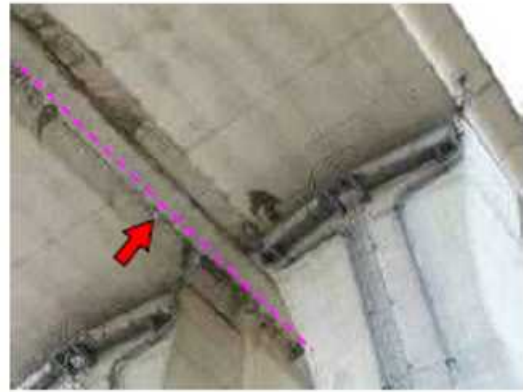
leakage from construction joints

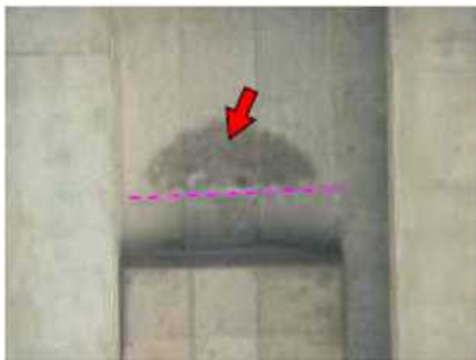
leakage from joints between primary and secondary floor slabs of continuous composite girders

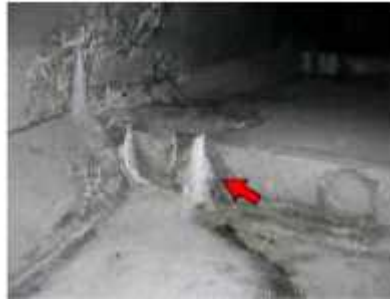
water leakage from the projection of lower floor slab

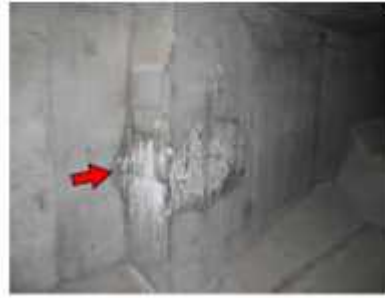
water leakage from the projection of fixed web

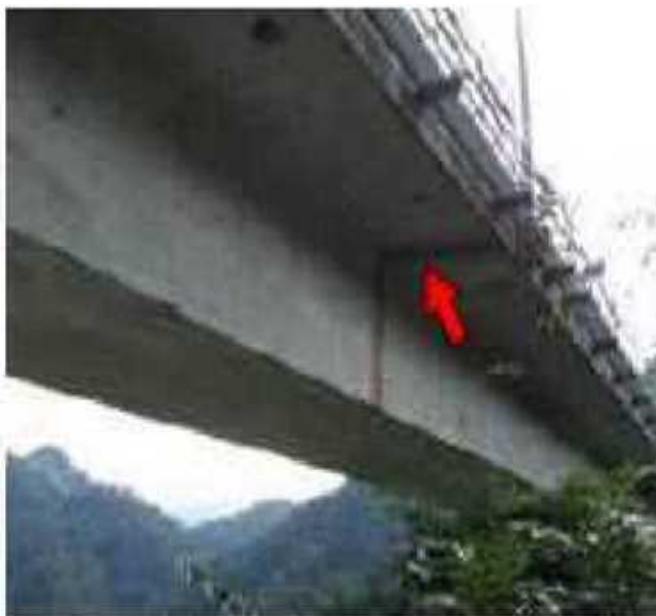
Water leakage from outer surface of box girder

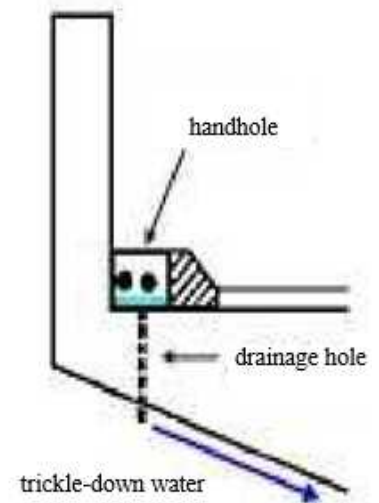
cause of trickle-down water

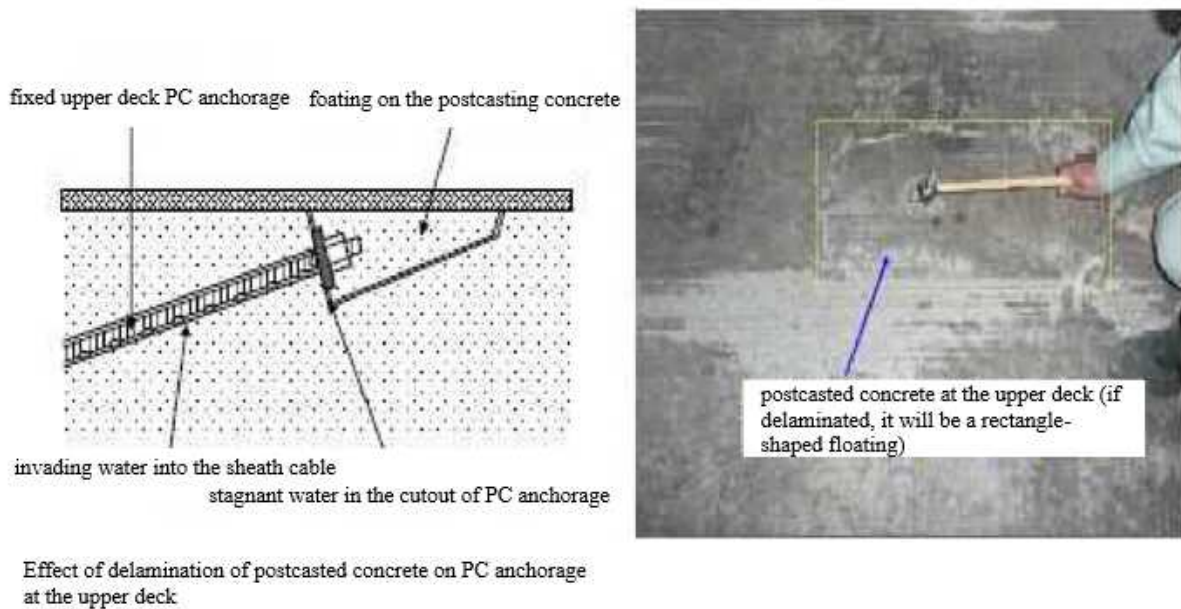
In case of PC bridge with fixed upper deck anchorage, post casting concrete delaminates and pot hole occurs. Thus, if water floods into cutout of PC anchorage, PC anchorage corrodes or PC cable breaks out by invading water.

Figure 1-7-21 the effect of post casting concrete delamination

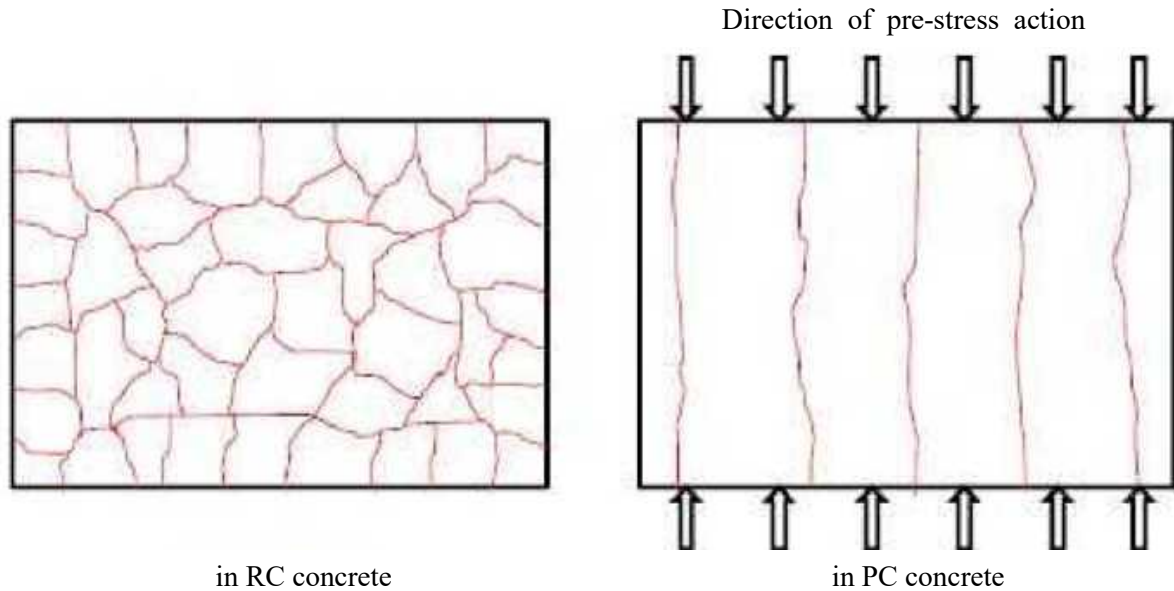
concrete differ from one of reinforced concrete. For example, in case of alkali silica reaction, cracks of RC concrete is alligator crack and on the other hand, cracks of PC concrete is along to the direction of pre stressed introduction.

in RC concrete
 in PC concrete
 Difference in crack patterns between RC concrete and pre-stresses concrete
 (Example ASR crack pattern)

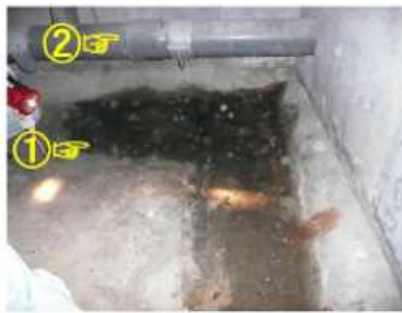
water leakage found in the girder

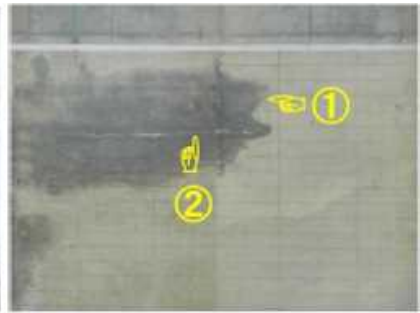
water soaking on the floor slab

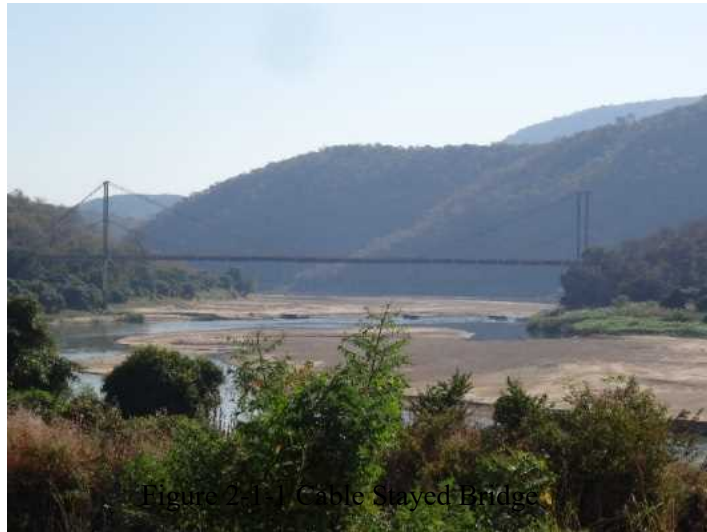
Cable Stayed Bridge is similar to Suspension Bridge that support the load of the deck in different ways. The difference is how the cables are connected to the towers. In suspension bridges, the cables are installed across the towers, transmitting the load from deck to the towers down to the anchorages. In cable-stayed bridges, the cables are attached only to the towers to support the load.

Figure 2-1-1 Cable Stayed Bridge

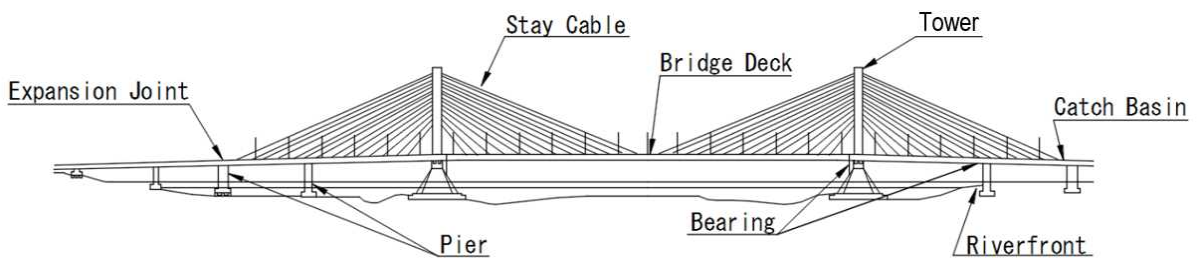
The components of the bridge are shown below. Generally, it has a bridge deck, pylons and stay cables as superstructure, and piers as substructure. Other important components of the bridge are bearings which connect superstructure and substructure, and expansion joints which allow movement of superstructure at the end of superstructure. Riverfront is the soil or rock surrounding the piers.

Figure 2-1-2 Bridge Component (Cable Stayed Bridge)

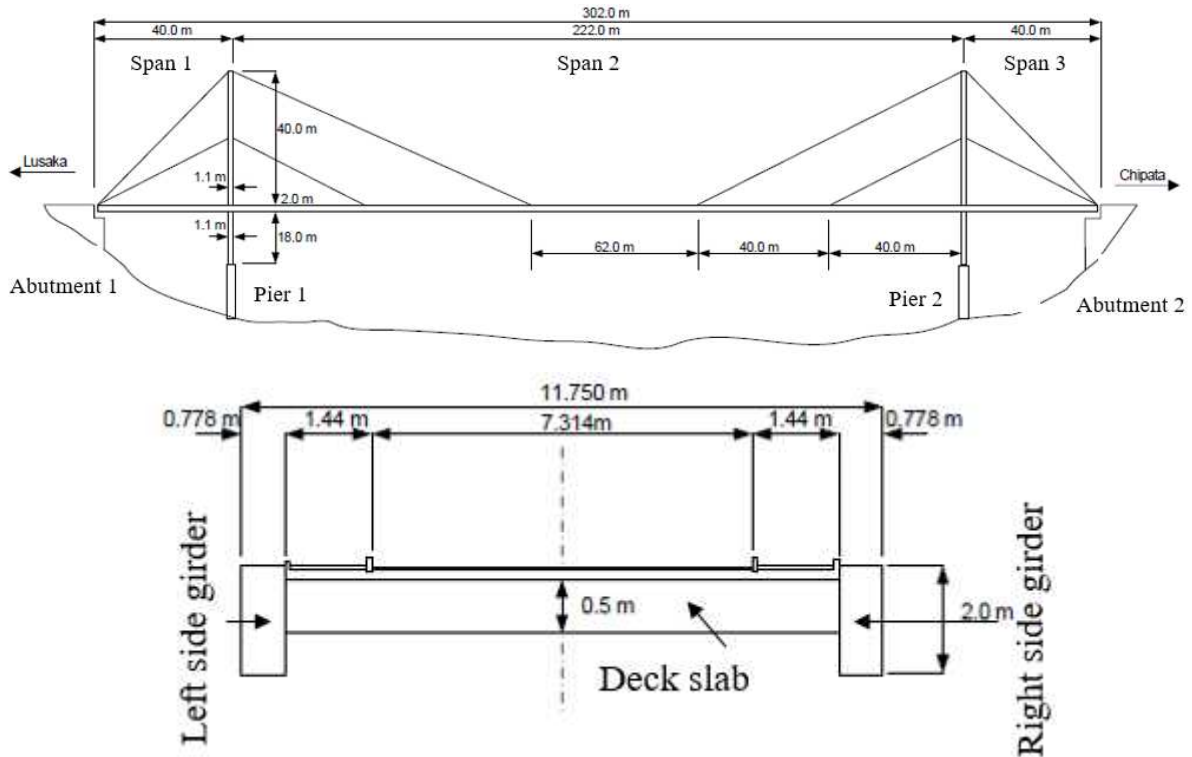
The bridge is assessed in the direction of increasing chainage. Refer to Figure 2-1-3.

Figure 2-1-3 Bridge Geometry Definition

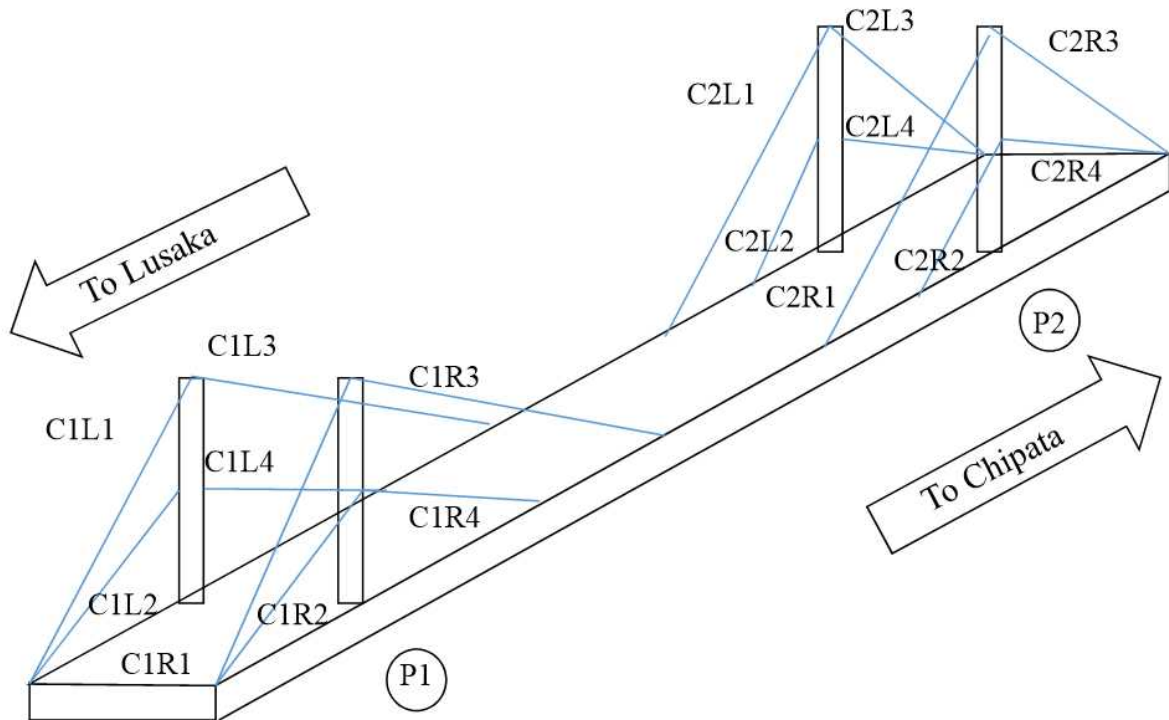
- The girder on the extreme left in span 2 is designated as Span 2 – Girder 1 (S2LG)
- Abutment 1 and 2 may be named Abutment A and B respectively.
- Cable is numbering C1L11, which C means cable, 1 means Pier number, L means Left side and 11 means cable number. Cable numbering is shown in Figure.

Figure 2-1-4 Cable numbering

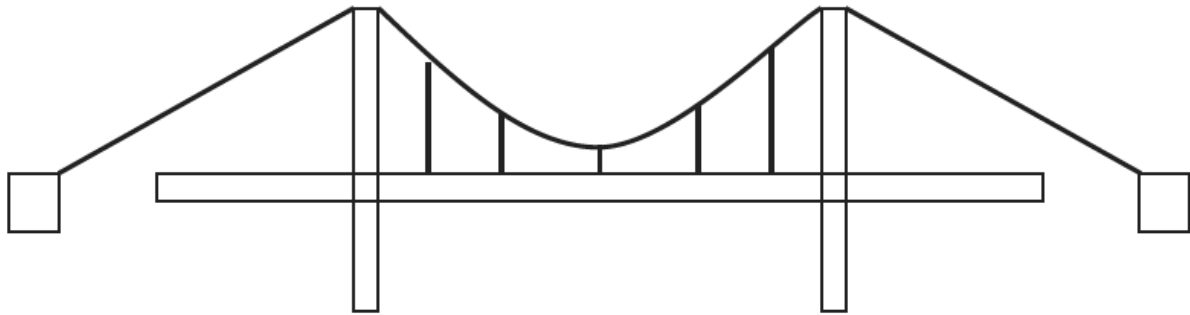
Figure 2-1-5 Suspension Bridge

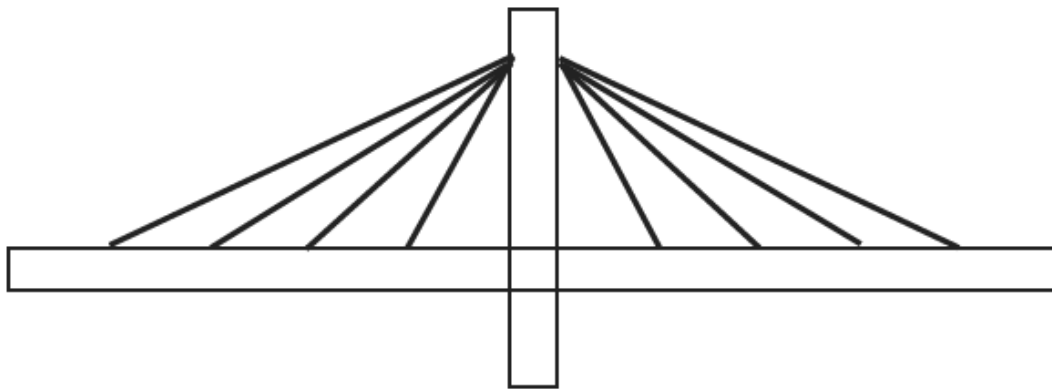
cables are extended from several points on the girder to a single point at the top of the tower. Secondly, a harp design, cables are attached at different heights along the tower, running parallel to one another. Luangwa Bridge is a harp design cable arrangement.

Figure 2-1-6 Cable Stayed Bridge (Fan Design)

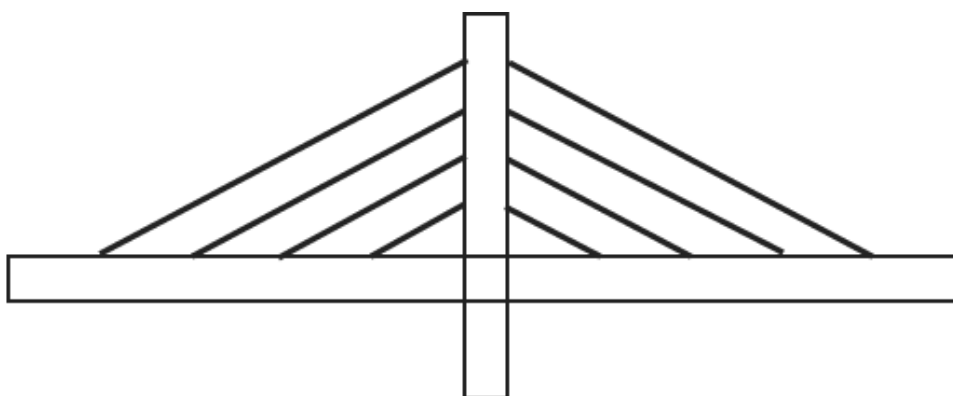
Figure 2-1-7 Cable Stayed Bridge (Harp Design)

For the support of girder, a cantilever approach is often used near the tower, but lengths further from the tower are supported by stay cables. All horizontal forces from Stay Cables are balanced at the tower, and no anchorage needed to resist a horizontal tension from

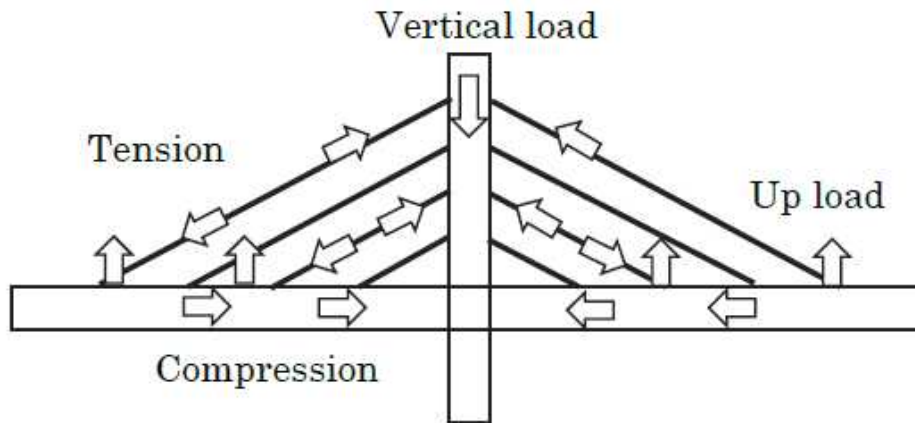
Figure 2-1-8 Load Distribution System in Cable Stayed Bridge

Due to the diagonally tensioned stayed cables, compressive forces and bending moments are imposed on the girder and the tower. The towers are the load-bearing structures which transmit vertical loads to the ground. The bridge girder should be stronger to resist the resulting axial compression loads, so greater stiffness is necessary. At the same time, it reduces the deformation of the girder, and the bridge could resist wind load.

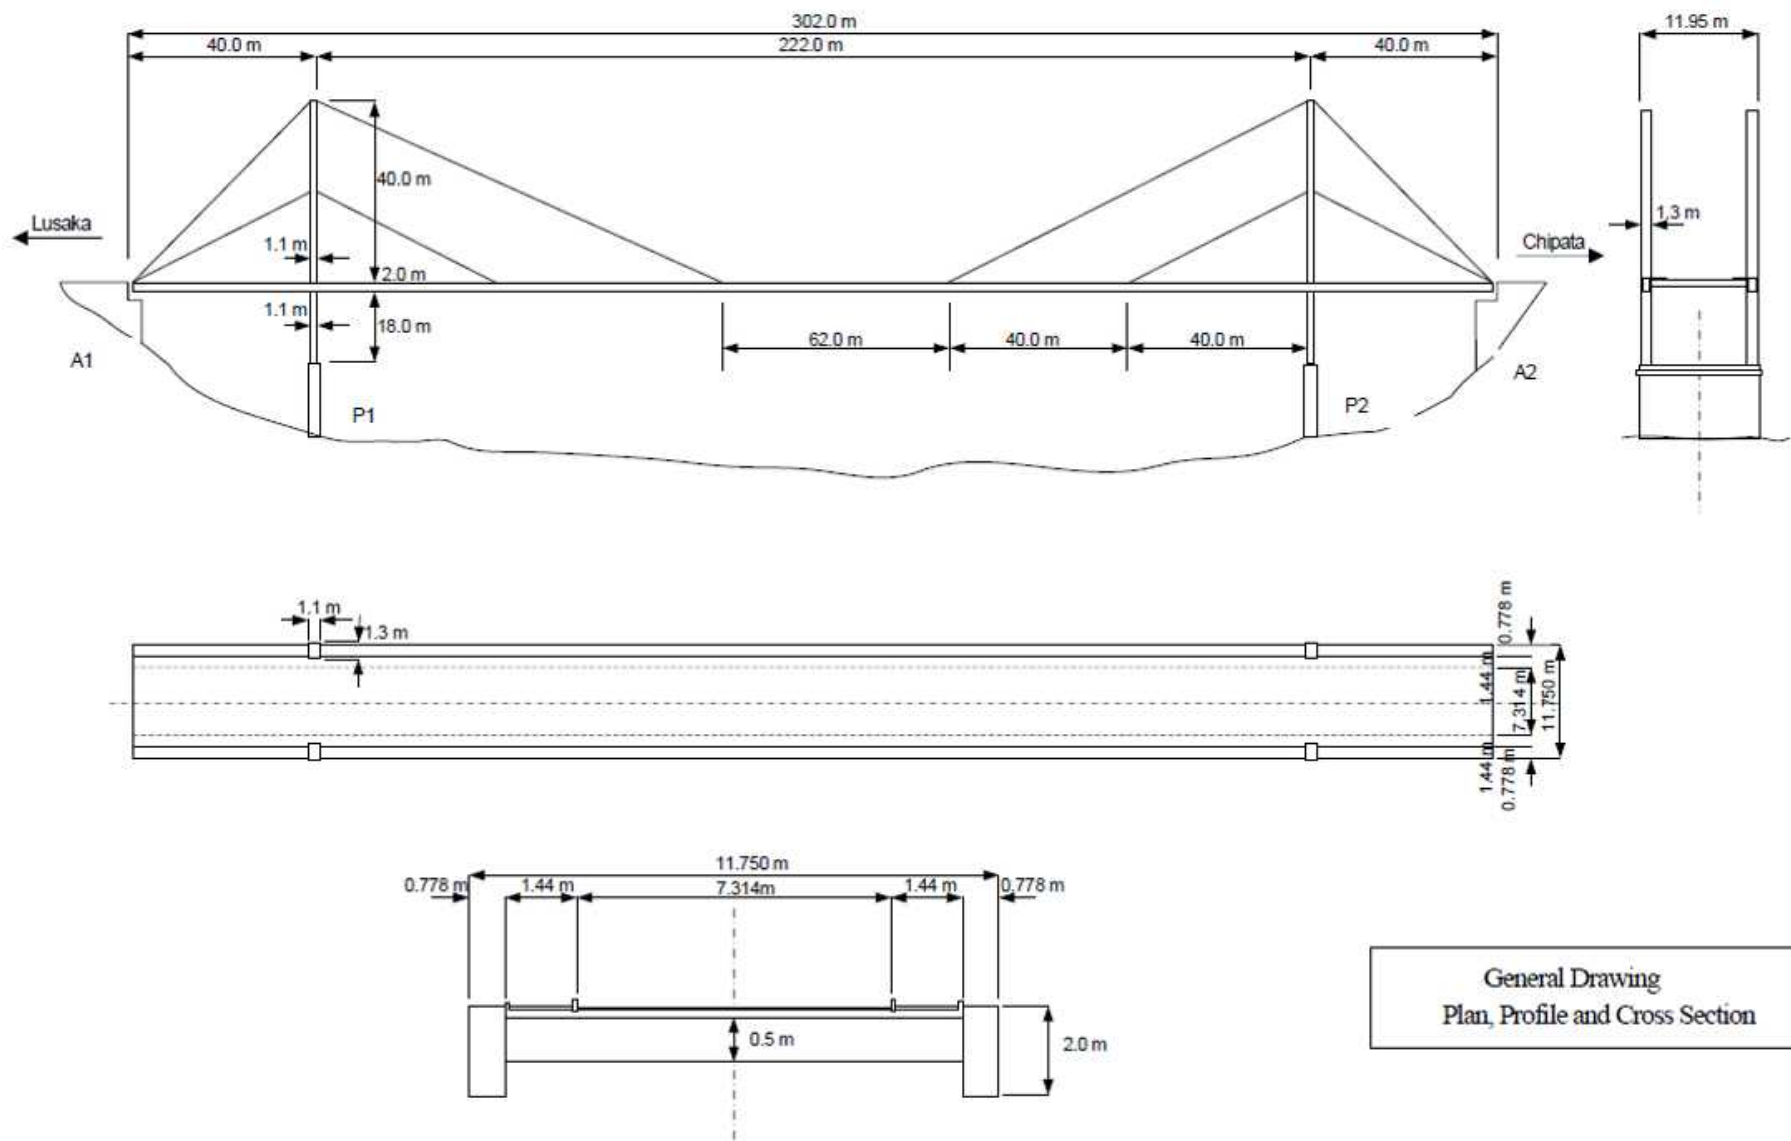
Figure 2-1-9 General View

Shown in Figure 2-1-9 is the General Views of Luangwa Bridge.

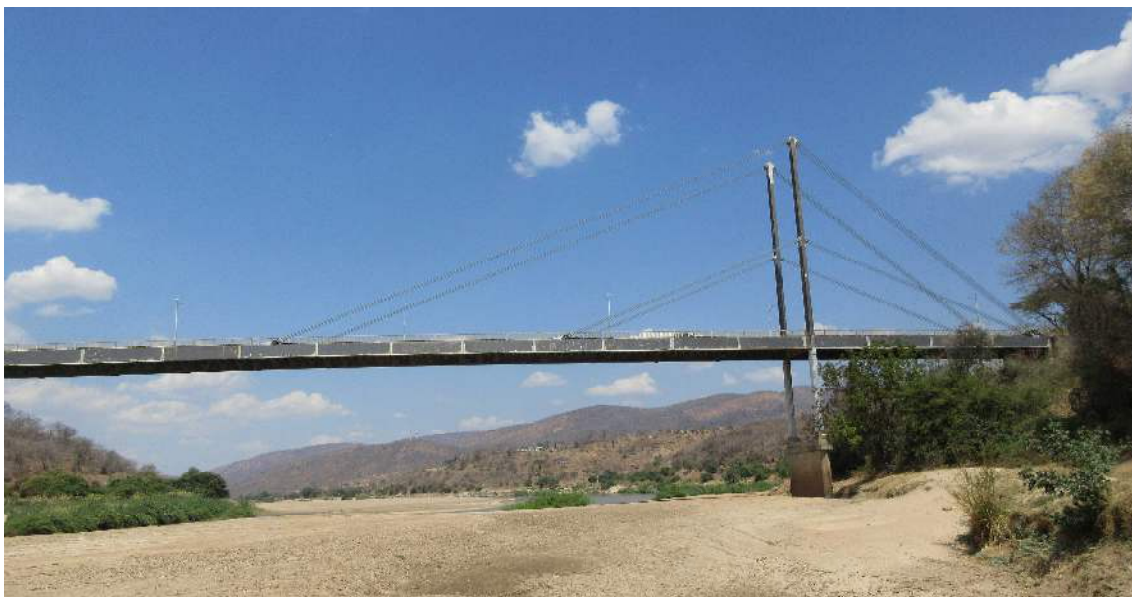
Figure 2-2-1 Photo of Luangwa Bridge

The Luangwa Bridge was constructed with the support of British in 1968. It was repaired and reinforced, but it was aging. The problem is strength and durability against rapid increased traffic and passing heavy vehicle. For these reasons, vehicles that can pass must be less than 55 tons, driving speed is limited under 30km/h and only one car can pass this bridge at one time.

The Luangwa Bridge is the only bridge which connect Lusaka province and eastern province. Its length is 302 meter (40+222+40) and its bridge type is cable stayed bridge. Compared with the cable stayed bridge which is designed generally at the present time, its side span is significantly short. The girder of central span tends to droop down even under dead load. Design drawing of Luangwa Bridge is not exist, and the design is probably based on British Standard 153 (1958). It is not assumed that more than 50 ton heavy trucks pass over the bridge.
