BRIDGE MAINTENANCE CAPACITY BUILDING IN ZAMBIA

BRIDGE INSPECTION GUIDEBOOK

2024

**Road Development Agency
Japan International Cooperation Agency**

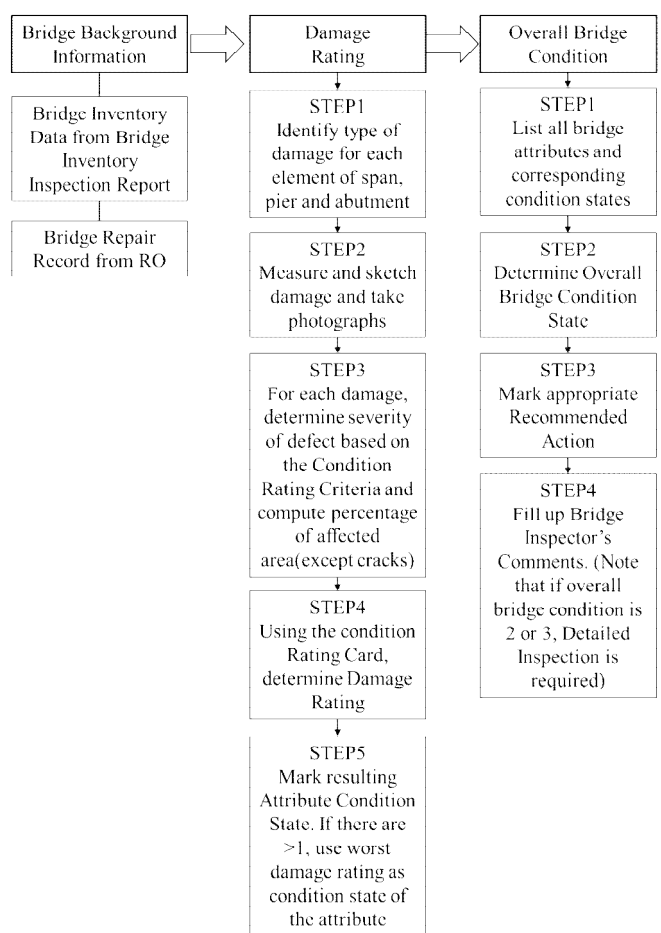
Figure 2-3-1 Flowchart of Bridge Periodic Inspection

The step-by step procedure for conducting the Periodic Inspection is illustrated in the following flowchart.

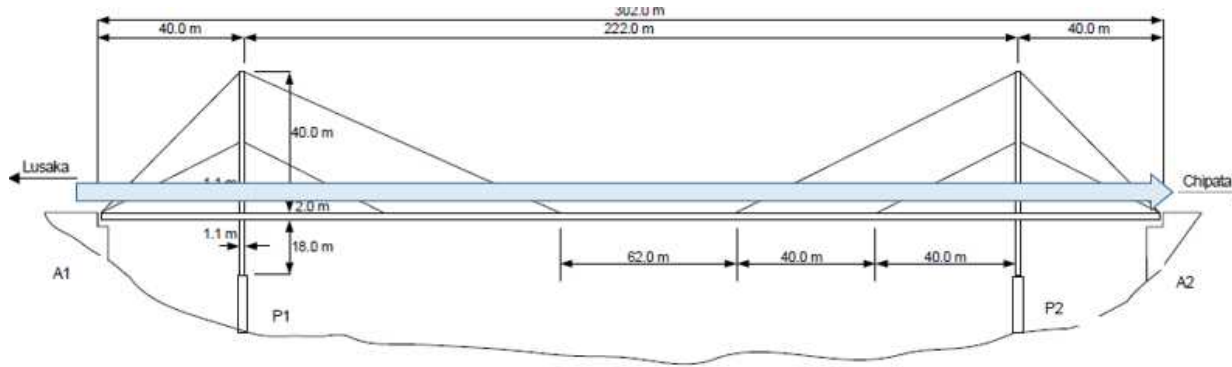
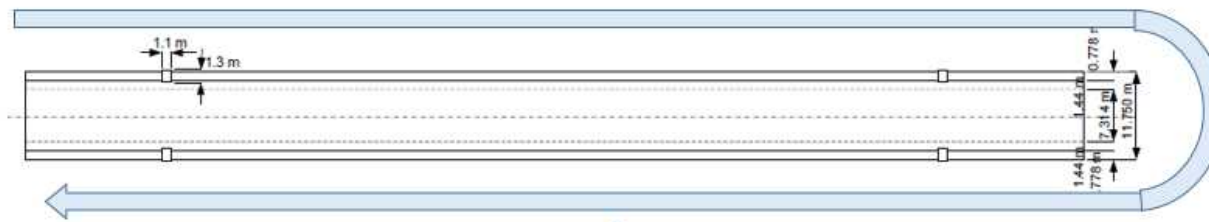
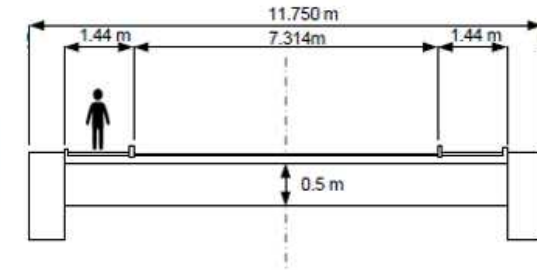
Figure 2-3-2 Periodic Inspection Route of Luangwa Bridge (1 of 3)

Inspection of Upper Deck

- Main Members to be inspected
- Cable
 - Cable Cover, Socket, Anchorage
 - Tower
 - Railing
 - Curb
 - Stabilizer
 - Pavement (Concrete)
 - Drainage
 - Expansion Joint

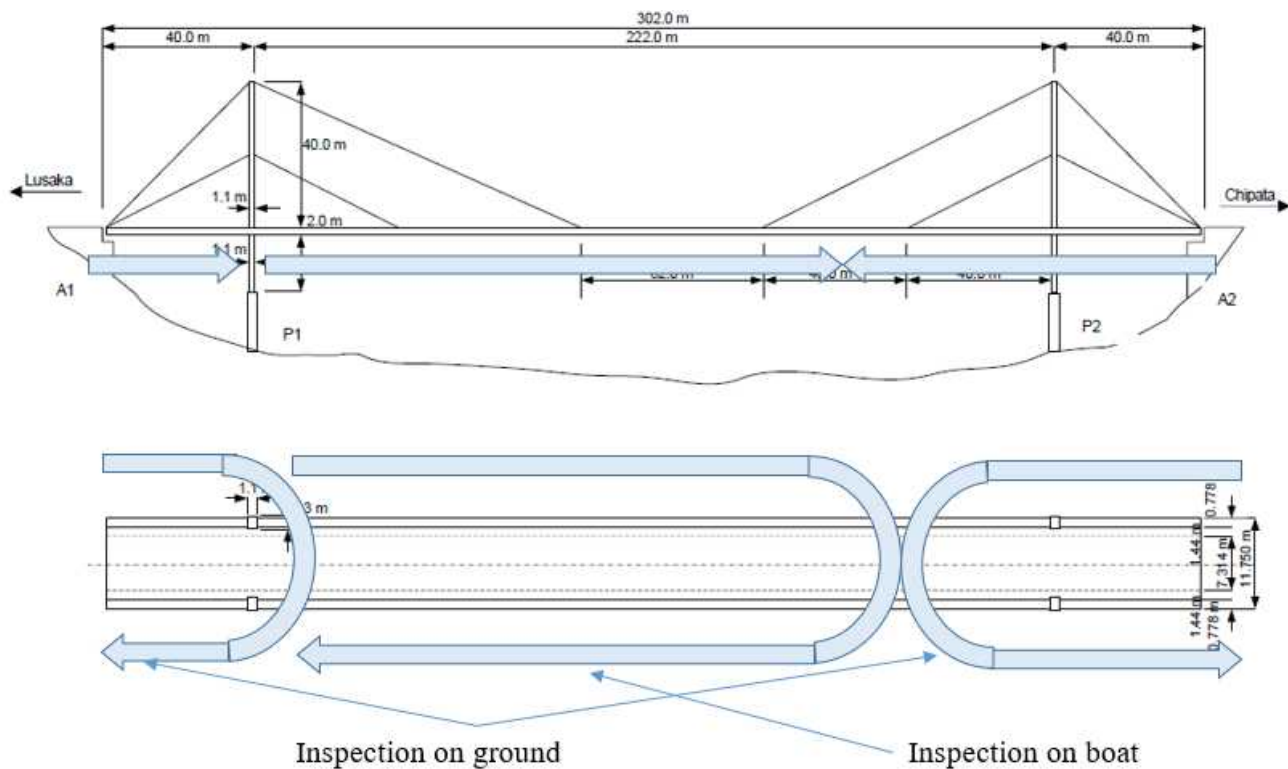
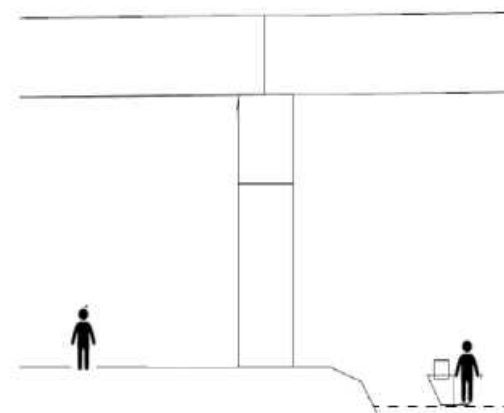
Figure 2-3-3 Periodic Inspection Route of Luangwa Bridge (2 of 3)

Inspection of Underside

- Girder
- Cross Section
- Pier (Side)
- Pier (Top)
- Bearing
- Connection
- Bolt

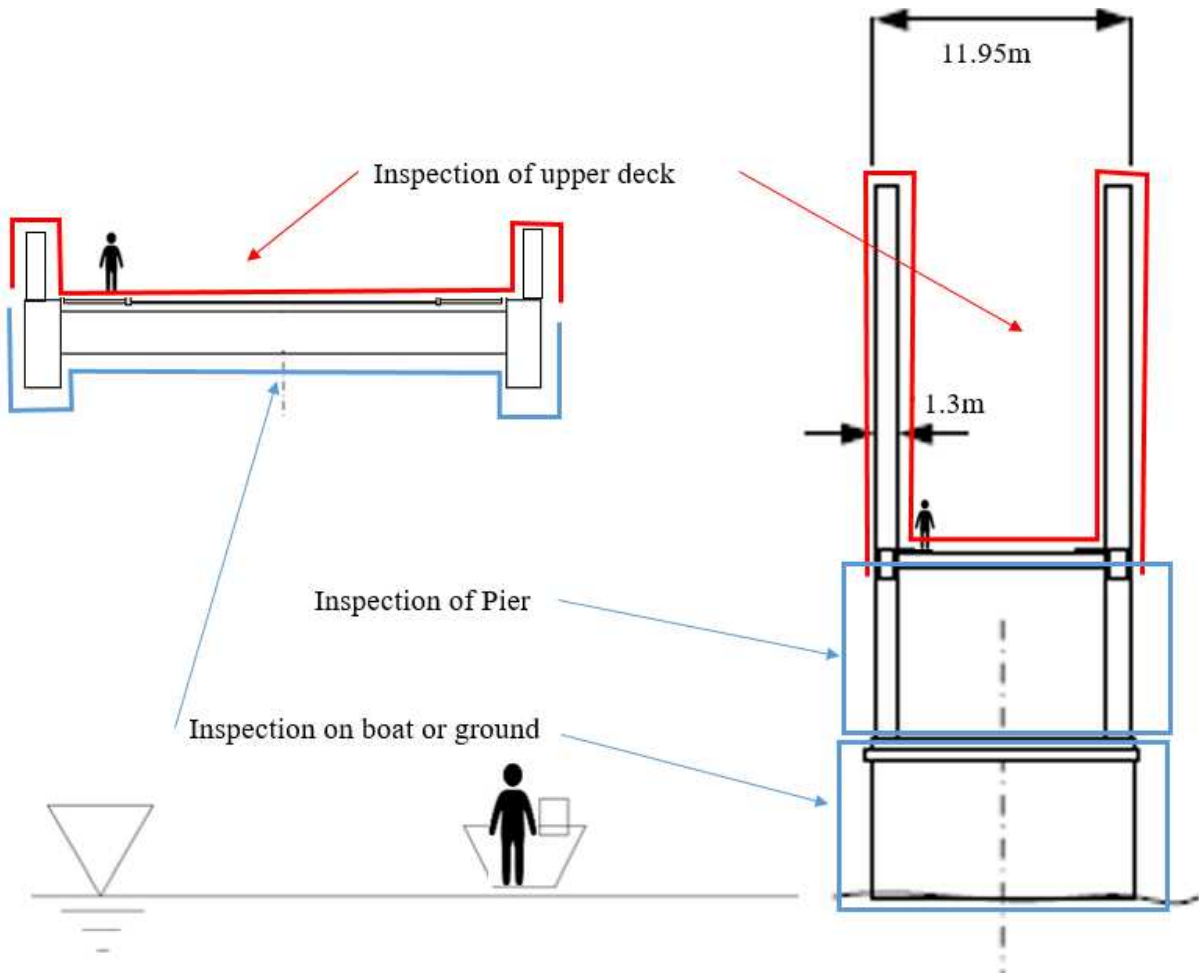
Figure 2-3-4 Periodic Inspection Route of Luangwa Bridge (1 of 3)

Inspection Area of Each Place

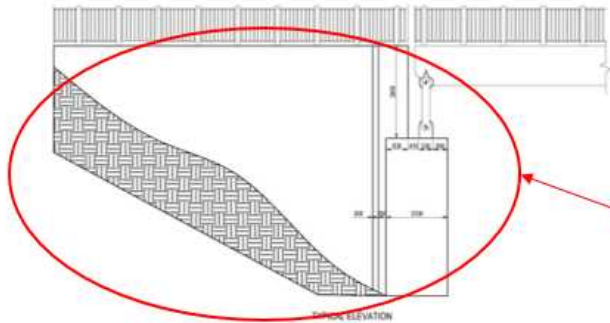
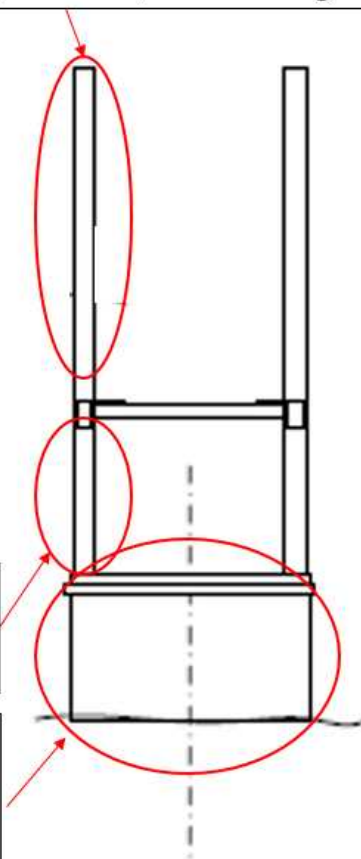
Figure 2-3-5 Check Points of Periodic Inspection – Luangwa Bridge (1 of 2)

Railing
Corrosion, Loose Connection
Impact / Accident Damage
Paint Peel Off

Concrete Deck slab
Cracking, Spalling /Scaling/ Disintegration
Delamination, Rebar Exposure / Corrosion
Honeycomb, Water Leakage

Outside of Tower
Corrosion, Cracking, Deformation / Buckling
Loose Connection, Bolt Loss, Water Leakage

Cross Girder
Corrosion, Cracking, Deformation / Buckling
Loose Connection, Bolt Loss, Water Leakage

Box Girder
Corrosion, Cracking, Deformation / Buckling
Loose Connection, Bolt Loss, Water Leakage

Pier (Steel)
Corrosion, Cracking, Deformation / Buckling
Loose Connection, Bolt Loss, Water Leakage

Pier (Concrete) / Abutment
Cracking, Spalling /Scaling/ Disintegration
Delamination, Rebar Exposure / Corrosion
Honeycomb, Water Leakage, Tilt / Settlement

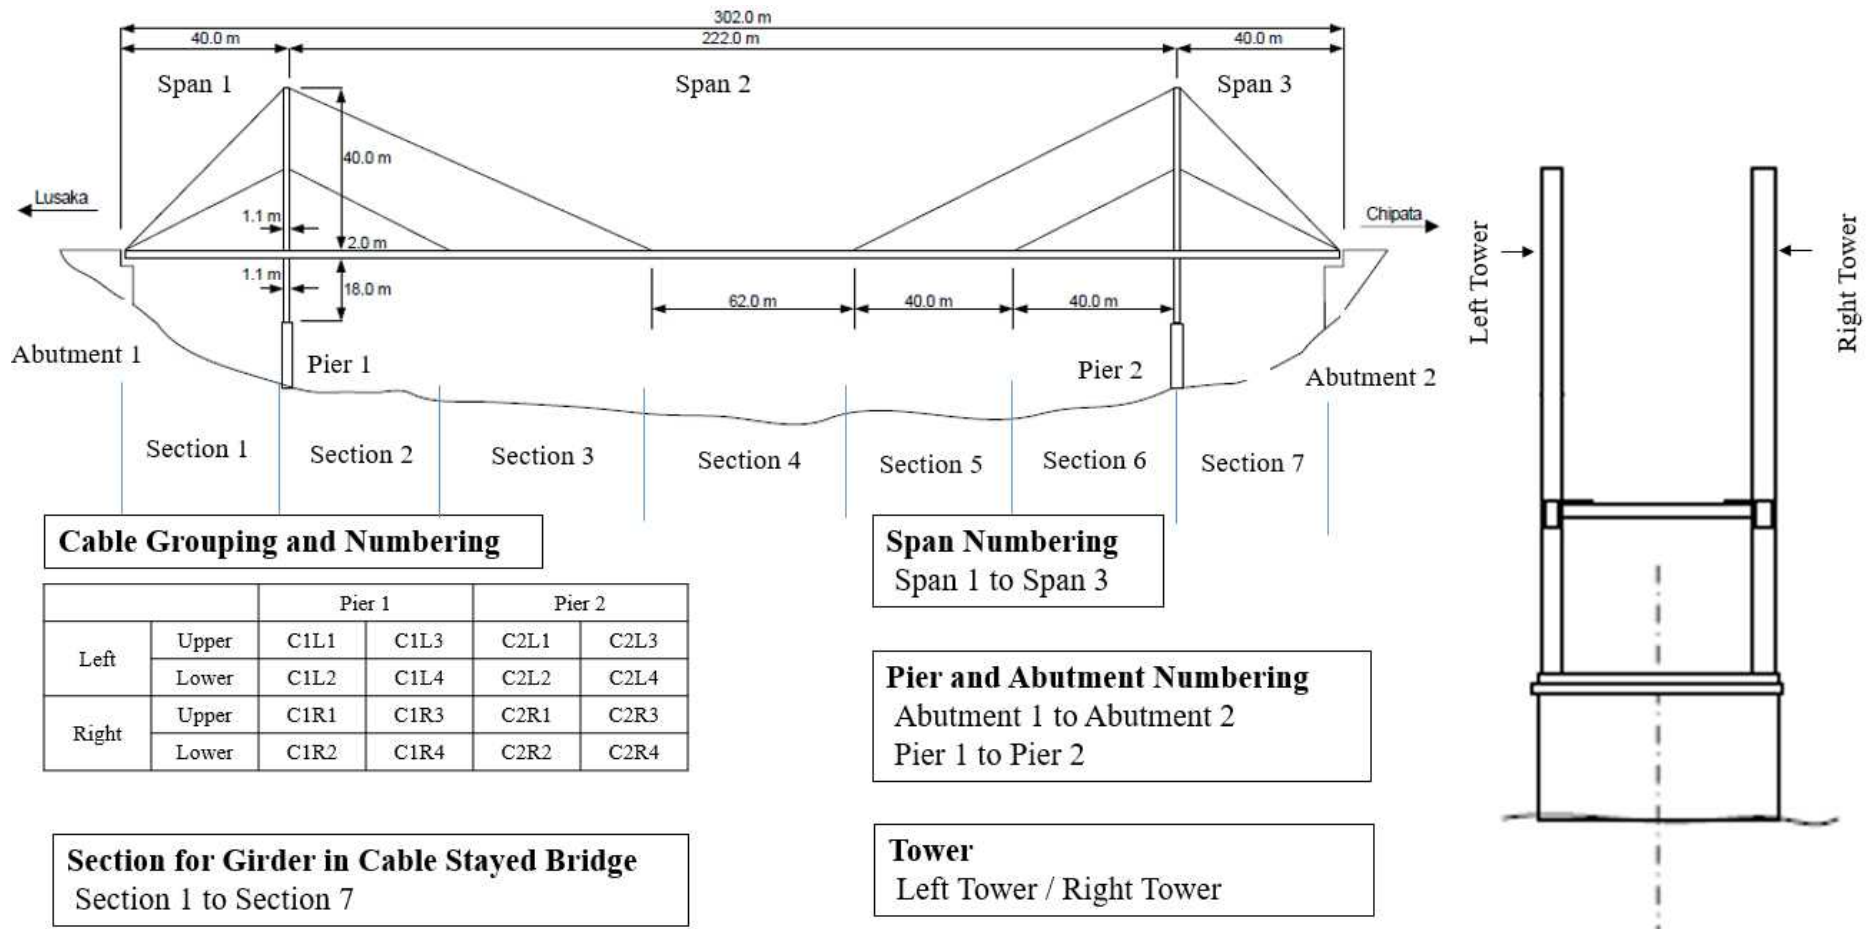
Figure 2-3-7 Numbering of Members – Luangwa Bridge

Special / long span bridges are complex structures. Before conducting inspection, proper numbering of elements and attributes on the forms should be considered to avoid misinterpretation on its location. During inspection, each attributes shall be numbered / marked for easy identification. Numbering and marking of attributes are shown in Figure 2-3-7.

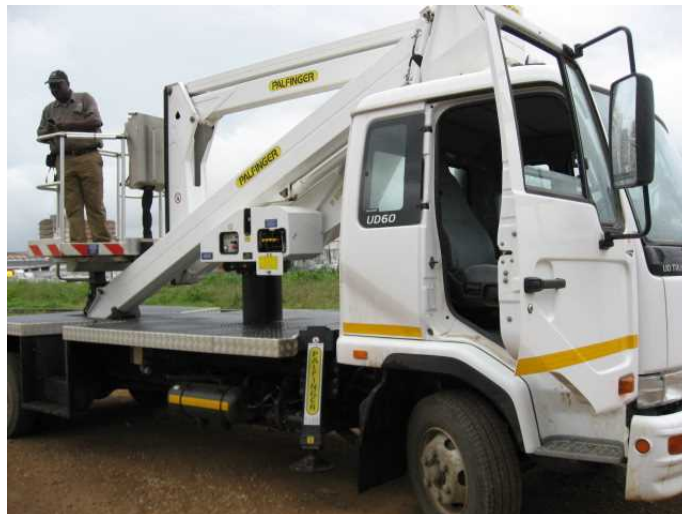
Figure 2-3-8 Photo of Aerial Work Platform Type BIV

Generally, two types of BIV are used in the inspection of bridges. One type is Bucket Type BIV which is also called Aerial Work Platform (AWP). This type of BIV is widely used for maintenance and construction of bridge and also for power and telecommunications industries. They can lift inspectors up to high level to inspect tower, cable band chord and etc. Figure 2-3-8 shows the picture of the Bucket Type BIV.

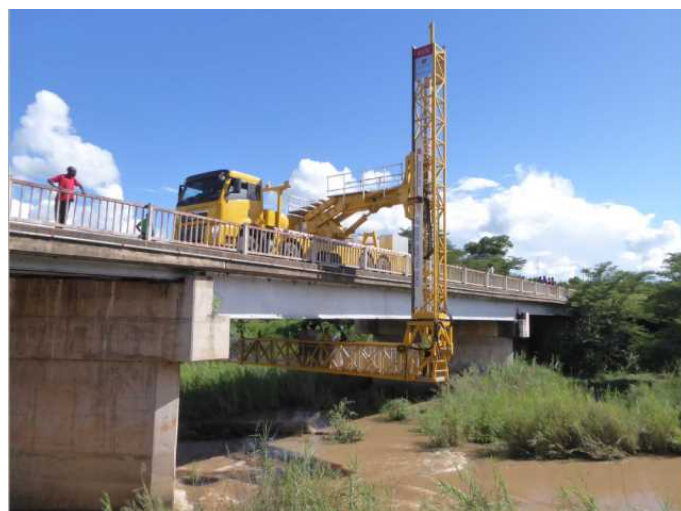
Figure 2-3-9 Photo of Telescoping Articulated Platform Type BIV

Another type of BIV is Telescoping Articulated Platform. This type can carry the inspector underneath the bridge to check girders, bottom of slab and etc. Figure 2-3-9 shows the picture of Telescoping Articulated Platform Type BIV.

When BIV used, a designated vehicle operator should accompany the inspection and operate the vehicle. Inspectors should be tied to the rigid frame by safety belt during lifting.

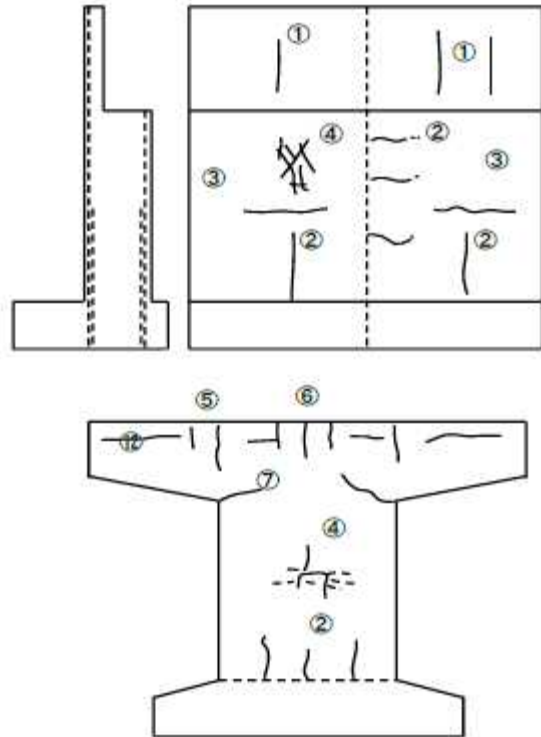
Figure 2-3-8 General Patterns of Defect (1 of 2)

General Patterns of Crack Defects on Abutment and Pier

Number	Pattern
1	Crack with regular interval
2	Crack on the concrete casting joint
3	Crack around the changing point of density of reinforcement bar
4	Crack like mesh
5	Crack on topside of overhang beam (coping)
6	Vertical crack on pier center
7	Crack on bottom side of overhang beam (coping)
8	Crack on upper and bottom part of column
9	Crack on column
10	Crack on haunch
11	Bending crack on the span center or beam
12	Horizontal crack on beam

As a reference, some special attributes of Luangwa Bridge are listed in Table 2-3-4. All other applicable descriptions in the BMS Manual for standard bridge are adopted in this Manual. General pattern of defects in bridges are shown in Figure 2-3-8 and 2-3-9.

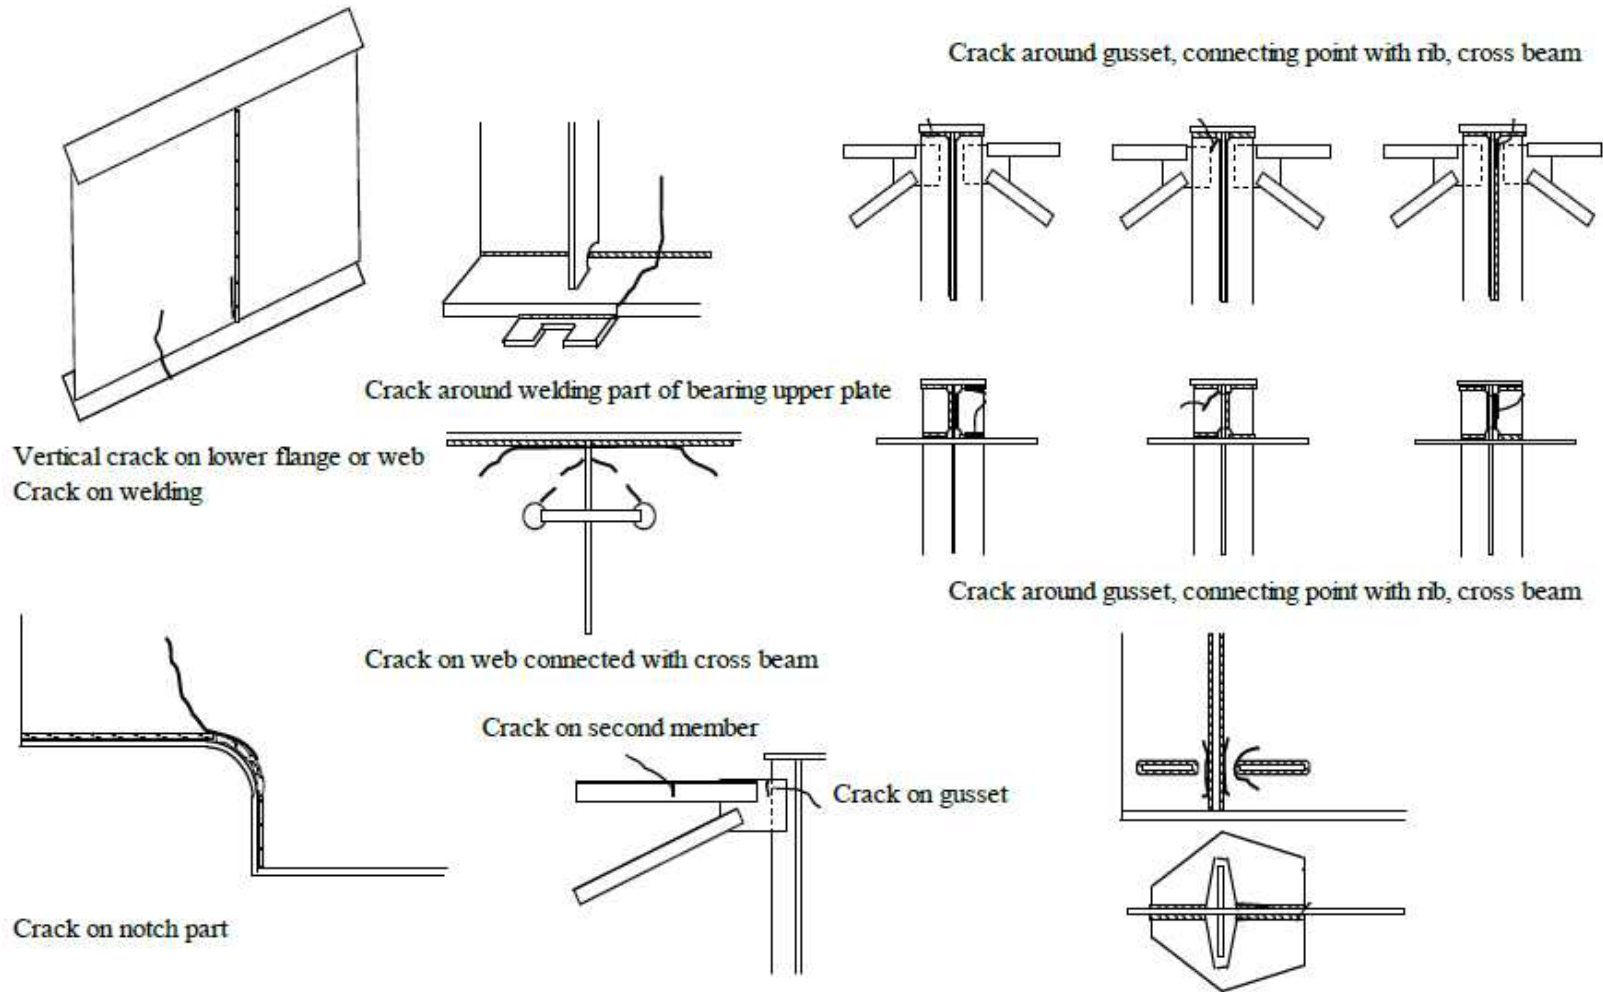
Figure 2-3-9 General Patterns of Defect (2 of 2)

General Patterns of Crack Defects on Steel Bridge

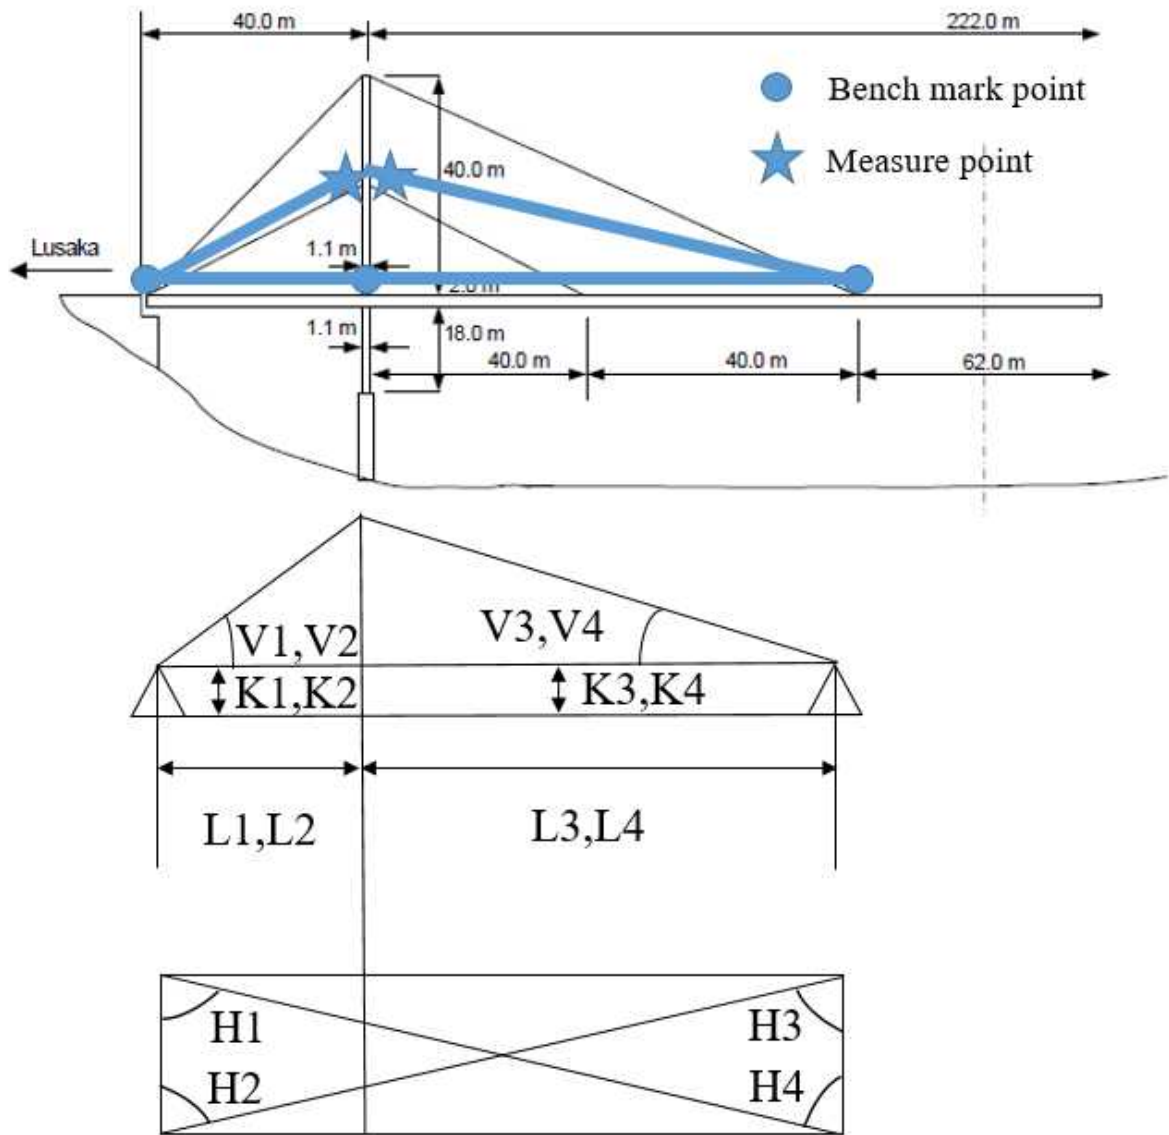
Figure 2-5-2 Geometrical Inspection:
Slope of Vertical Alignment of Arch Chord (1/2)

Measure: Angle (Vertical): $V1', V2', V3, V4'$
 Angle (Horizon): $H1', H2', H3', H4'$
 Length: $L1', L2', L3', L4'$
 Height: $K1', K2', K3', K4'$

Raise: $K1' + L1' \cdot \tan V1'$	Slope: $L1' / \tan H1'$
$K2' + L2' \cdot \tan V2'$	Slope: $L2' / \tan H2'$
$K3' + L3' \cdot \tan V3'$	Slope: $L3' / \tan H3'$
$K4' + L4' \cdot \tan V4'$	Slope: $L4' / \tan H4'$

Geometrical Inspection methods are shown in Figure 2-5-1, 2-5-2, 2-5-3, and 2-5-4. As a reference, Geometrical Inspection form (GIF) of Luangwa Bridge are shown in Appendix A-2-3.

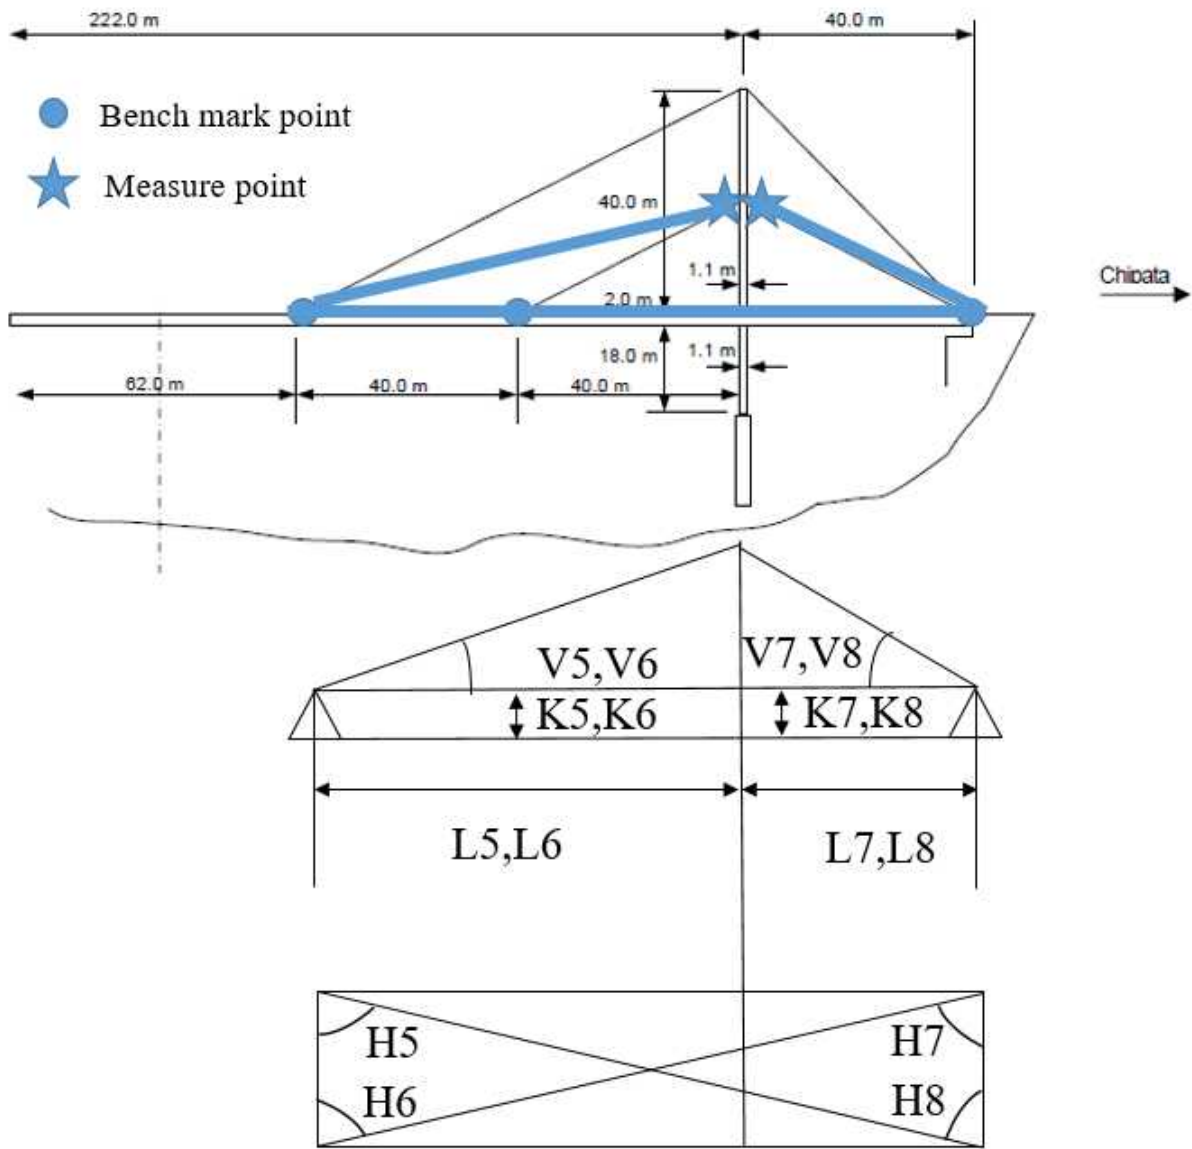
Figure 2-5-3 Geometrical Inspection:
Slope of Vertical Alignment of Arch Chord (2/2)

Measure: Angle (Vertical): $V5', V6', V7, V8'$
 Angle (Horizon): $H5', H6', H7', H8'$
 Length: $L5', L6', L7', L8'$
 Height: $K5', K6', K7', K8'$

Raise: $K5' + L5' \cdot \tan V5'$	Slope: $L5' / \tan H5'$
$K6' + L6' \cdot \tan V6'$	Slope: $L6' / \tan H6'$
$K7' + L7' \cdot \tan V7'$	Slope: $L7' / \tan H7'$
$K8' + L8' \cdot \tan V8'$	Slope: $L8' / \tan H8'$

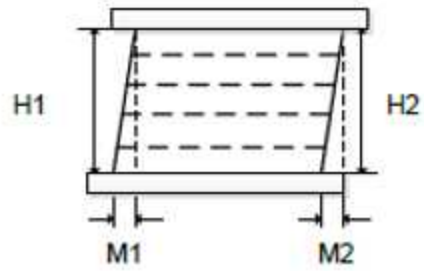
Figure 2-5-4 Geometrical Inspection:
Movement of Bearings and Expansion Joints

Bearing

Measure every bearing (everytime use same marking point)

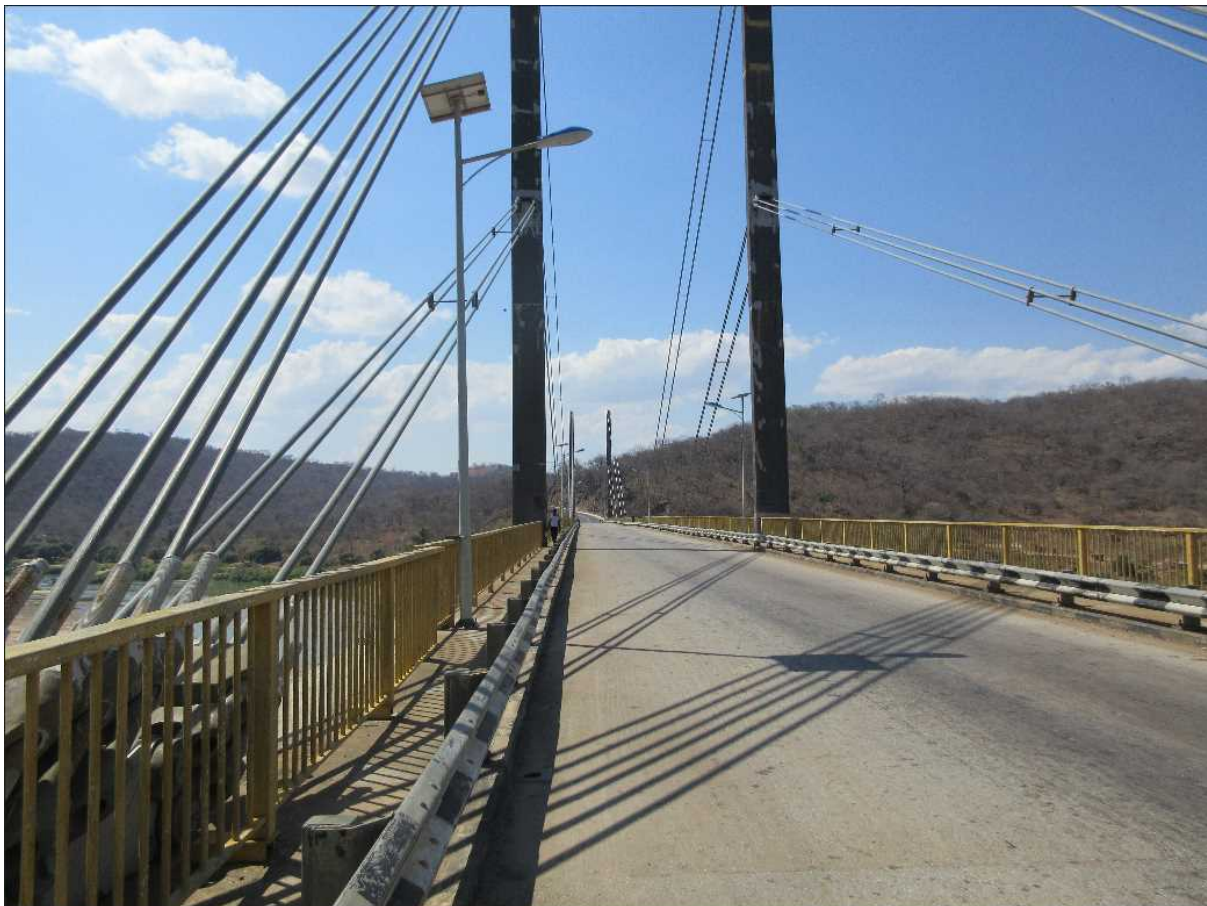
Figure 2-7-1 Stay cable in Luangwa Bridge

- Stay-cables (Figure 2-7-1): Cable fracture, corrosion, fatigue cracking, corrosion or cracking of the protective tubing, vibration
- Stay-cable anchors (steel, Figure 2-7-2 and Figure 2-7-3): Corrosion of the anchor, deformation or buckling close to the anchor, deterioration or corrosion of paint, water leakage or water accumulation, fatigue cracking

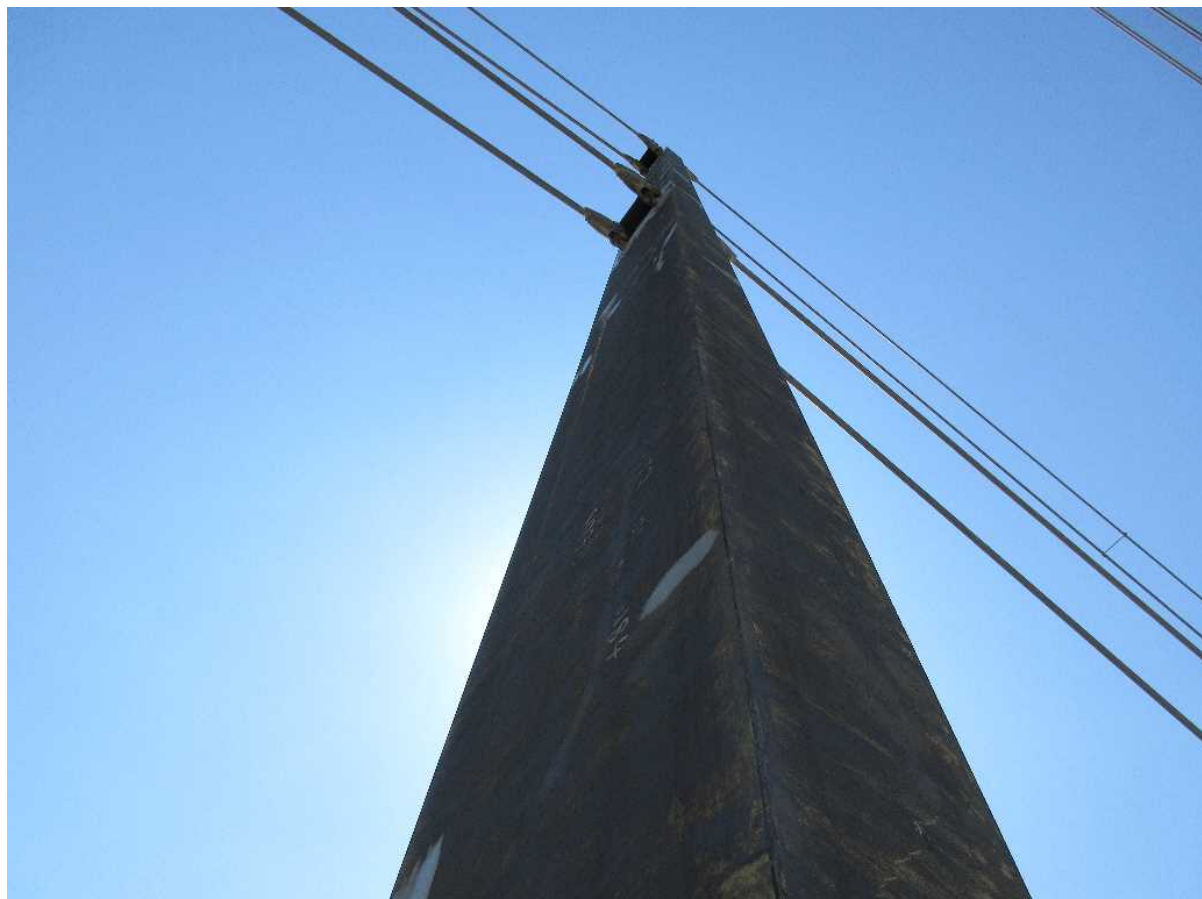
Figure 2-7-4 Tower in Luangwa Bridge

- Tower (steel, Fig 2-7-4): Corrosion at the boundary between the concrete foundation and steel tower, corrosion and deterioration of paint caused by airborne salt, cracking of concrete foundation
- Others: Subsidence or inclination caused by earthquake or ground deformation, deterioration of tower-side stay-cable anchors

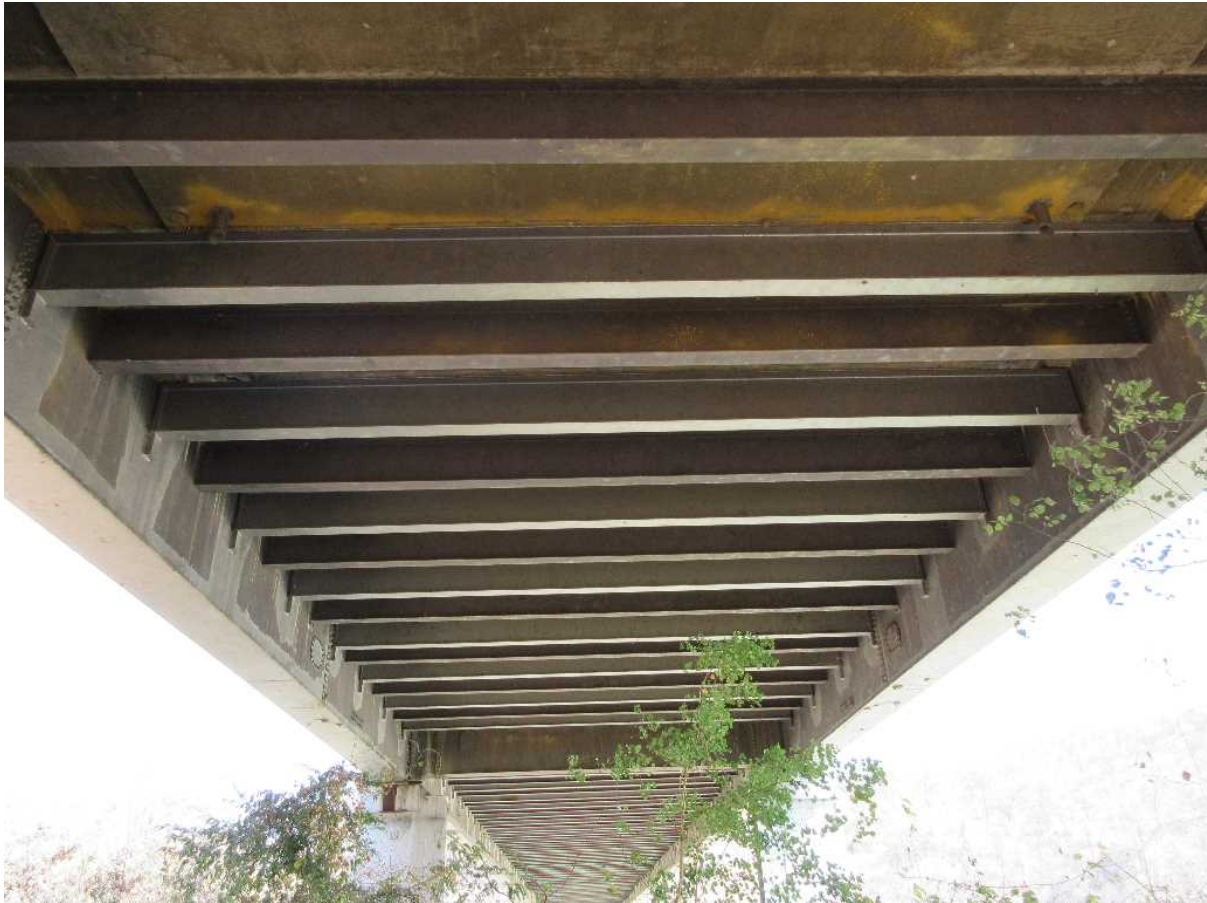
Figure 2-7-5 Two Box girders in Luangwa Bridge

· Two box girders (steel, Fig 2-7-5): Torsion and deformation according to heavy traffic vehicle. In the Luangwa Bridge, reinforcement work is being carried out to additionally construct a cross girder, so any torsion of the box girder have not been shown.

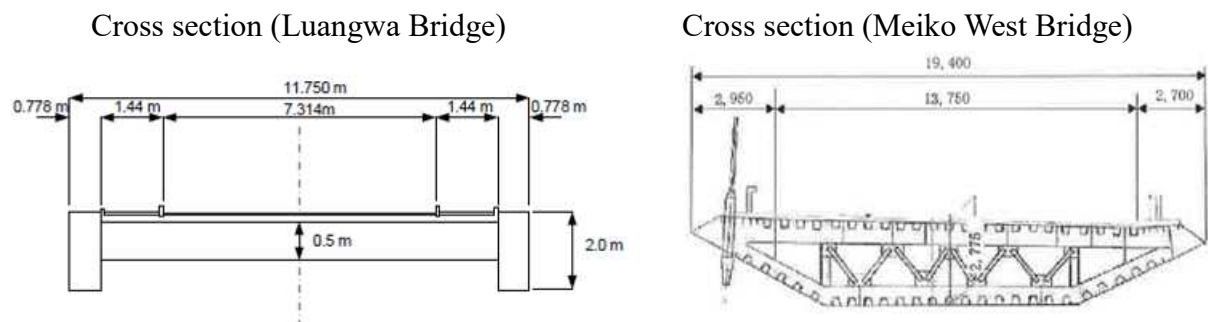
Figure 2-7-6 comparison of cross section

Compared with another Stayed Cable Bridge, girder span is so wide and height of the girder is low in Luangwa Bridge as shown in Figure 2-7-6, therefore, it is structurally unbalanced. So we have to inspect two box girders and cross girders in order to make sure that there are no problems.

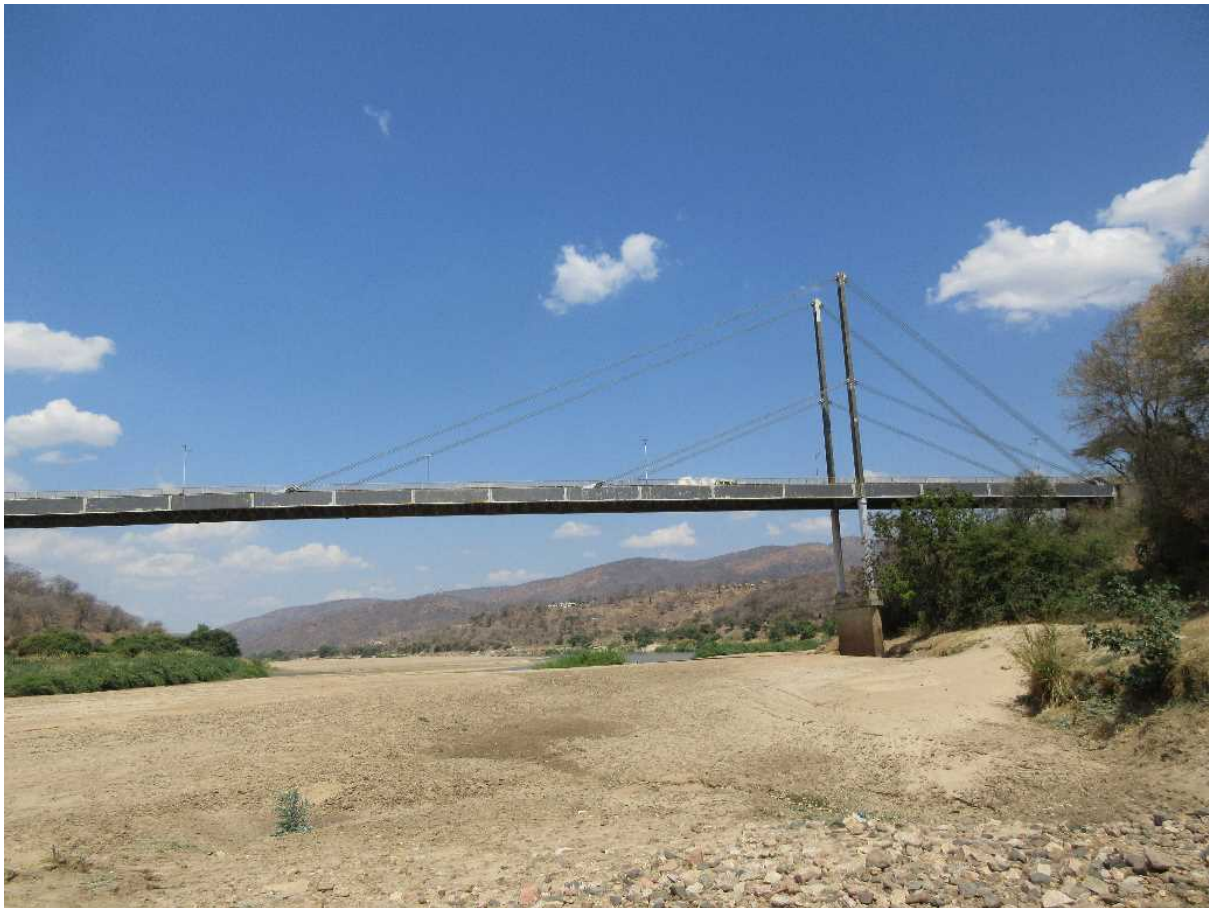
Figure 2-7-7 sagging of deck slab in Luangwa Bridge

- Deck slab (Figure 2-7-7): Sagging of the central span of the bridge. Especially, central span of Luangwa Bridge (222 meters) is longer than end span (40 meters). According to the report, the tension of cables was getting to lose when it was constructed. And the tension of cables have not lose after that. It is considered that sagging of central span occurs due to lose tension not due to heavy traffic load.

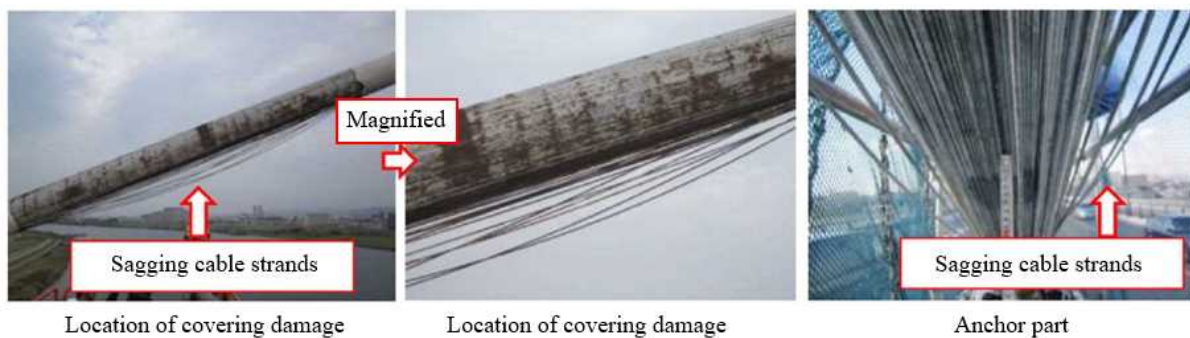
Figure 2-7-8 Example of partial cable fracture caused by corrosion

At cable-stayed Bridge in Japan, as a result of possible stress corrosion cracking, the cable strands sagged and partial cable fracture occurred as shown in Figure 2-7-8.

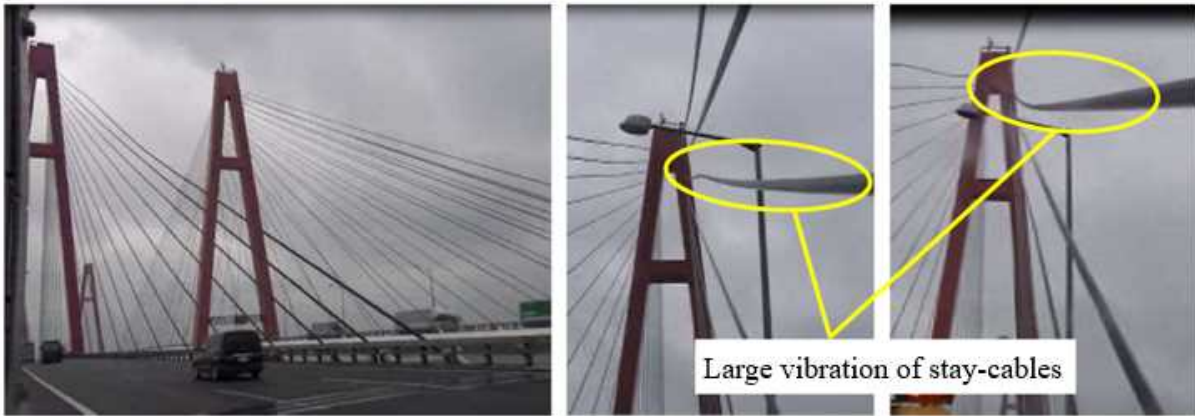
Figure 2-7-9 Example of rain vibration

Examples of vibration in the stay-cables of cable stayed bridges and similar structures, and examples of deterioration caused by vibration, are shown in Figure 2-7-9, Figure 2-7-10 and Figure

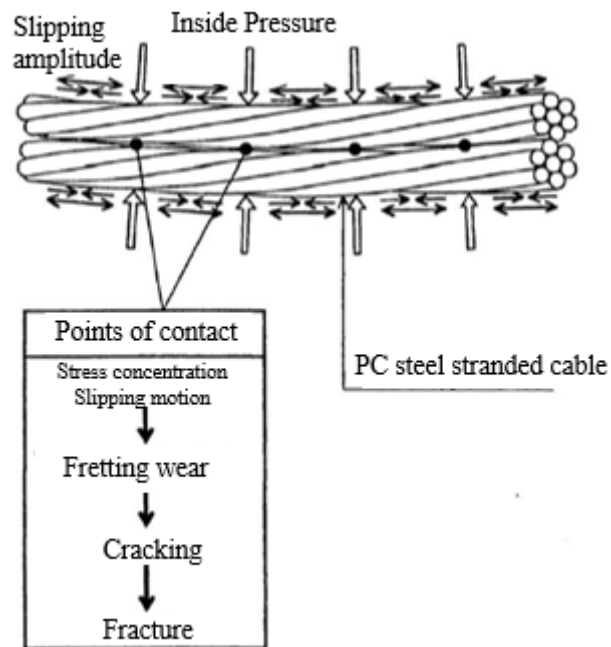
Figure 2-7-10 Concept diagram of fretting fatigue

Fretting is a wear phenomenon that occurs between two surfaces in contact that are subjected to minute relative movement. When PC steel stranded cables are bound together to create a tendon, in the case of a deviator there are multiple overlapping layers of steel material and inside pressure acts as a result of the change from the outer steel material to the inner steel material. When this occurs, the steel stranded cables are in point contact with one another, and this produces stress concentration at the points of contact due to inside pressure. Under this condition, when changes in axial-direction stress occur in the steel material and result in minute relative slipping in the PC stranded cables or strand tubes, wear and tear occurs at the points of contact. When this progresses, it results in fracture. This series of phenomena is referred to as fretting fatigue.

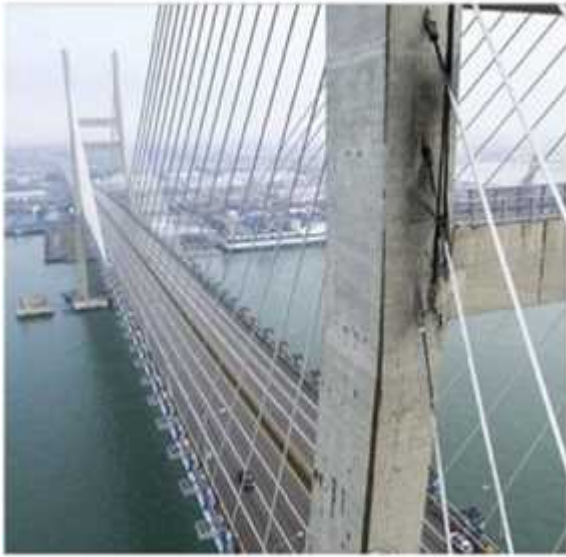
Figure 2-7-12 Conditions of stay-cable fracture

In the same way at the Bridge in Korea, a fire thought to have been caused by lightning resulted in fracture of the top level of stay-cables as shown in Figure 2-7-12. Following the incident, countermeasures were carried out including placing a lightning arrestor cable on top of the stay-cables to reduce the frequency of direct lightning strikes on the stay-cables, and using non-flammable material at points that attract lightning strikes. As shown in Figure 2-7-13, there are also cases of lightning arrestor cables being installed as a lightning countermeasure on cable stayed bridges in Japan as well.

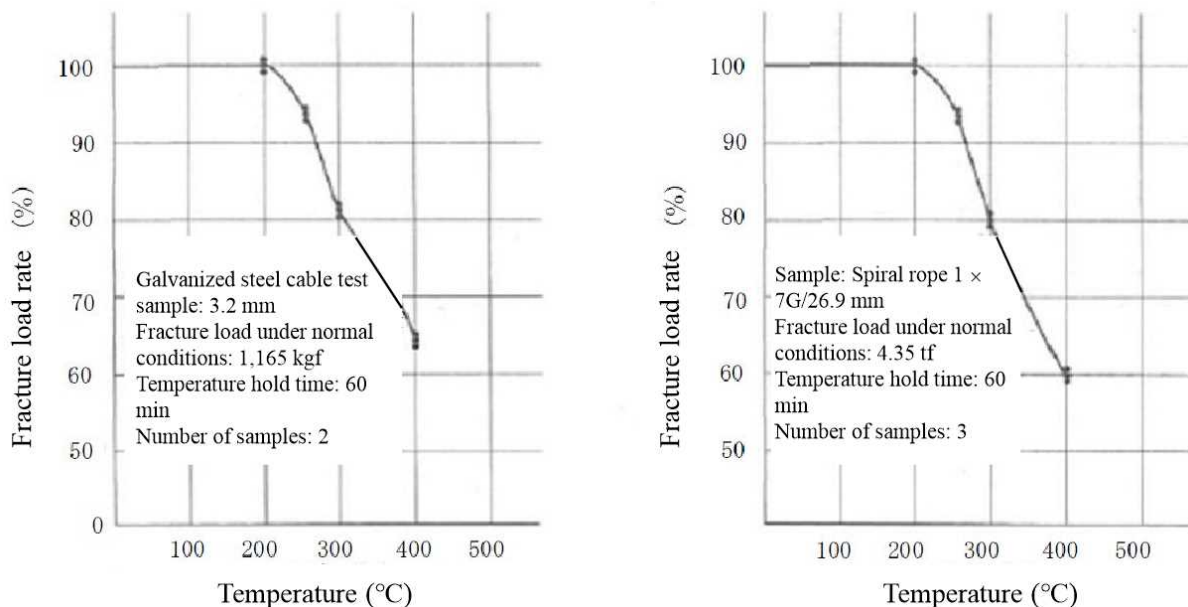
Figure 2-7-14 Results of cable high-temperature fracture test

Although no cases have been reported so far, there are concerns about the effects of vehicle fires caused by accidents or other reason. The results from a cable high-temperature fracture test are shown in Figure 2-7-14. When high temperature conditions occur for a prolonged time around a stay-cable, deterioration of the cable may result in decreased tensile force or, in the worst case, fracture.

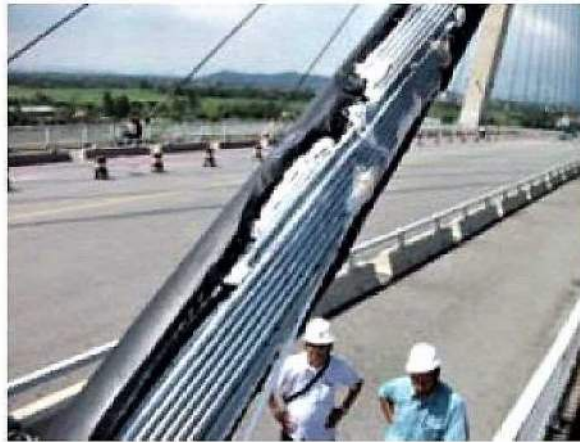
At the cable stayed Bridge in Vietnam, three ships that were set adrift by a typhoon collided with and damaged the bridge, and the stay-cables were replaced. The cable fracture conditions are shown in Figure 2-7-15.

Figure 2-7-15 cable fracture conditions

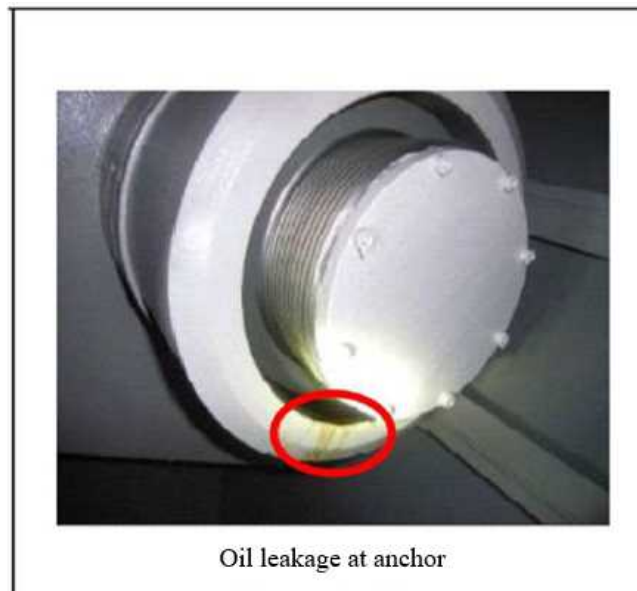
An example of deterioration in the tower-side stay-cable anchor of a cable stayed bridge is shown in Figure 2-7-16

Figure 2-7-16 Example of deterioration in tower side stay cable anchor

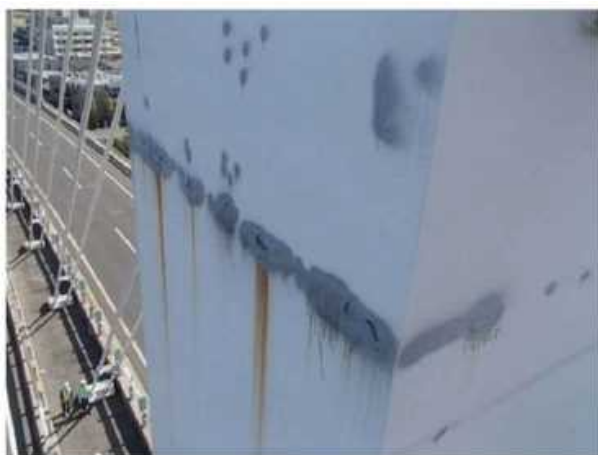
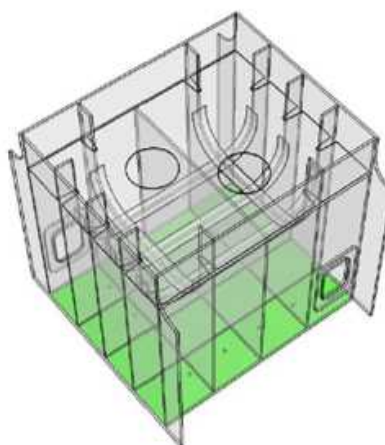
Corrosion of the main tower base is most often caused by water accumulation. Therefore inspections for water accumulation must be conducted, and at the same time checks must be performed to ensure that drain holes are created in suitable locations and are functioning correctly. An example of corrosion in a tower (steel) of a cable stayed bridge is shown in Figure 2-7-17.

Corrosion at joint (metal touch structure)

Corrosion at tower base (water accumulation)

Figure 2-7-17 Example of tower corrosion
