BRIDGE MAINTENANCE CAPACITY BUILDING IN ZAMBIA

BRIDGE INSPECTION GUIDEBOOK

2024

**Road Development Agency
Japan International Cooperation Agency**

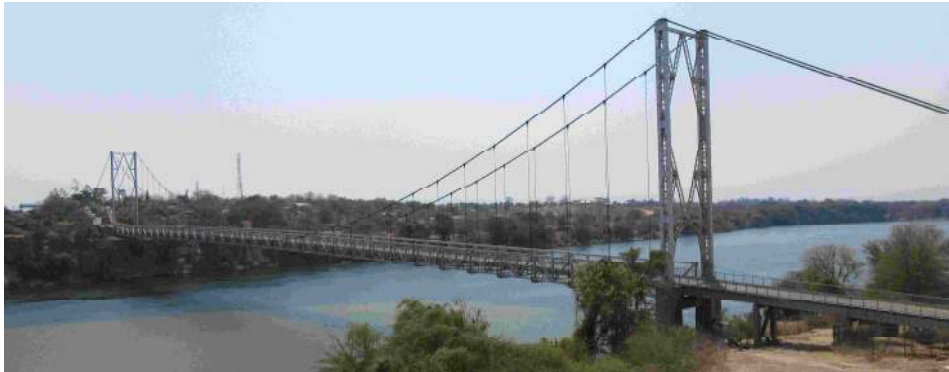
A Suspension Bridge is a type of bridge which the deck is hung below main suspension cables connected by hanger ropes. Main suspension cables are suspended between towers and have group of parallel wires bundled together to support the stiffening girder/trusses. Main suspension cables have to be anchored at each end of the bridge to hold tension stress. So main suspension cables and anchorages are the most important members to support the whole structure.

Figure 3-1-1 Suspension Bridge

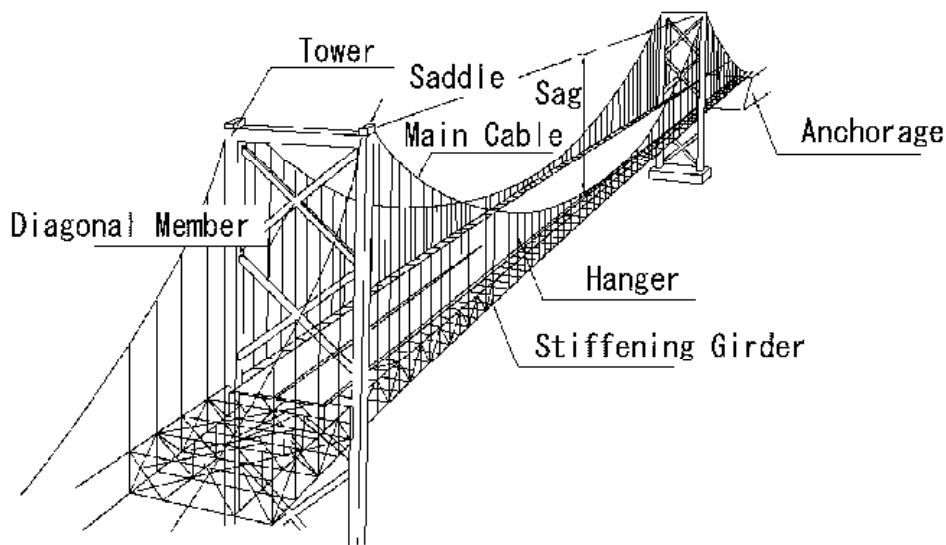
Suspension Bridge is similar to Cable Stayed Bridge that supports girder by cables and likewise has high tower. However, these two bridge support the load of the deck in different ways. The difference is how the cables are connected to the towers. In Suspension Bridge, the cables are installed across the towers, transmitting the load from deck to the towers down to the anchorages. In Cable Stayed Bridges, the cables are attached only to the towers to support the load.

Figure 3-1-2 Bridge Component (Suspension Bridge)

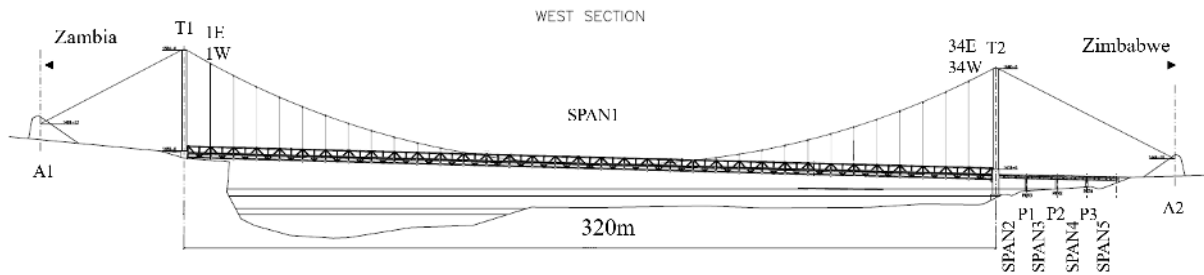
The bridge is assessed in the direction of increasing chainage. Refer to Figure 3-1-3.

Figure 3-1-3 Bridge Geometry Definition

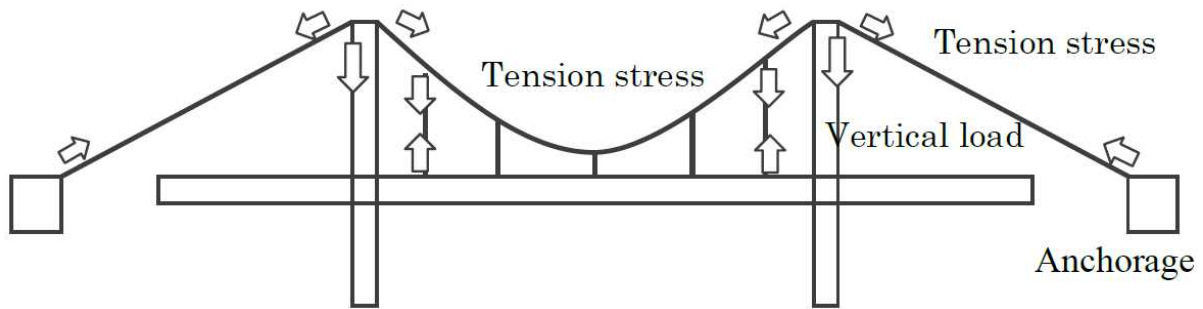
towers and have group of parallel wires bundled together to support the stiffening girders / trusses. Any load applied to the bridge is transformed into tension in main suspension cables through hanger ropes and transferred to tower as a vertical load. The tower which supports the main suspension cables transmits the vertical loads to the foundation through piers. Main suspension cables must be anchored at each end of the bridge to hold tension stress. So main suspension cables and anchorages are the most important members to support the whole structure.

Figure 3-1-4 Load Distribution System for Suspension Bridge

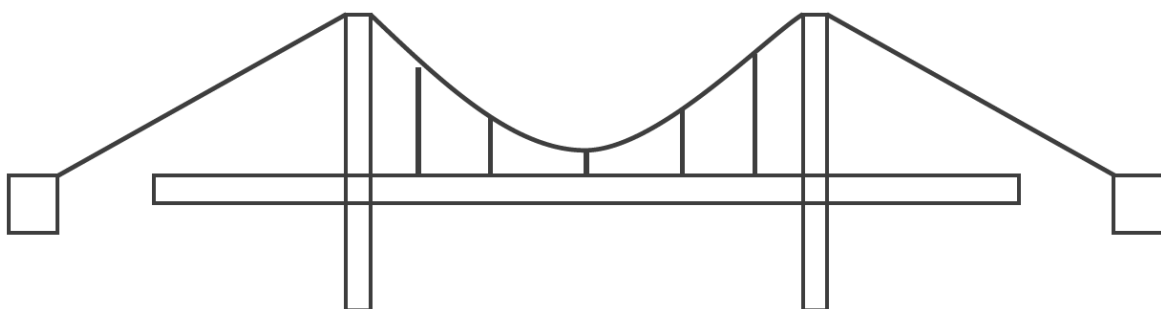
Suspension Bridge is similar to Cable Stayed Bridge that supports girders by cables and likewise has high tower. However, these two bridges support the load of the deck in different ways. The difference is how the cables are connected to the towers. In Suspension Bridge, the cables are installed across the towers, transmitting the load from deck to the towers down to the anchorages. In Cable Stayed Bridges, the cables are attached only to the towers to support the load.

Figure 3-1-5 Suspension Bridge

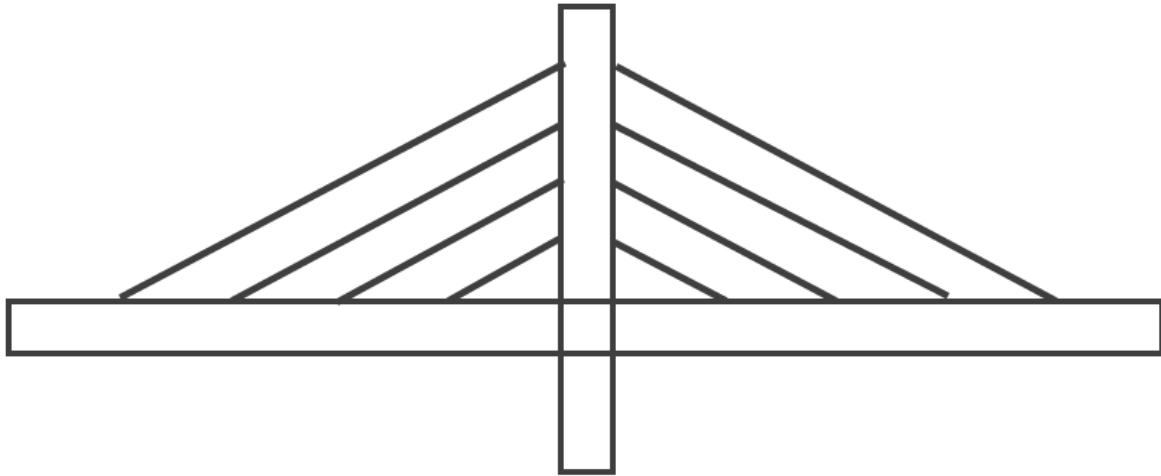
Figure 3-1-6 Cable Stayed Bridge (Harp Design)

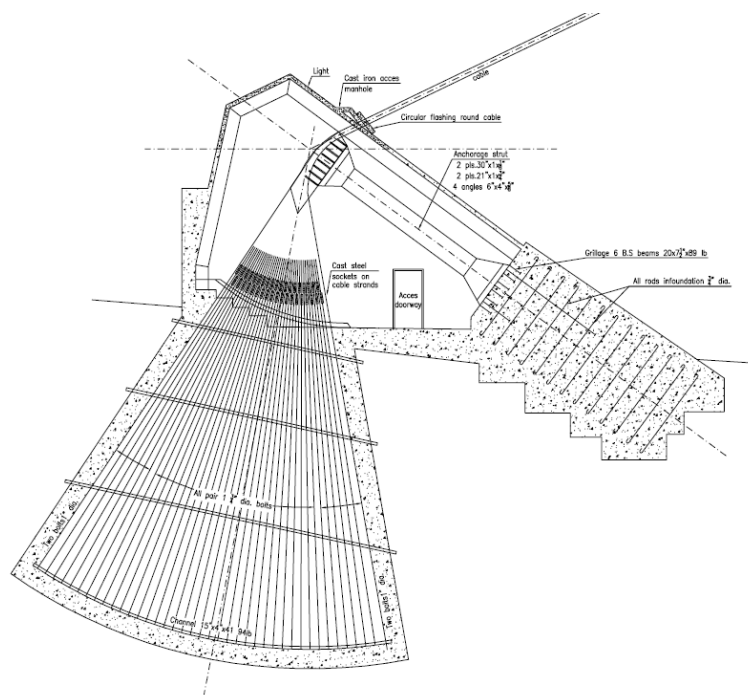
Anchorage structure includes foundation, anchor block, cable anchor frames and protective housing. Anchorages of Otto Beit Bridge are classified into gravity anchorage system. Gravity anchor relies on the mass of the anchorage to resist the tension of the main suspension cable. Figure 3-1-10 shows the anchorage in Otto Beit Bridge

Figure 3-1-10 Anchorage in Otto Beit Bridge

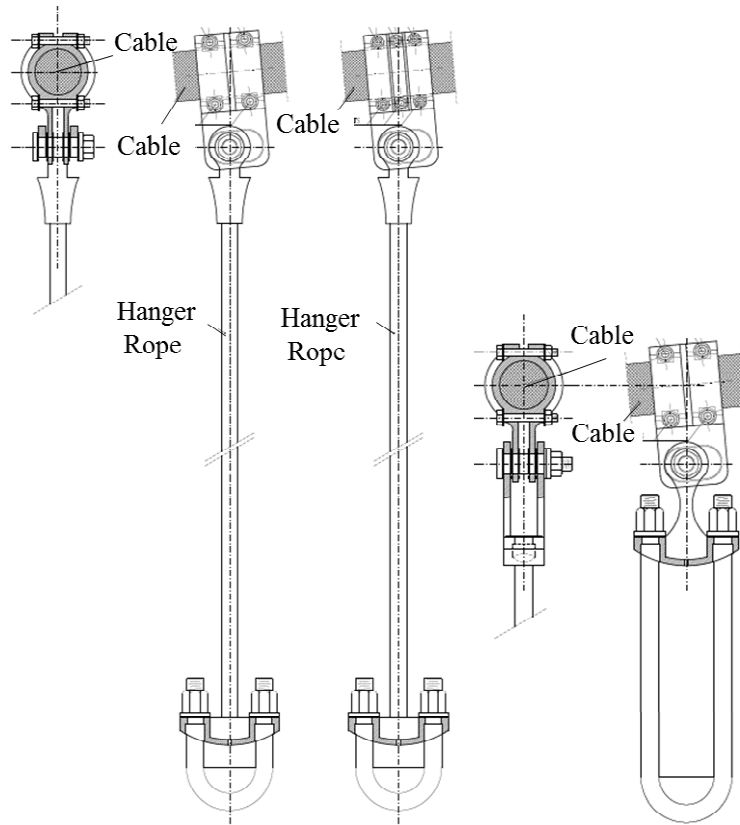
Hanger ropes are fixed to the main suspension cable with suspender clamp and shackle for U bolt shown in Figure 3-1-11. And hanger ropes are spiral strands, and diameter is 69mm (long hangers) and double round steel hangers (short hangers).

Figure 3-1-11 Connection system

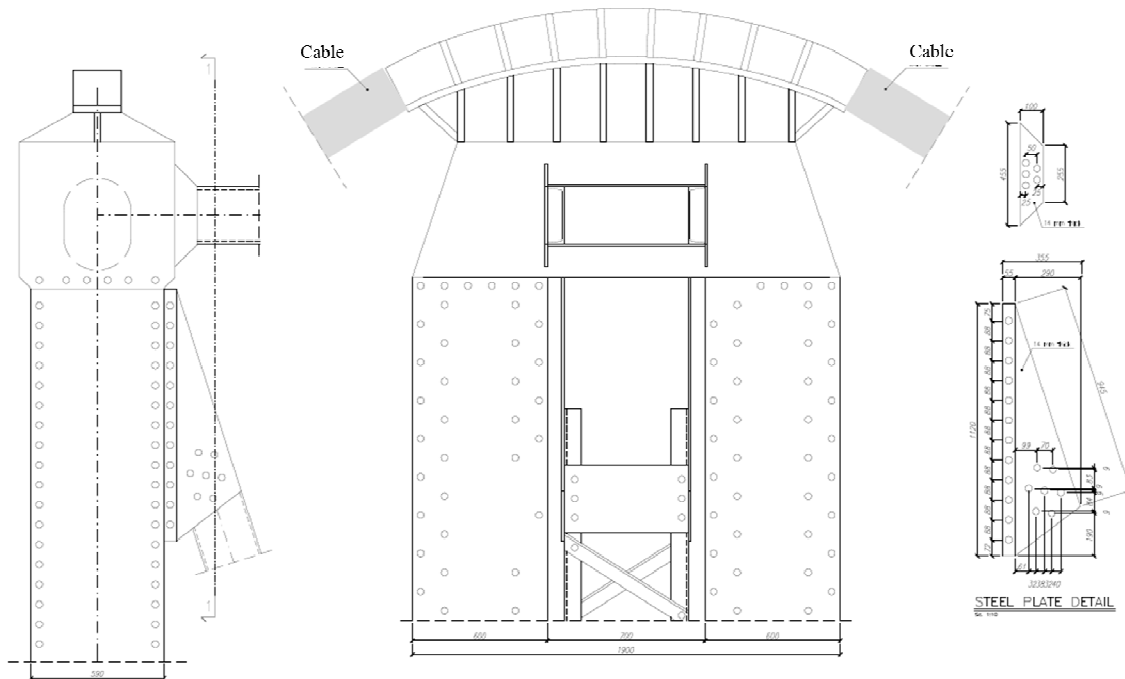
Tower saddle supports the main suspension cable at the tower.

Figure 3-1-12 Type of Saddle

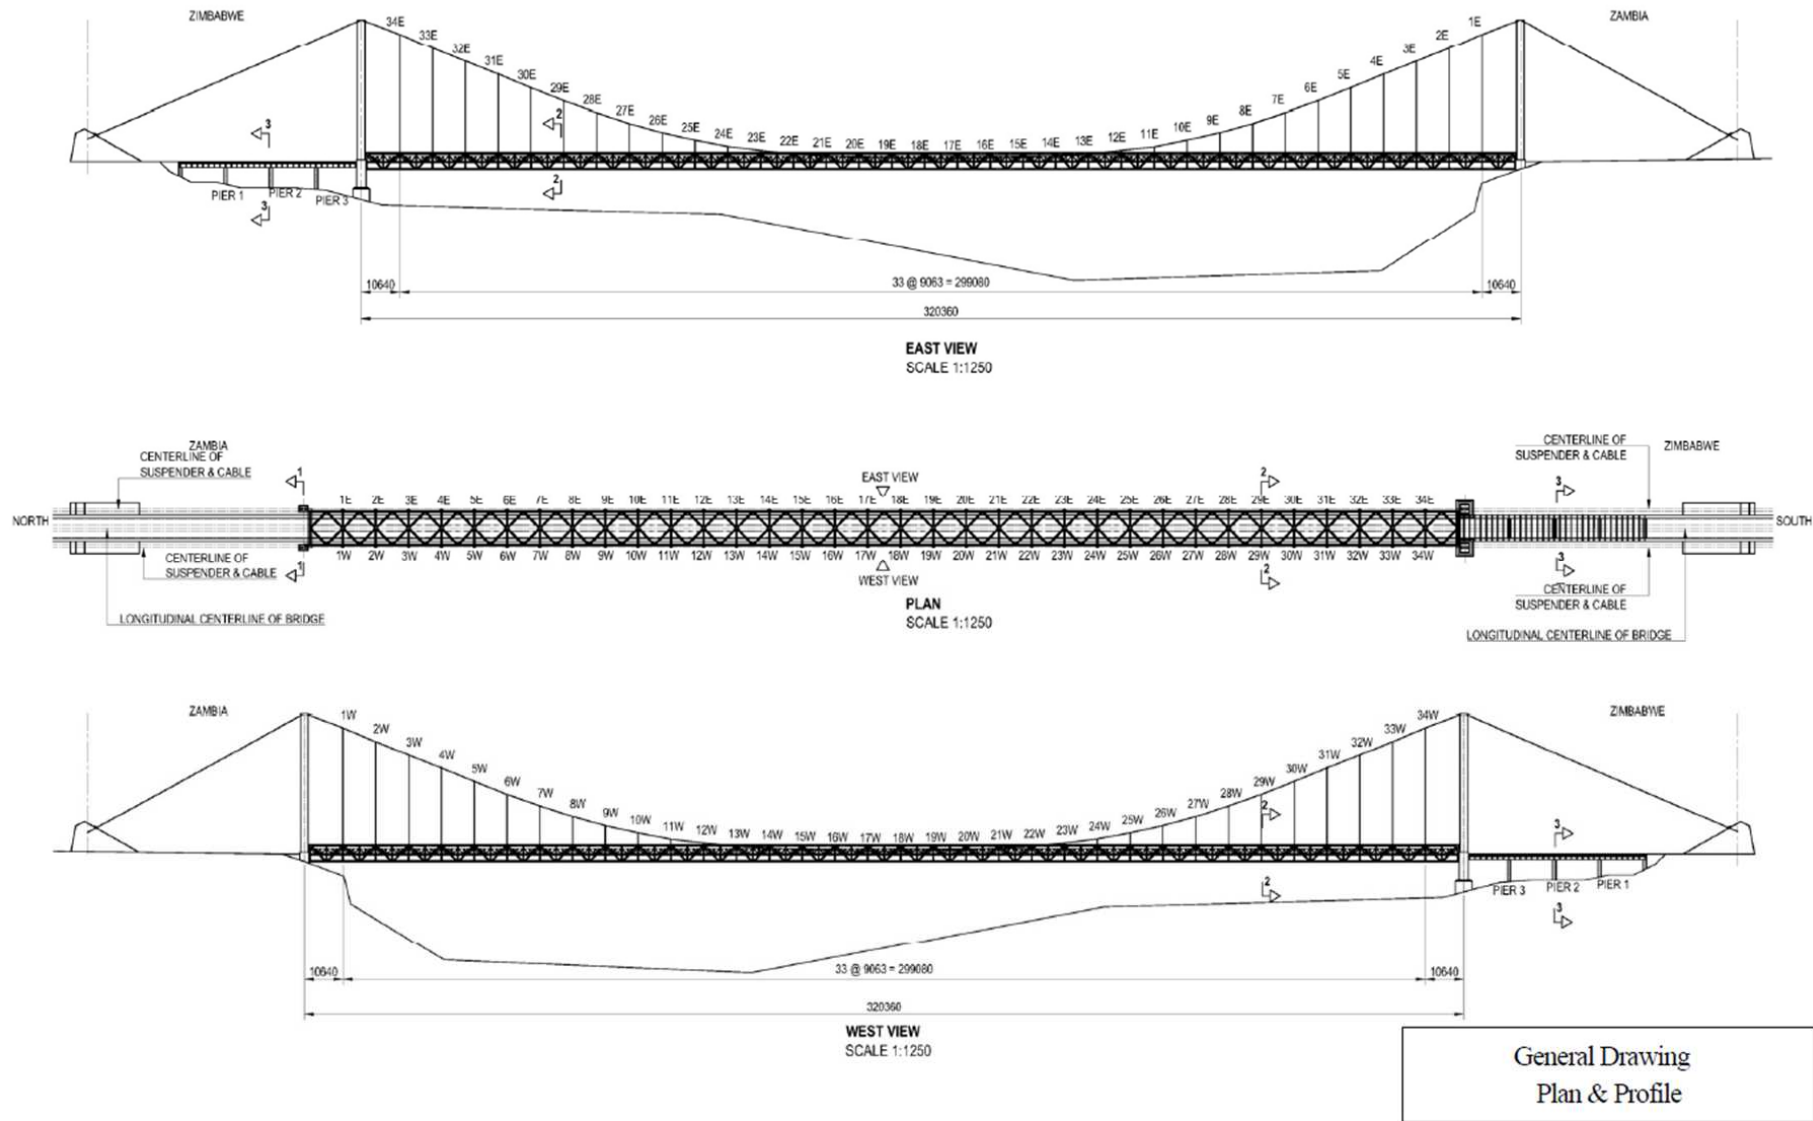
Figure 3-1-13 General View(1of4)

Shown in Figure 3-1-13, 3-1-14, 3-1-15 and 3-1-16 are the General View of Otto Beit Bridge.

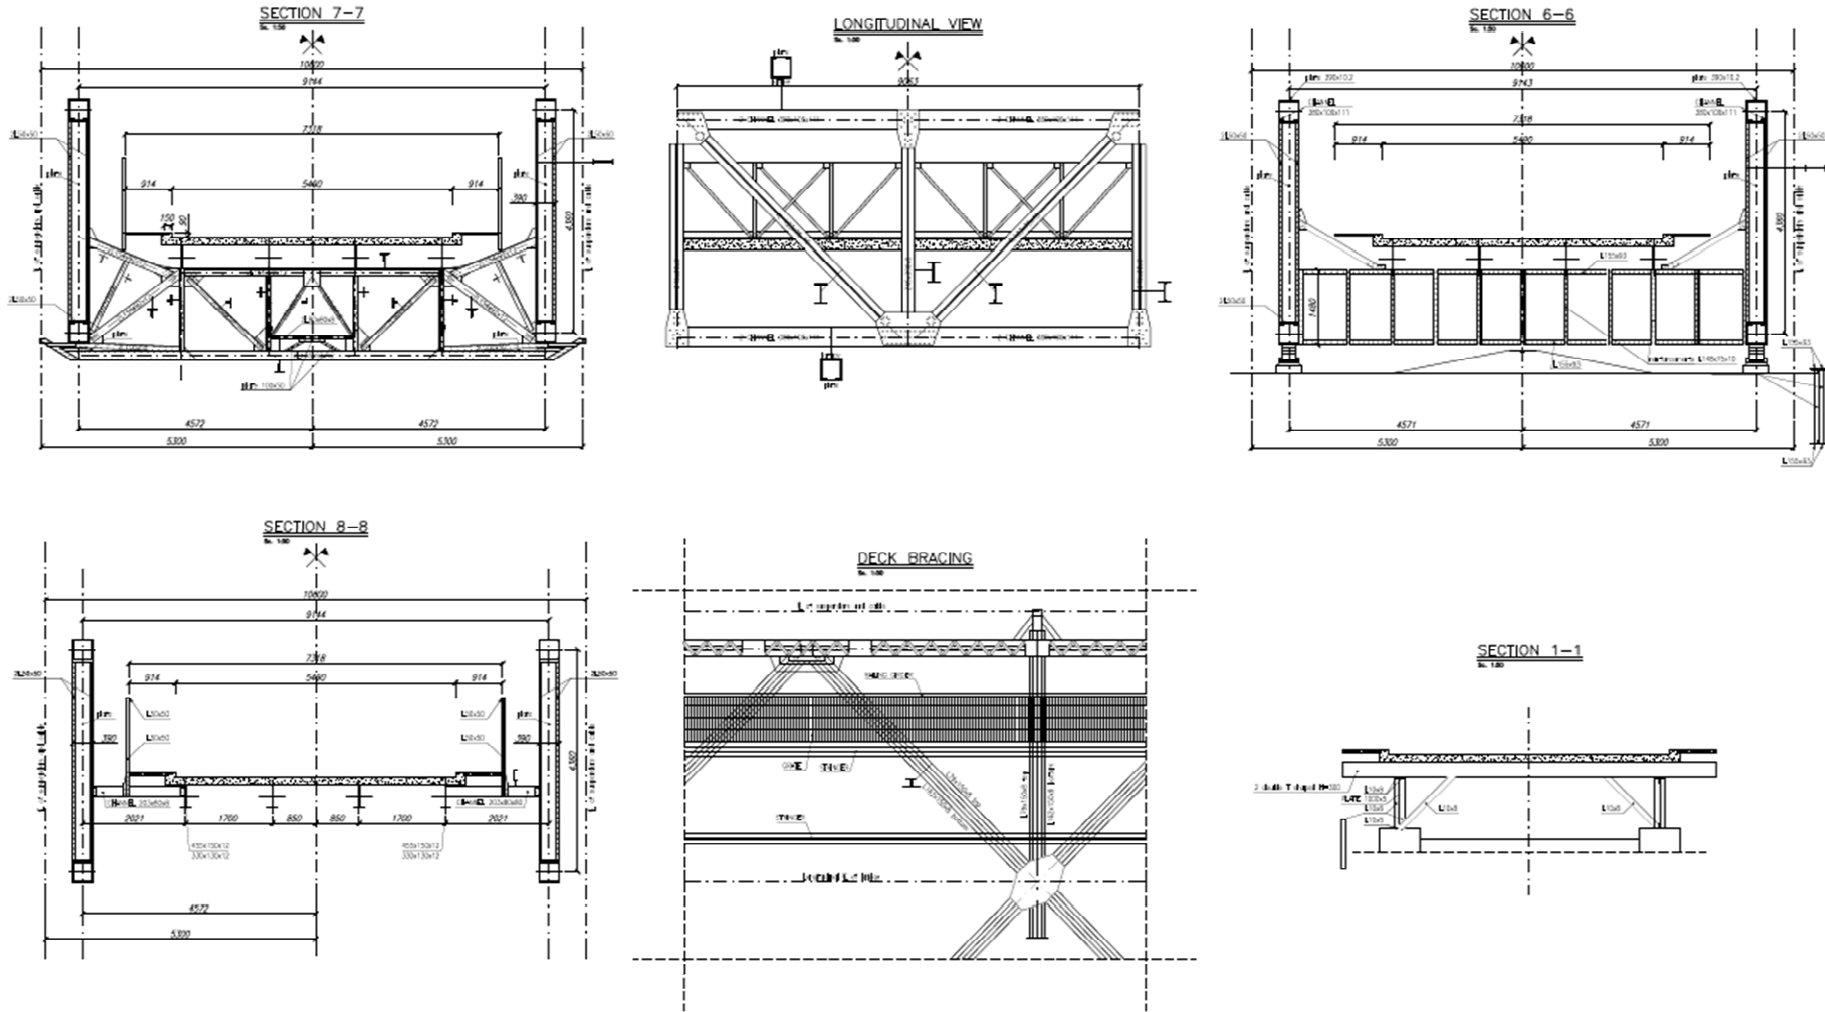
Figure 3-1-14 General View(2of4)

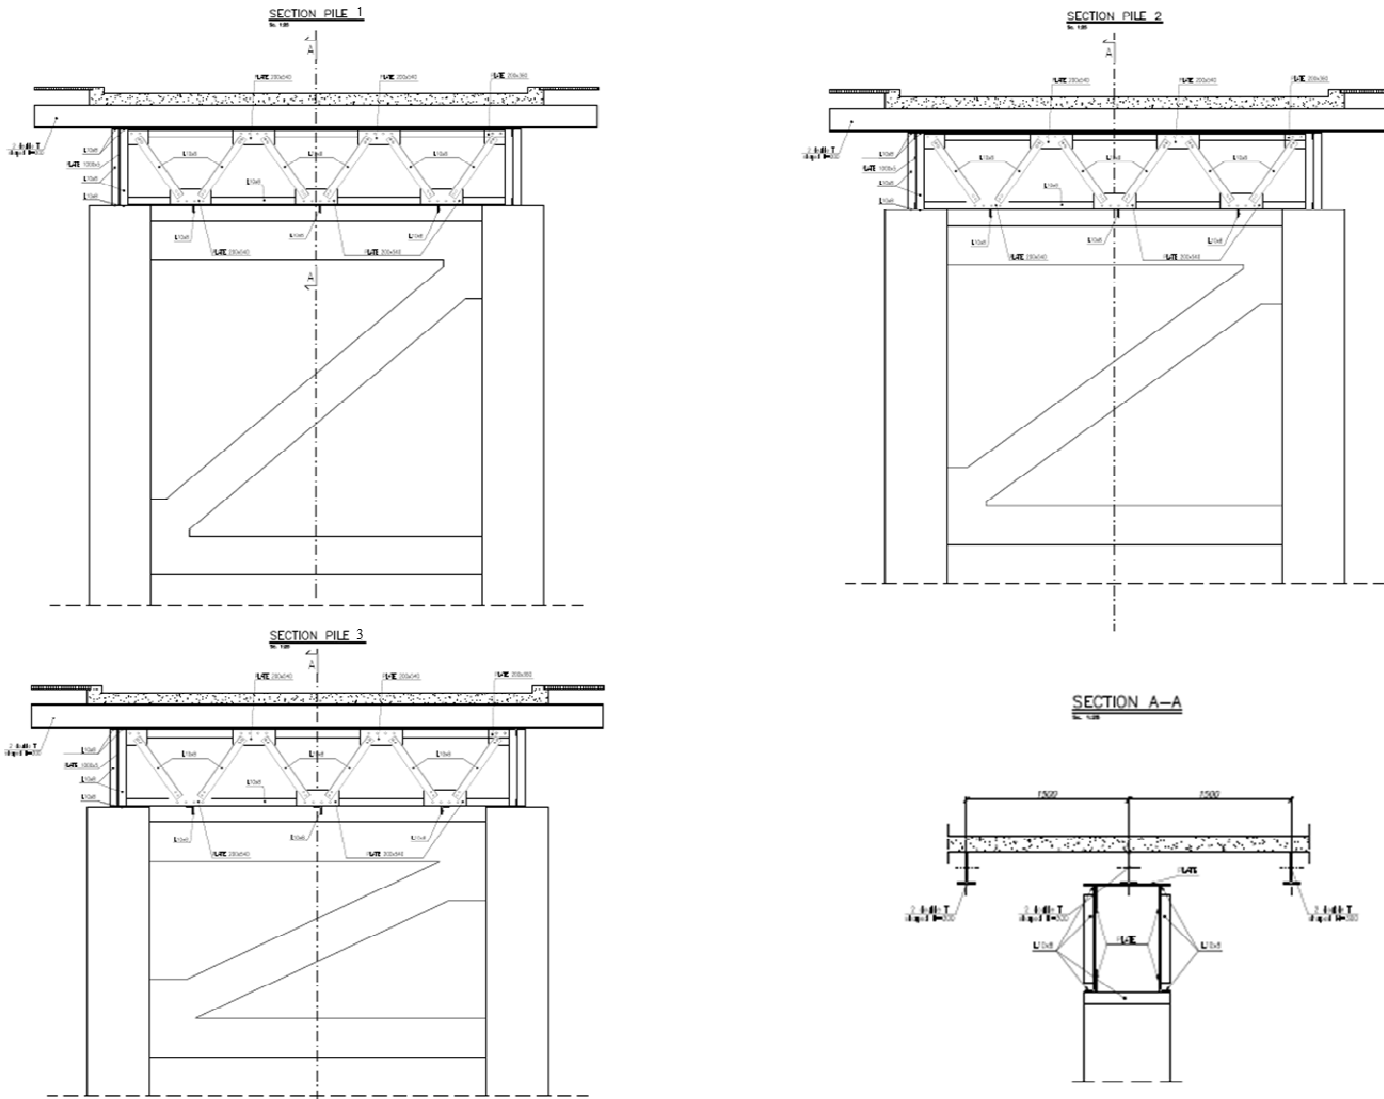
Figure 3-1-15 General View(3of4)

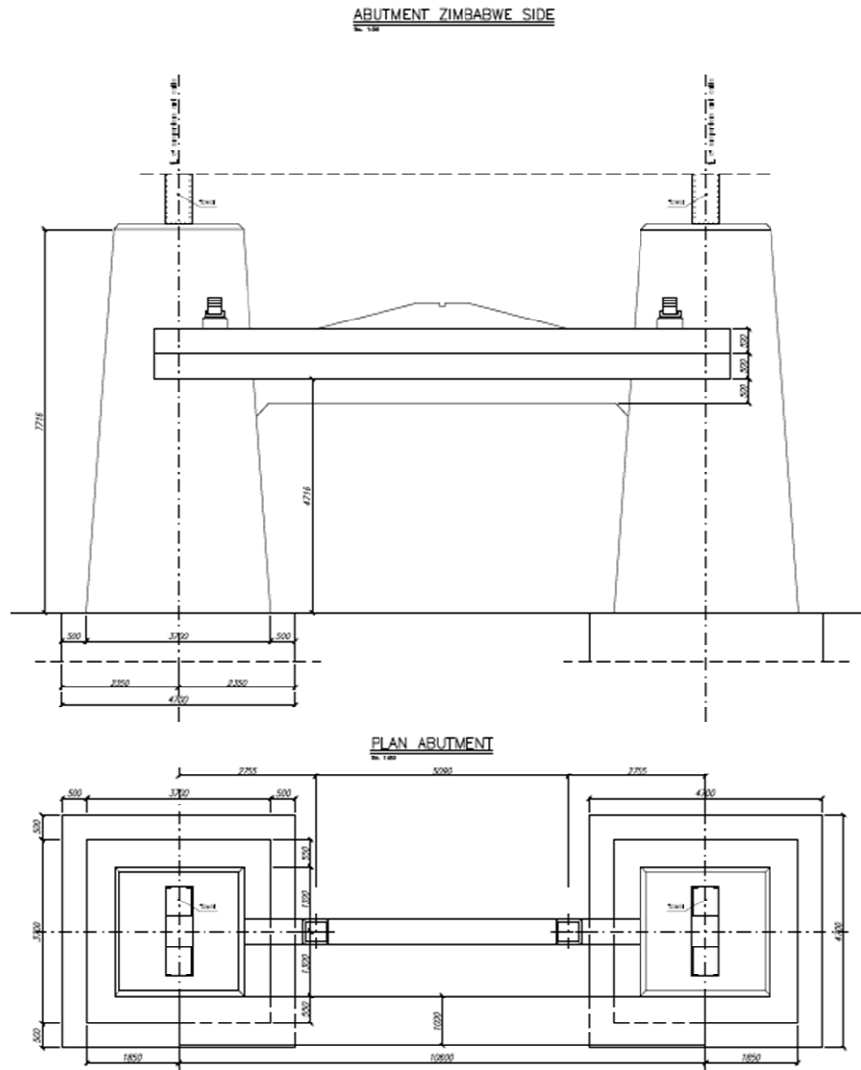
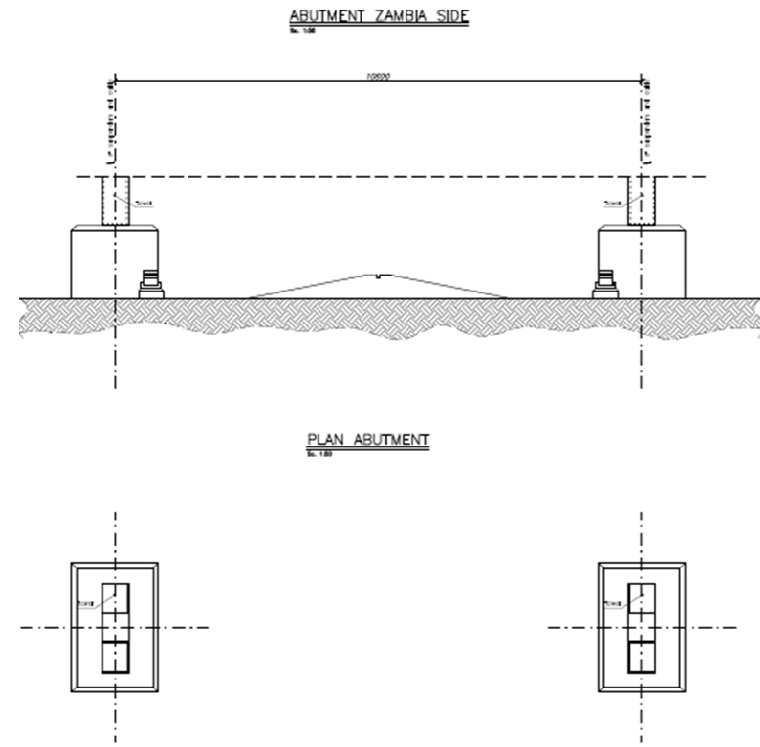
Figure 3-1-16 General View(4of4)

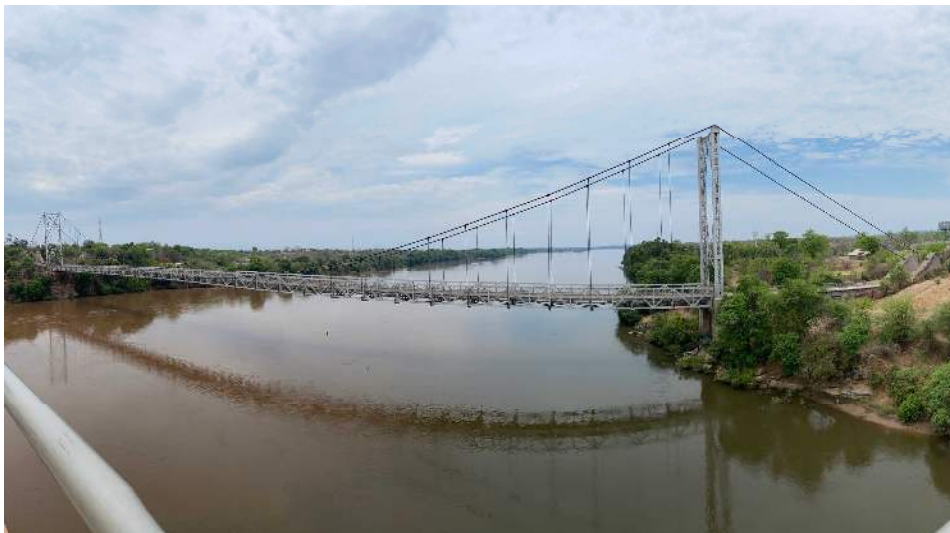
The Otto Beit Bridge was built in 1938-9 by Dorman Long and financed by the Beit Trust provide connectivity by linking Zambia to Zimbabwe across the Zambezi river. It was suspension bridge in single span and approach bridge is with 4 spans on the Zimbabwe side. The span length of suspension bridge is 320 meters and the span of approach bridge is $4 \times 12.4\text{m} = 49.6$ meters. Height of the tower is approximately 38.3 meters and bridge width is 7.318m (5.49 meters with 0.914 meter sidewalk on both sides).

Figure 3-2-1 Photo of Otto Beit Bridge

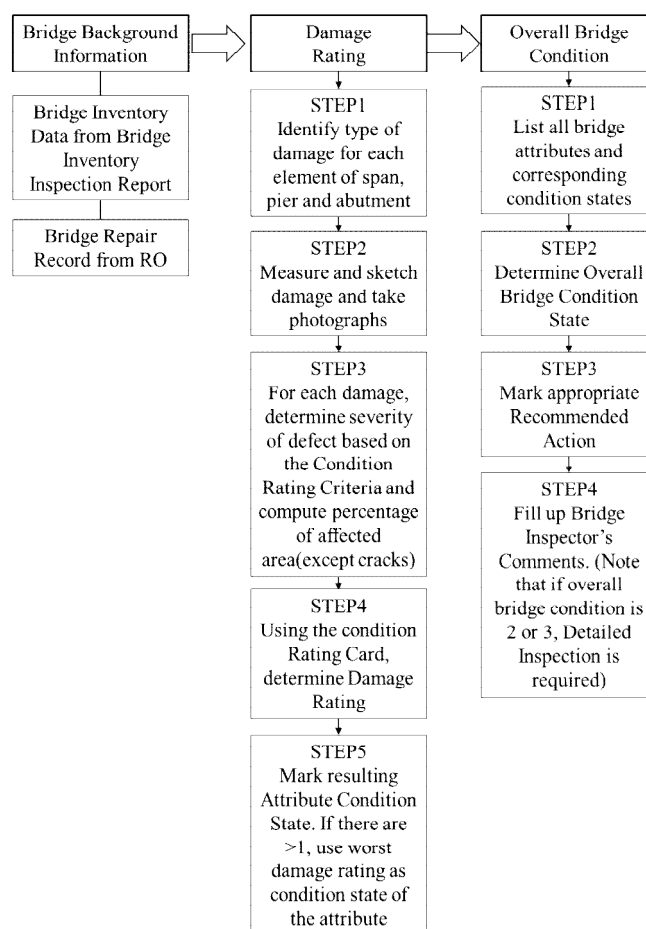
The step-by step procedure for conducting the Periodic Inspection is illustrated in the following flowchart.

Figure 3-3-1 Flowchart of Bridge Periodic Inspection

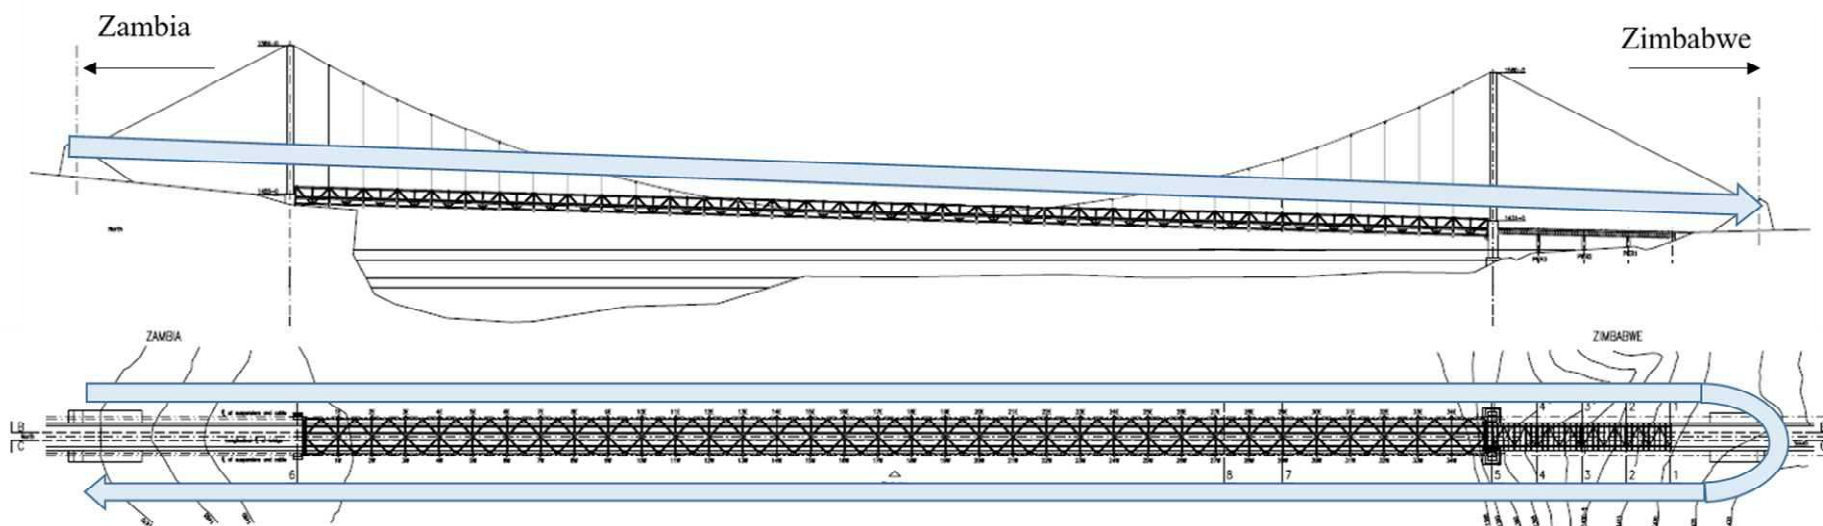
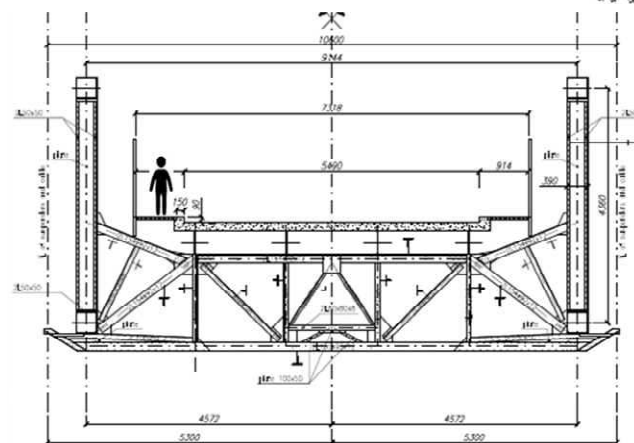
Inspection of Upper Deck

- Main Members to be inspected**
- Main Cable
 - Hanger Rope, Cable band and Suspender
 - Tower
 - Railing
 - Curb
 - Pavement (Concrete)
 - Drainage
 - Expansion Joint

Figure 3-3-2 Periodic Inspection Route of Otto Beit Bridge (1 of 4)

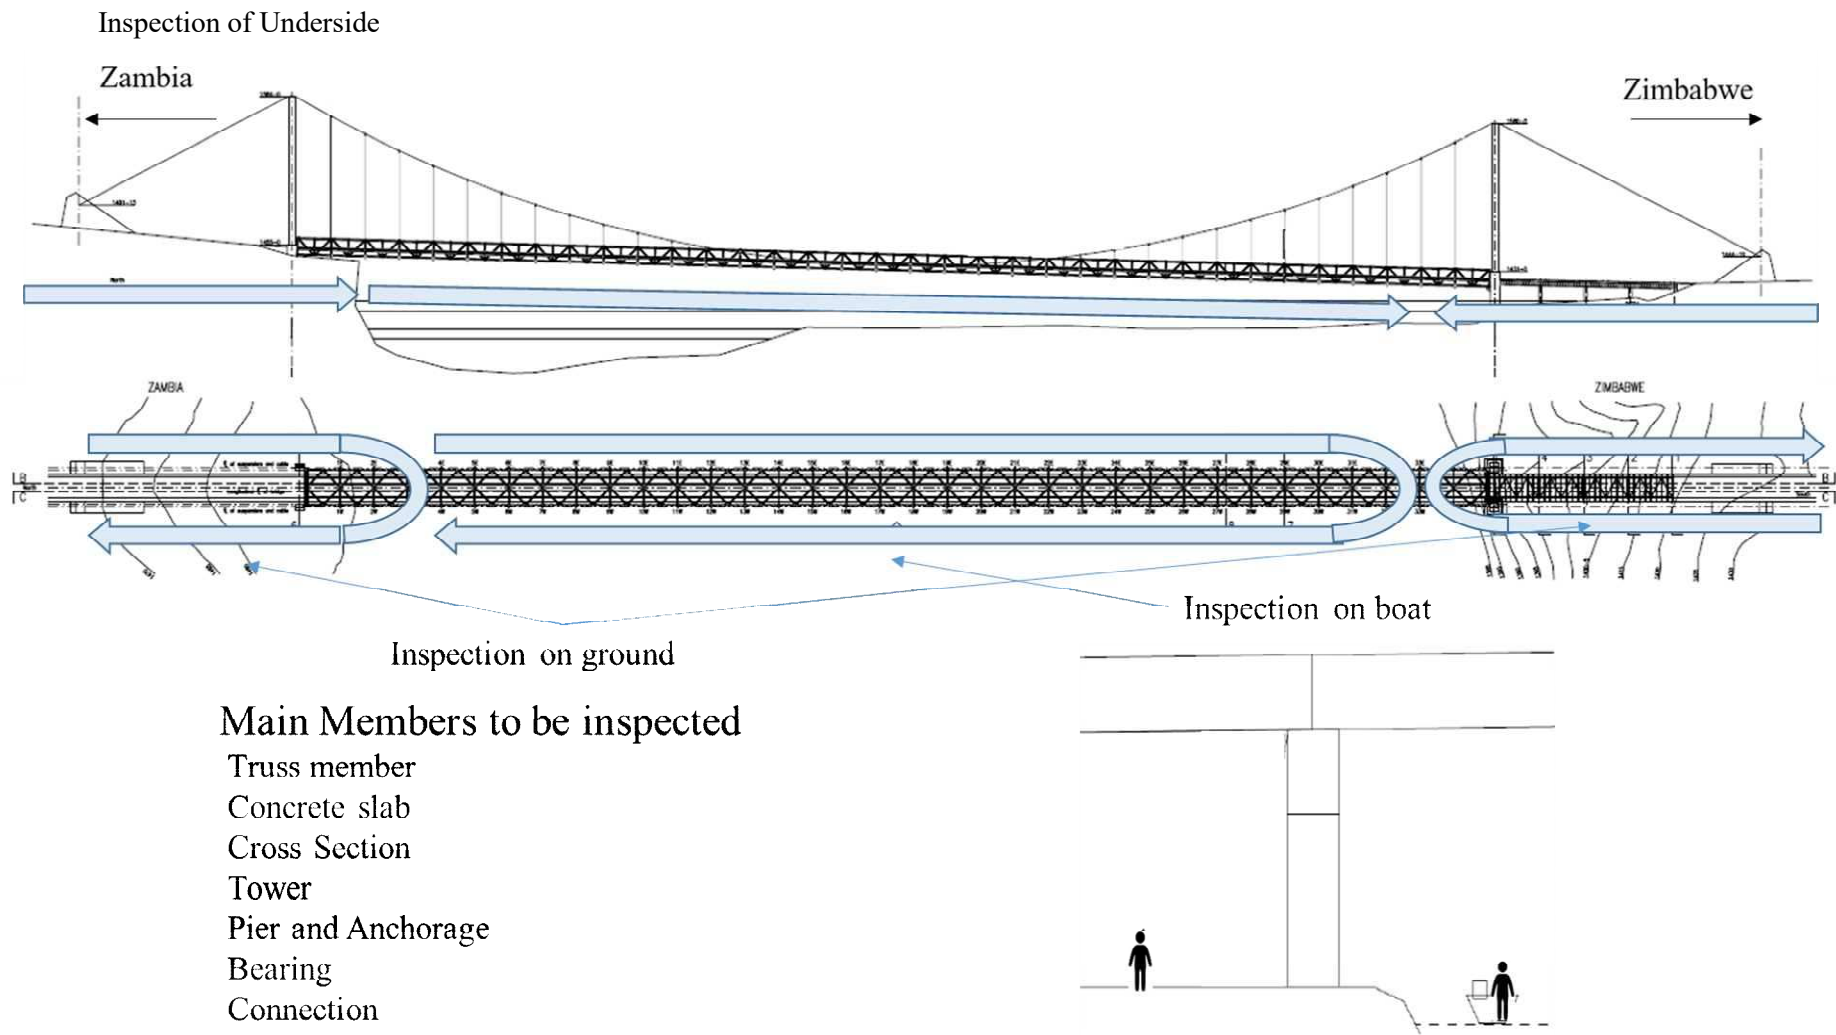
Figure 3-3-3 Periodic Inspection Route of Otto Beit Bridge (2 of 4)

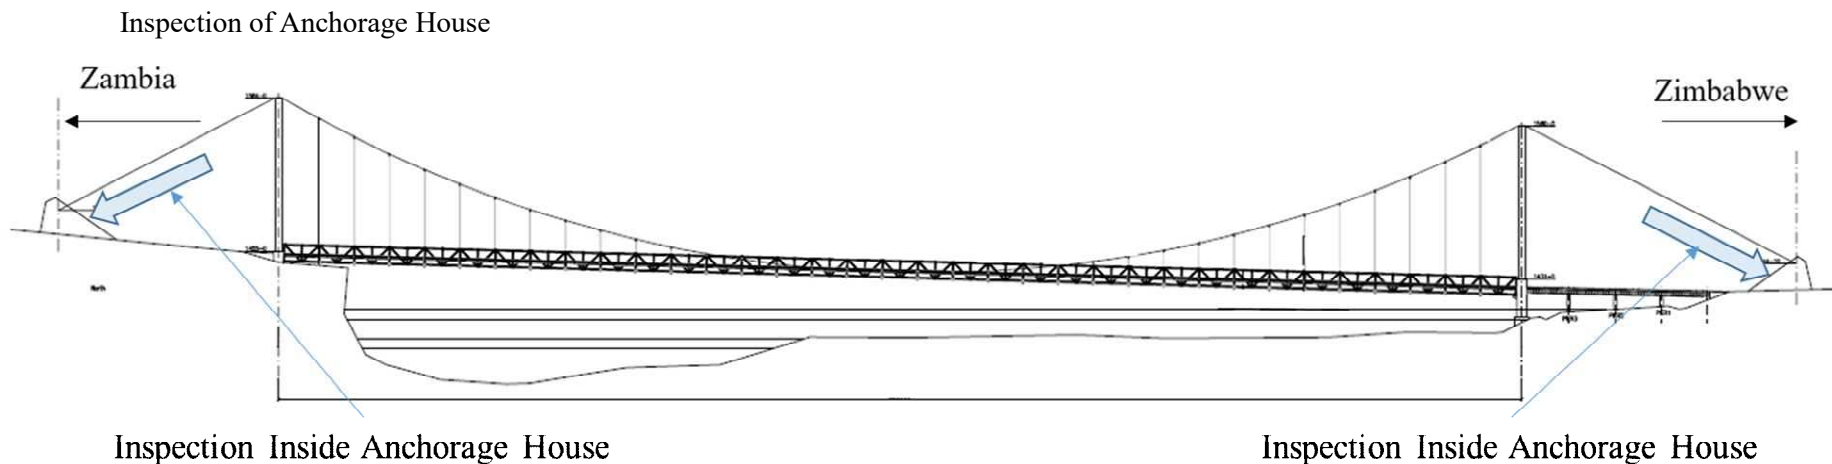
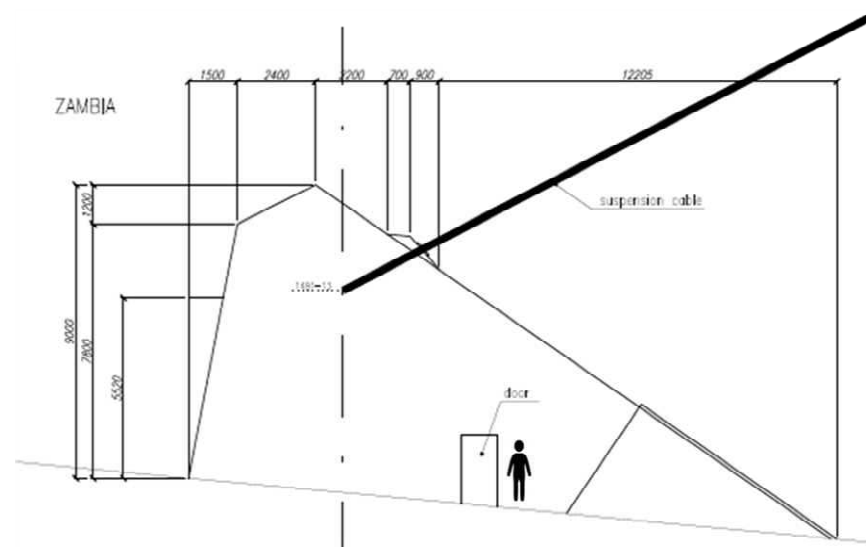
Main Members to be inspected

- Main Cable
- Anchor Bolt
- Anchorage and Anchor Bolt
- Anchor Saddle

Figure 3-3-4 Periodic Inspection Route of Otto Beit Bridge (3 of 4)

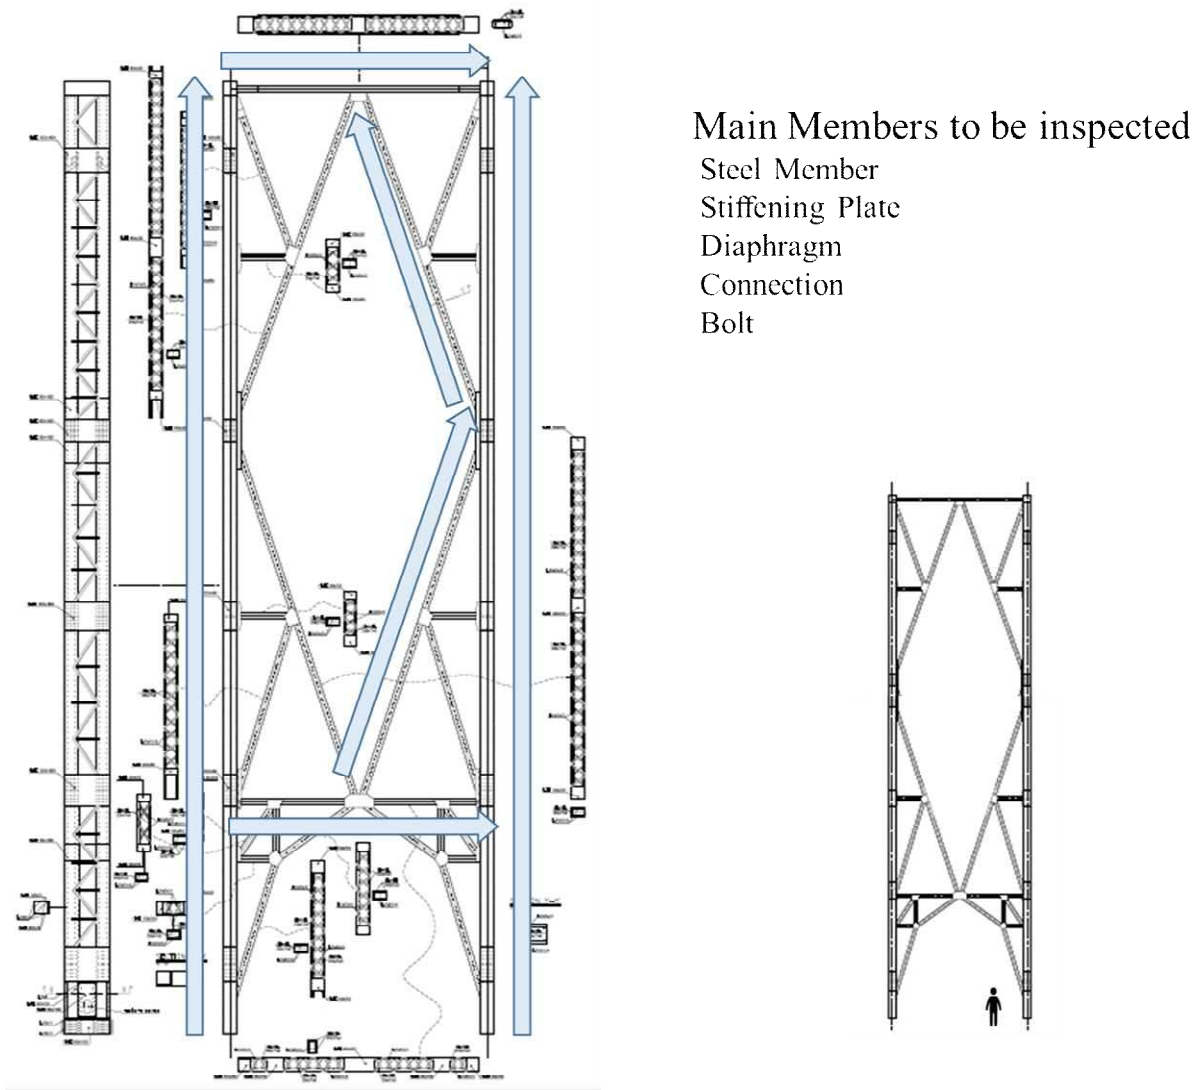
Inspection the Tower

Figure 3-3-5 Periodic Inspection Route of Otto Beit Bridge (4 of 4)

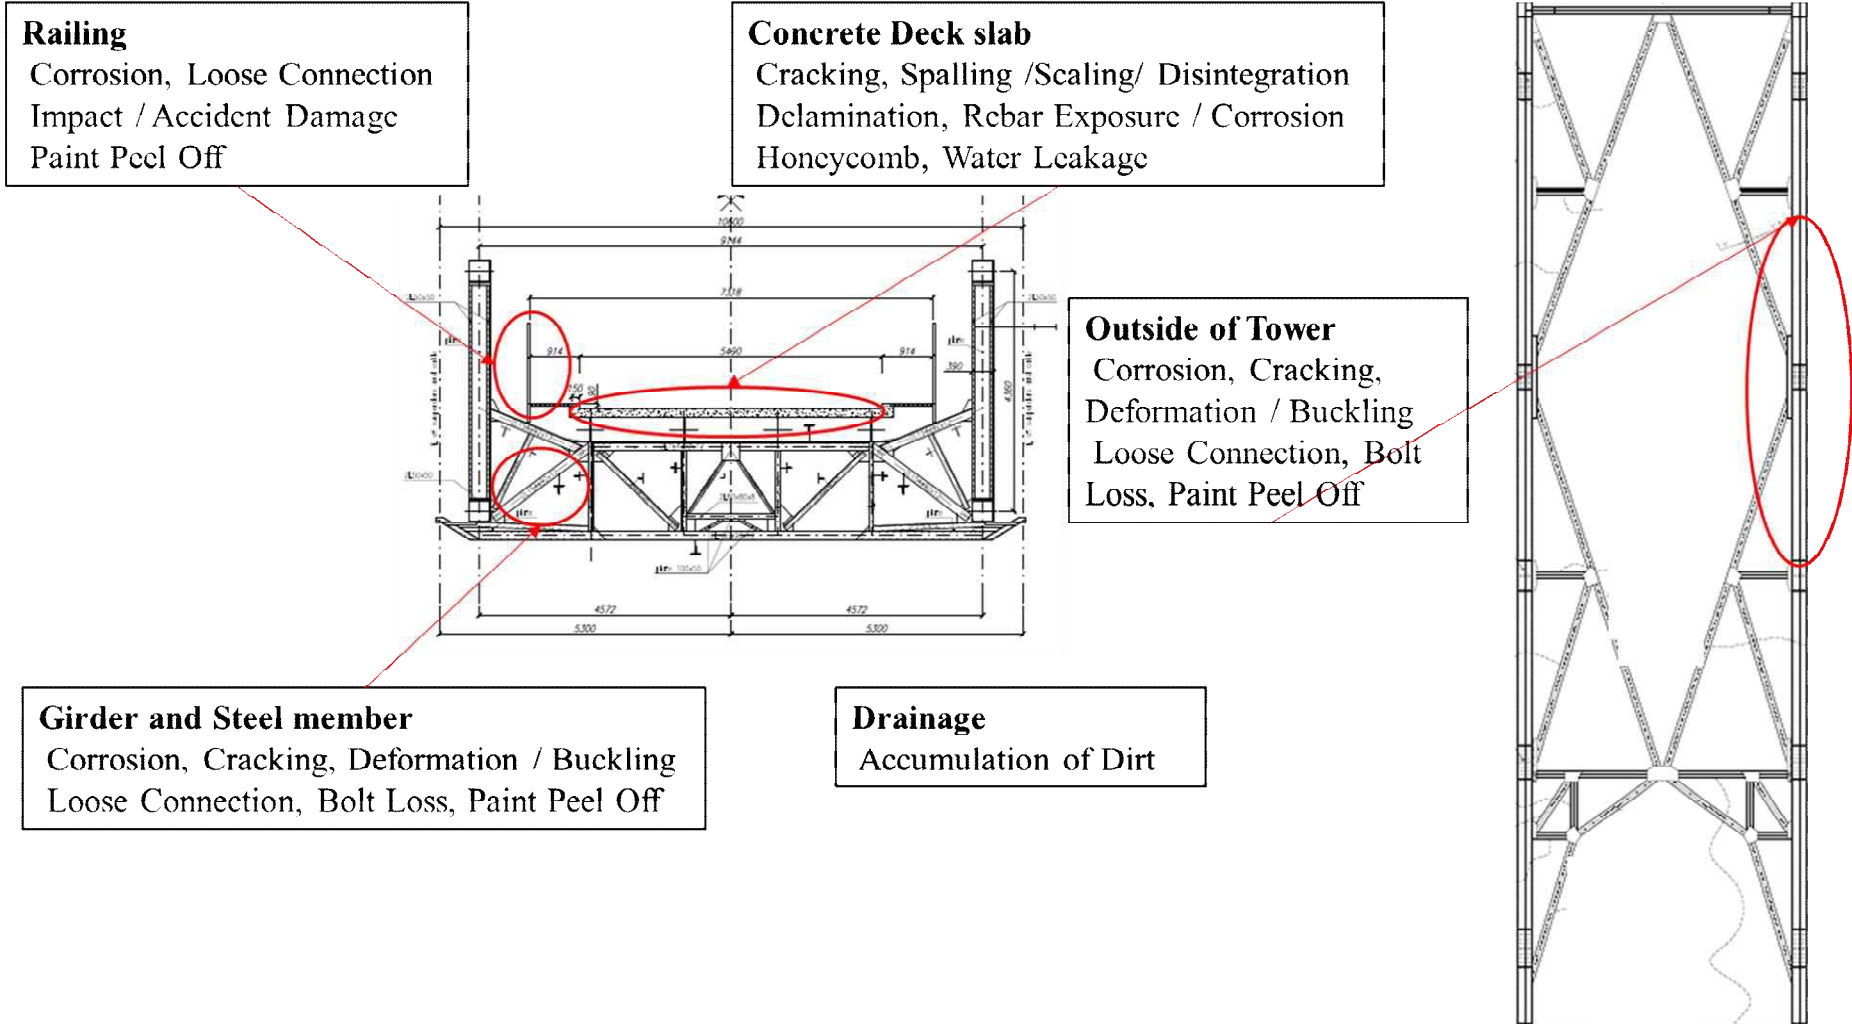
Main Span (Main Structure)

Figure 3-3-6 Check Points of Periodic Inspection – Otto Beit Bridge (1 of 4)

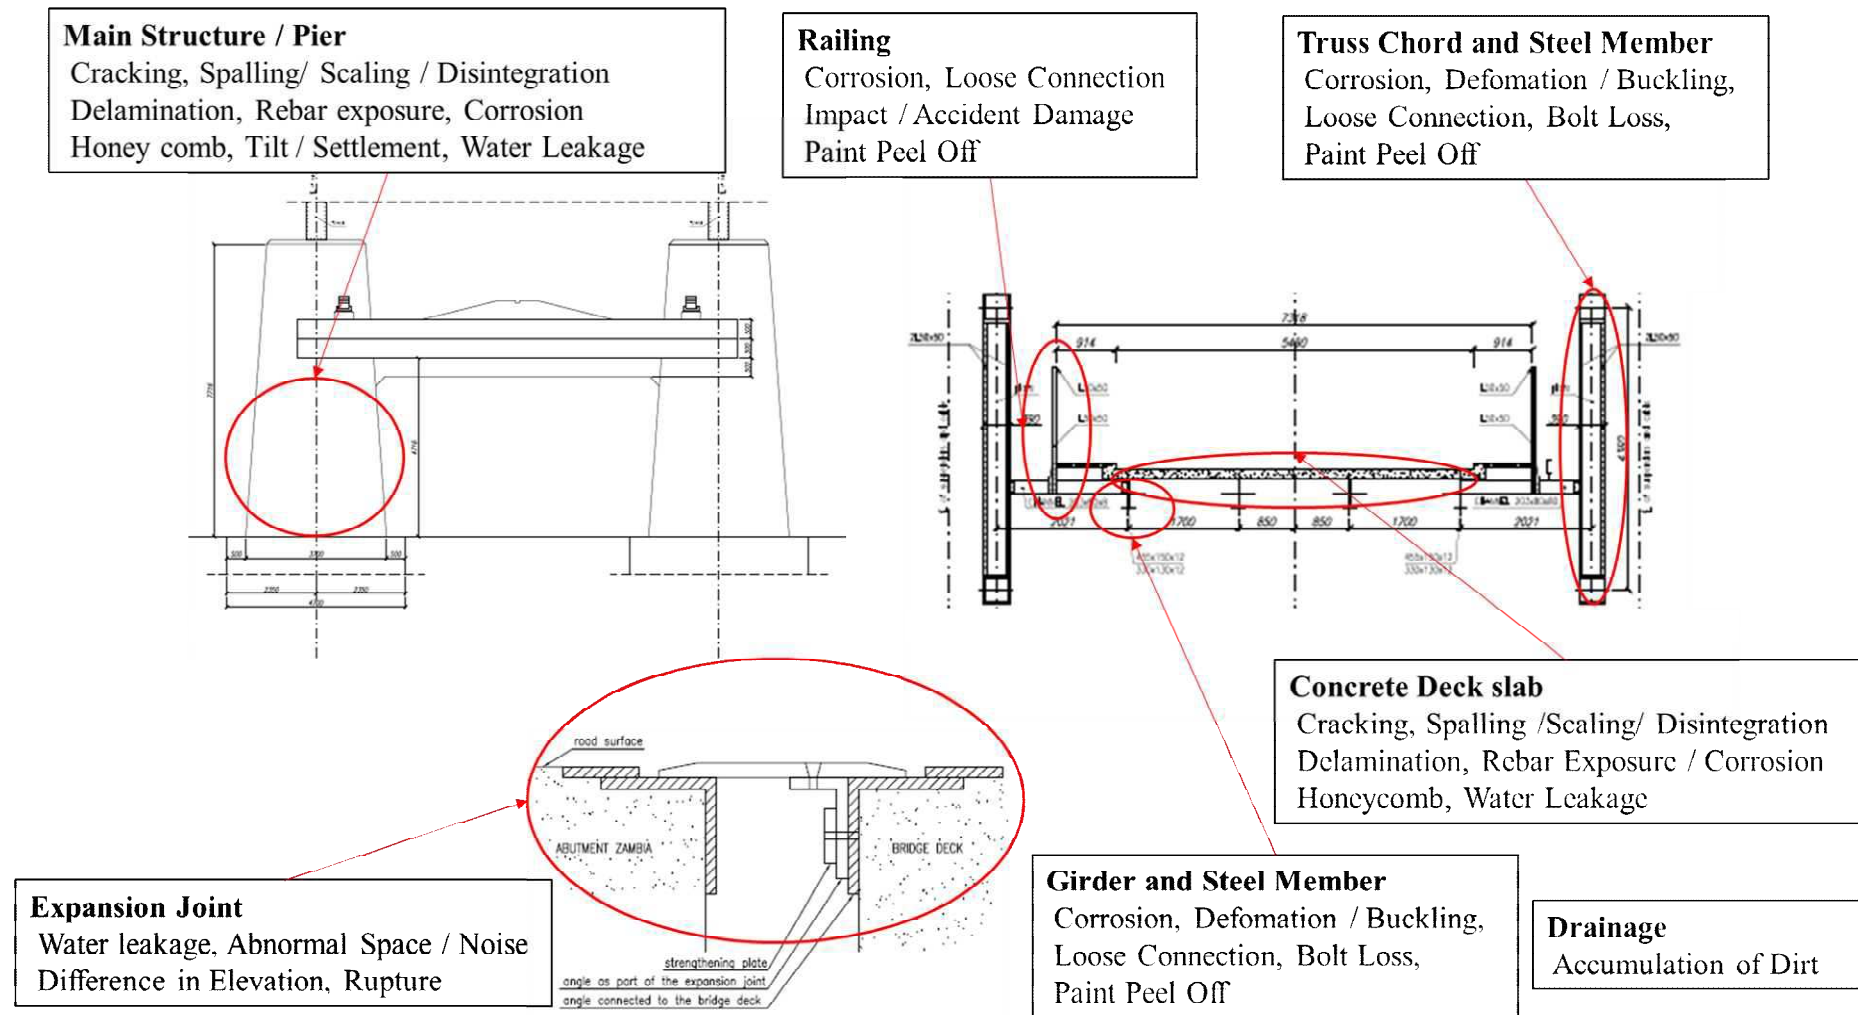
Approach Viaduct and Pier

Figure 3-3-7 Check Points of Periodic Inspection – Otto Beit Bridge (2 of 4)
