BRIDGE MAINTENANCE CAPACITY BUILDING IN ZAMBIA

BRIDGE INSPECTION GUIDEBOOK

2024

**Road Development Agency
Japan International Cooperation Agency**

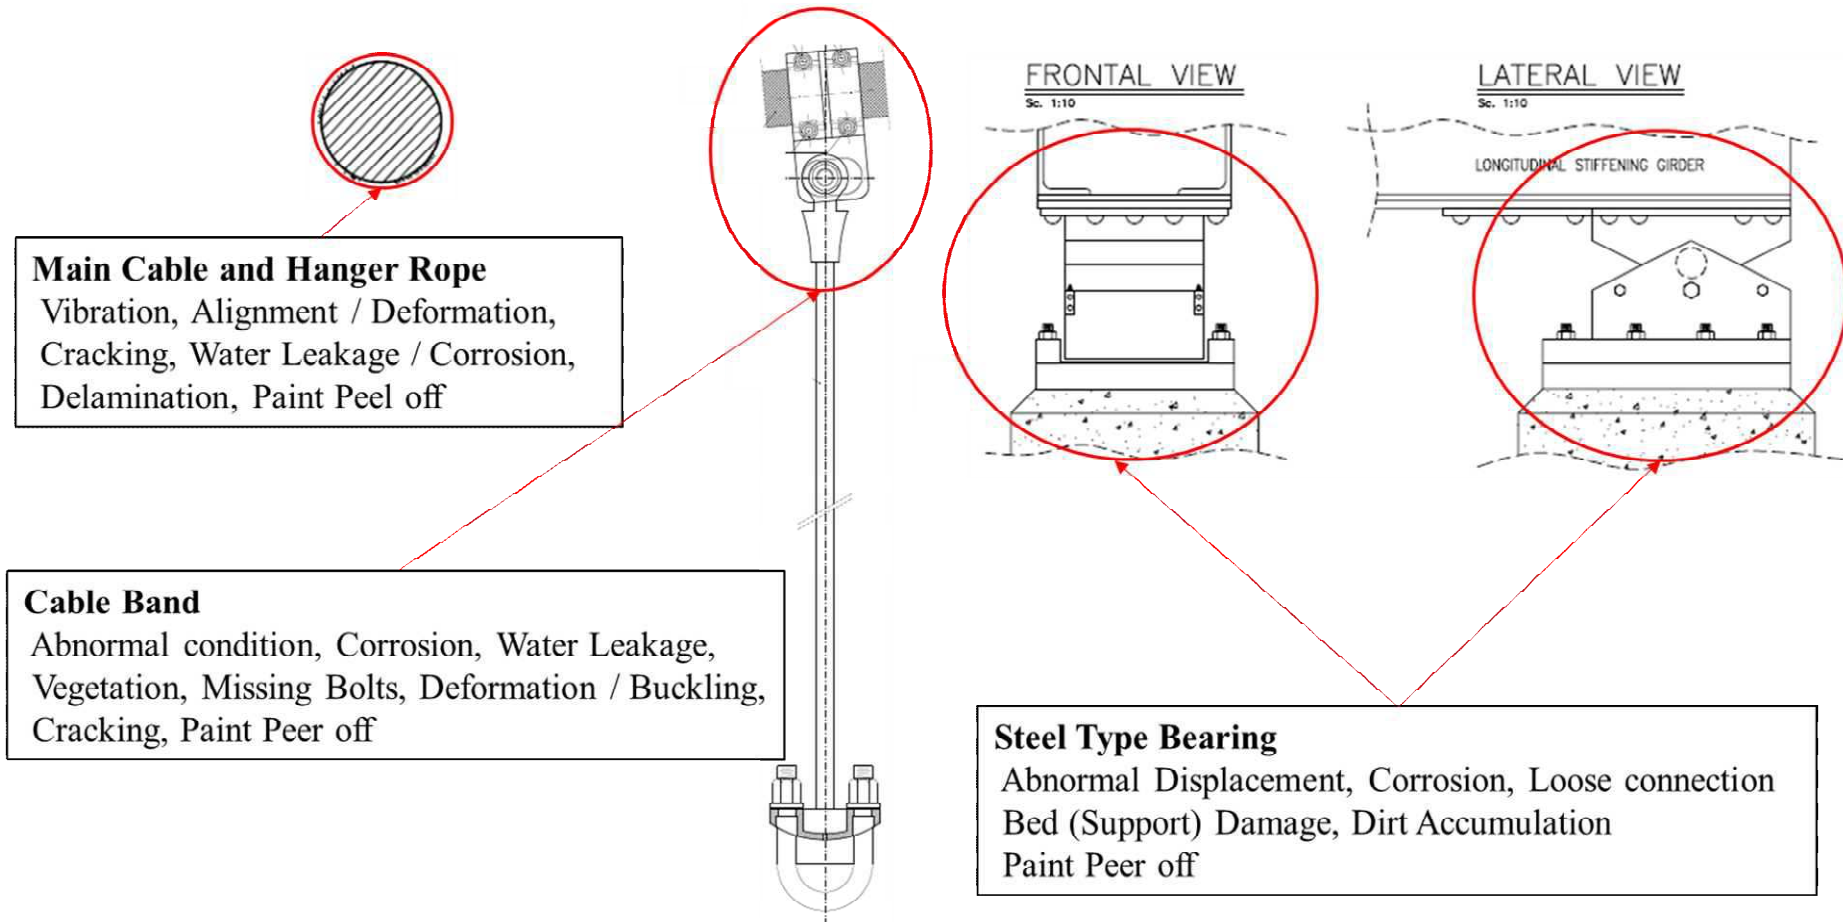
Cable, Cable Band and Bearing

Figure 3-3-8 Check Points of Periodic Inspection – Otto Beit Bridge (3 of 4)

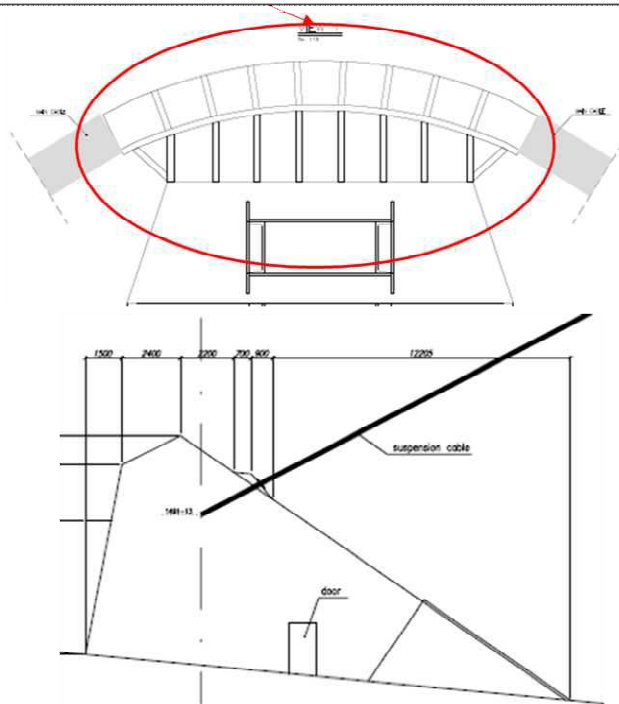
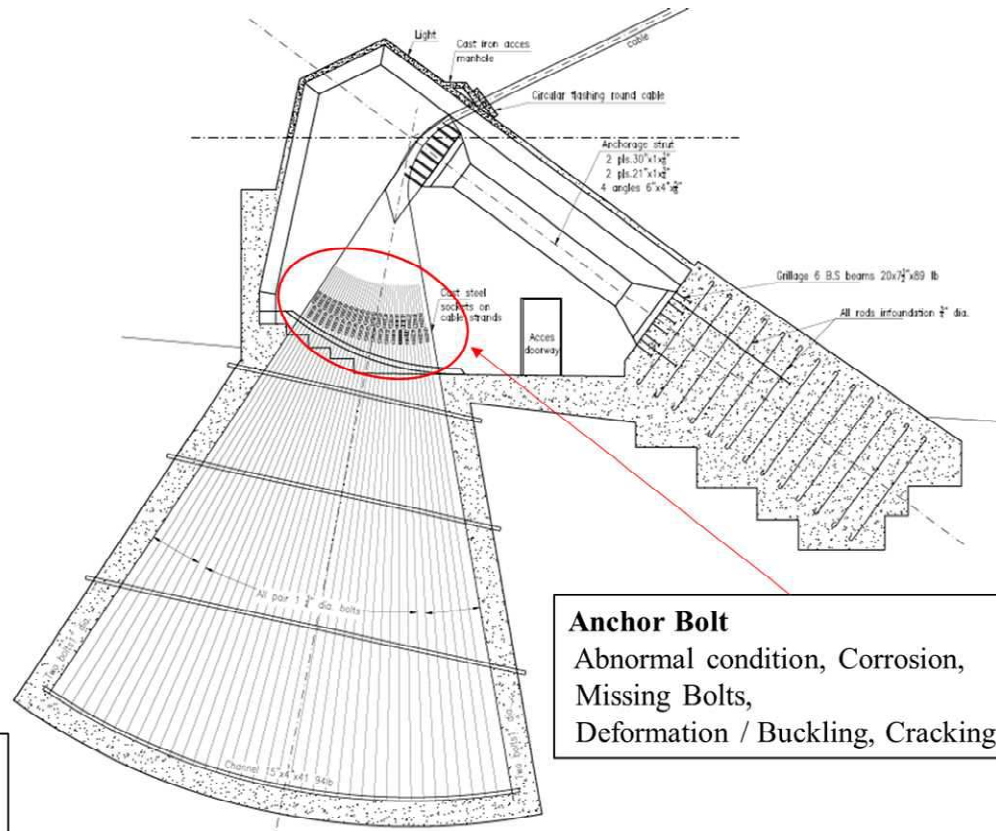
Tower Saddle

Abnormal Displacement, Corrosion, Loose connection, Paint Deterioration, Bed (Support) Damage, Dirt Accumulation

Anchorage

Water and Dirt Accumulation, Abnormal Condition, Water Leakage, Vegetation, Cracking, Spalling / Scaling / Disintegration, Delamination, Rebar Exposure / Corrosion, Honey comb, Buckling

Anchor Bolt

Abnormal condition, Corrosion, Missing Bolts, Deformation / Buckling, Cracking

Figure 3-3-9 Check Points of Periodic Inspection – Otto Beit Bridge (4 of 4)

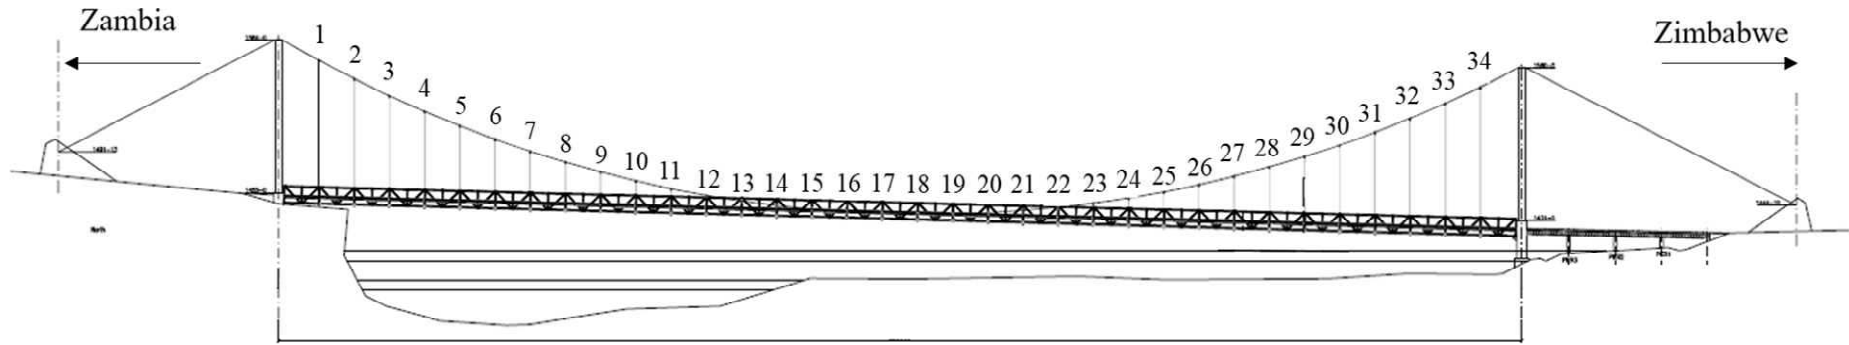
Suspension Bridge Hanger Ropes

Hanger Rope Left Side	1E	13E	25E	Hanger Rope Right Side	1W	13W	25W
	2E	14E	26E		2W	14W	26W
	3E	15E	27E		3W	15W	27W
	4E	16E	28E		4W	16W	28W
	5E	17E	29E		5W	17W	29W
	6E	18E	30E		6W	18W	30W
	7E	19E	31E		7W	19W	31W
	8E	20E	32E		8W	20W	32W
	9E	21E	33E		9W	21W	33W
	10E	22E	34E		10W	22W	34W
	11E	23E			11W	23W	
	12E	24E			12W	24W

E: East (left)
W: West (right)

Figure 3-3-10 Numbering of Members – Otto Beit Bridge

Special / long span bridges are complex structures. Before conducting inspection, proper numbering of elements and attributes on the forms should be considered to avoid misinterpretation on its location. During inspection, each attributes shall be numbered / marked for easy identification. Numbering and marking of attributes are shown in Figure 3-3-10, 3-3-11, 3-3-12 and 3-3-13.

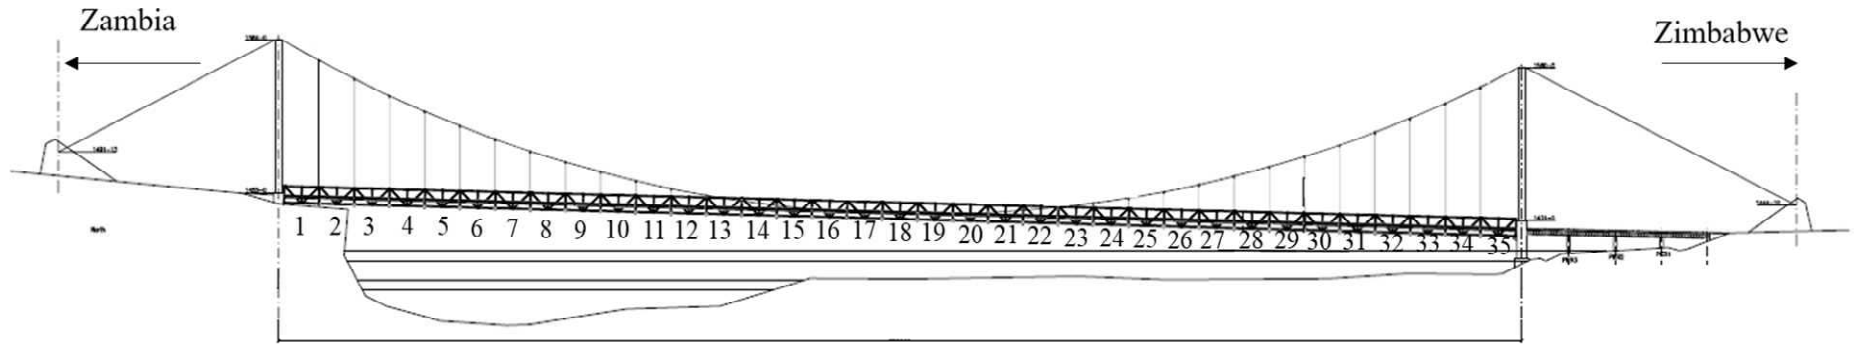
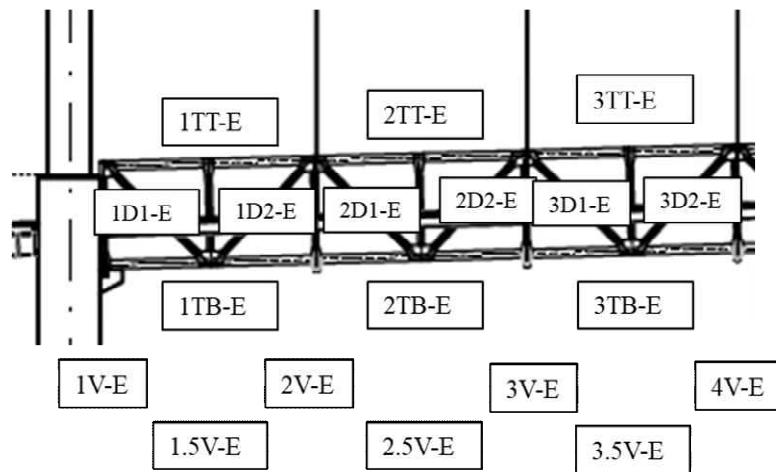
Suspension Bridge – Truss at Left Side

1V-E	Vertical Truss Member	1D1-E	Diagonal Truss Member
1.5V-E		1D2-E	
2V-E		2D1-E	
...	2D2-E		
36V-E	Truss Top Member	3D1-E	
1TT-E		3D2-E	
2TT-E		...	
3TT-E		35D1-E	
...		35D2-E	
35TT-E	Truss Bottom Member		
1TB-E			
2TB-E			
3TB-E			
...			
35TB-E

Figure 3-3-11 Numbering of Members – Otto Beit Bridge

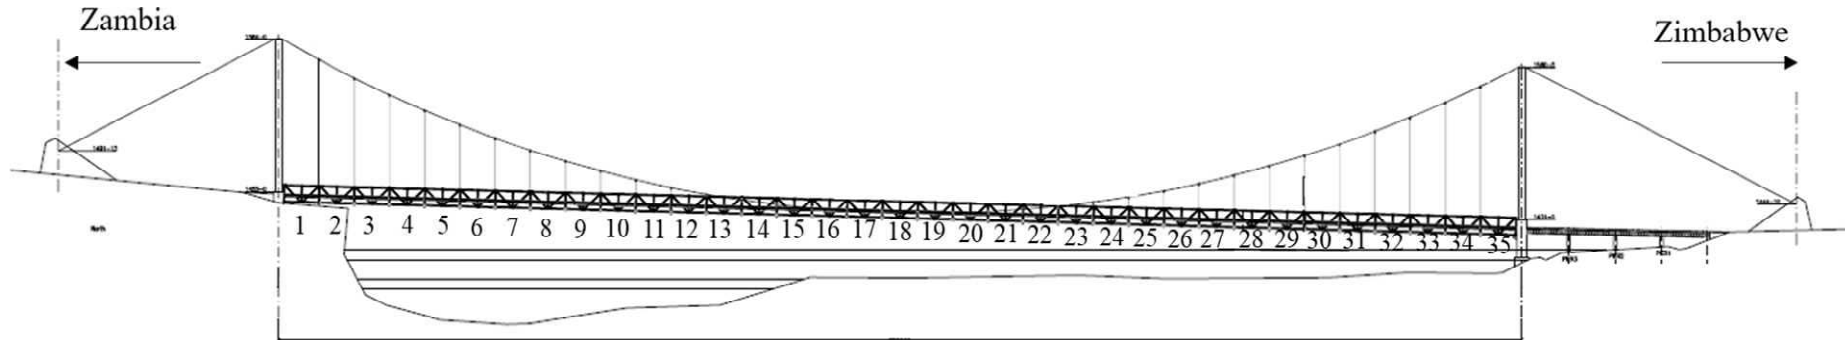
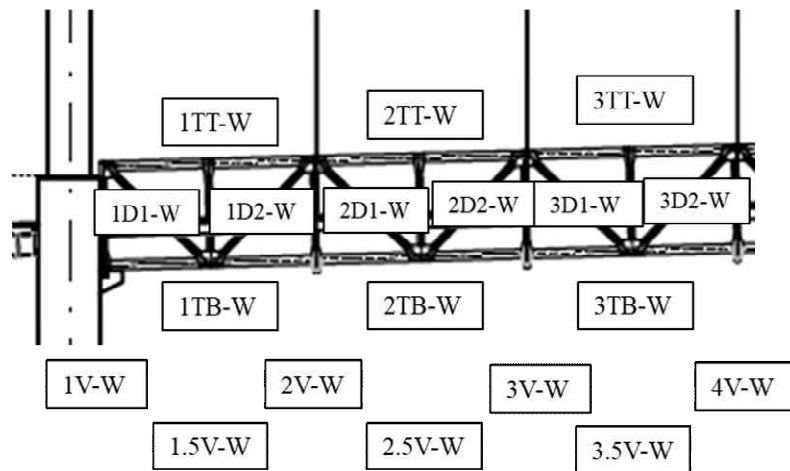
Suspension Bridge – Truss at Right Side

1V-W	Vertical Truss Member	1D1-W	Diagonal Truss Member
1.5V-W		1D2-W	
2V-W		2D1-W	
...	2D2-W		
36V-W	3D1-W		
1TT-W	Truss Top Member	3D2-W	
2TT-W		...	
3TT-W		35D1-W	
...		35D2-W	
35TT-W			
1TB-W	Truss Bottom Member		
2TB-W			
3TB-W			
...			
35TB-W

Figure 3-3-12 Numbering of Members – Otto Beit Bridge

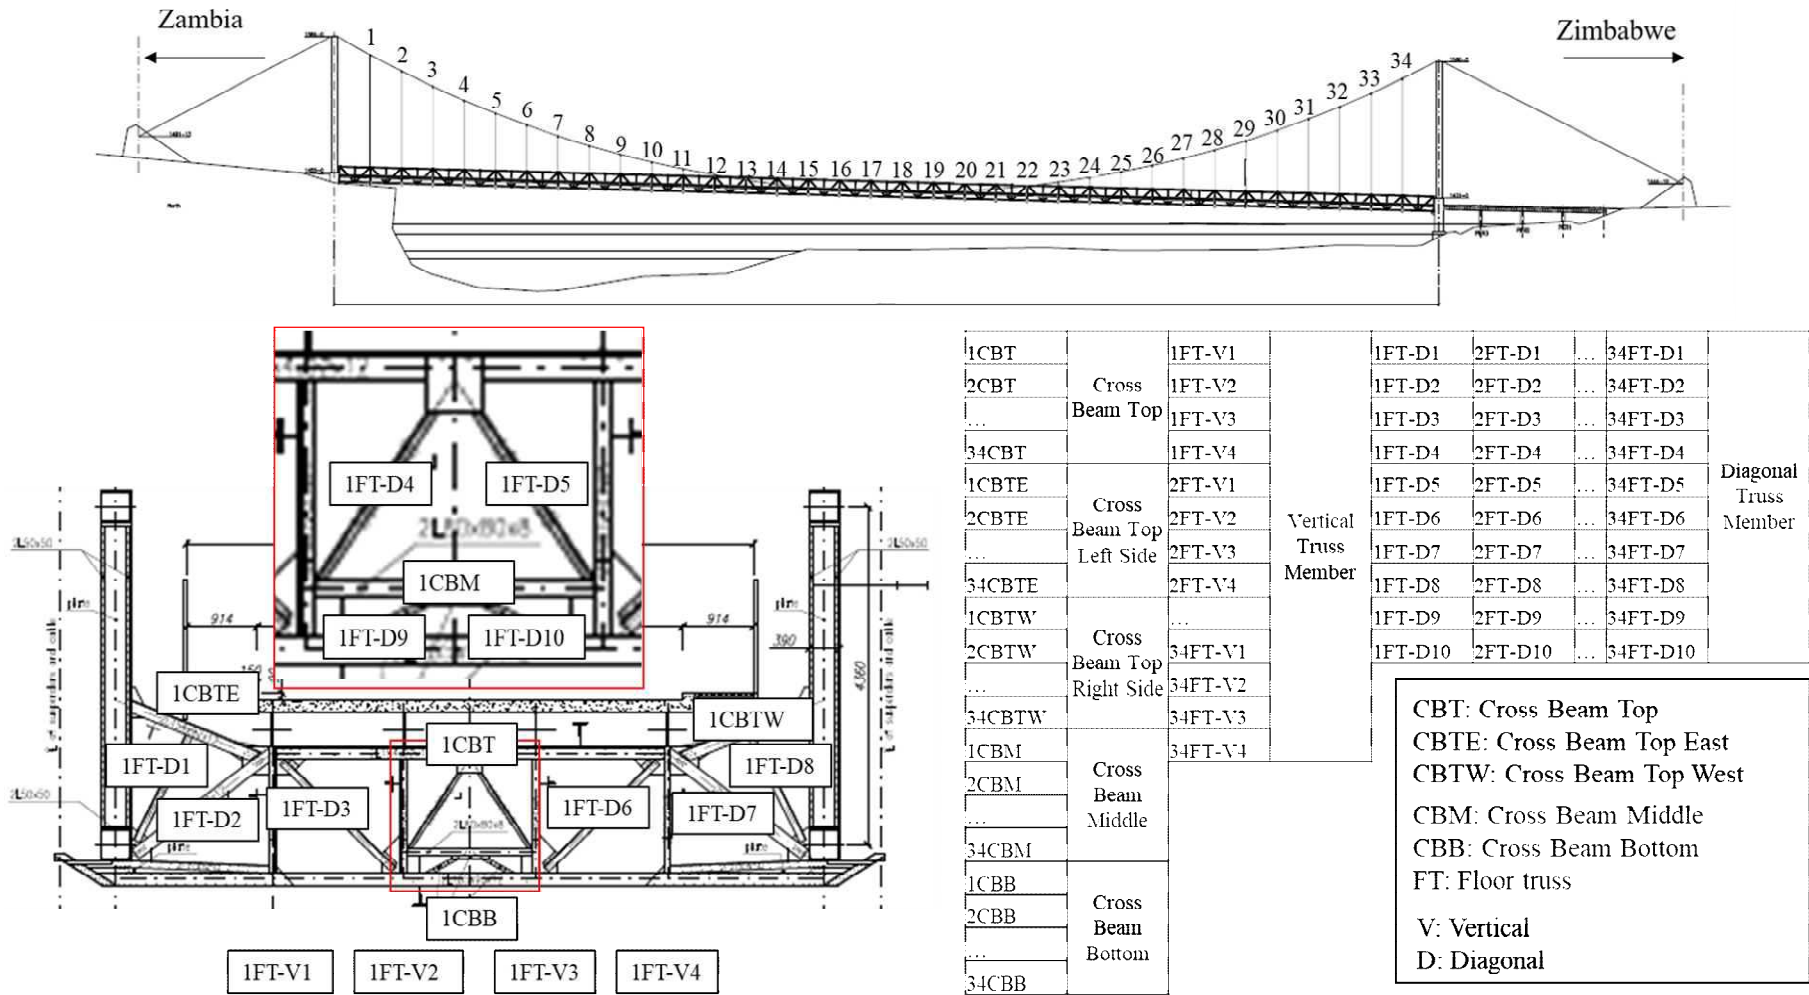
Suspension Bridge – Cross Beams and Floor Truss

Figure 3-3-13 Numbering of Members – Otto Beit Bridge

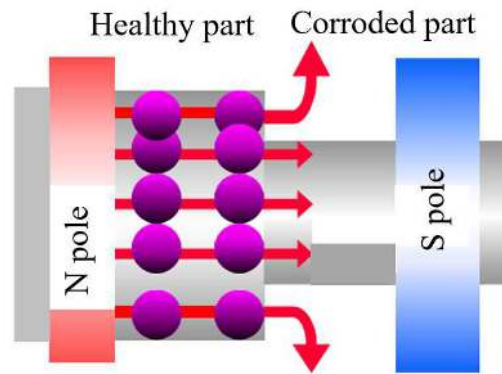
Reductions in the section area of a steel rope are evaluated by measuring the magnetic flux of its section exposed to a magnetic field. As shown in Figure 3-4-1. This method is based on the proper relationship between the magnetic flux and the section area of a steel structure placed in a magnetic field.

Figure 3-4-1 Mechanism of Main Flux Method

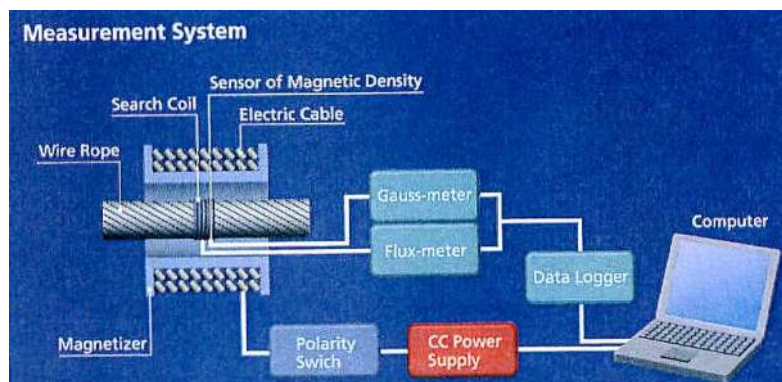
Figure 3-4-2 Measurement System of Main Flux Method

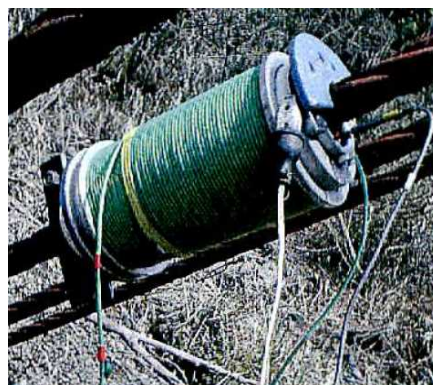
Figure 3-4-3 Inspection Device of Main Flux Method

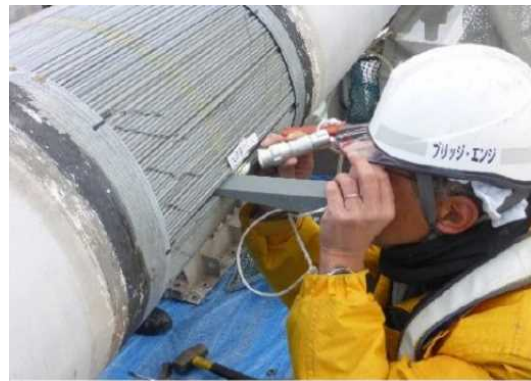
Figure 3-4-4 Internal main cable inspection (cable wires were wedged)

Internal main cable method inspection is conducted to evaluate the soundness of the cables by removing an exhaust cover of the main cable. The steel wires are visually observed by driving wedge into the cable as shown Figure 3-4-4. The example of internal main cable inspection is shown in Figure 3-4-5. Surprisingly, some cross sections had rust on the majority of the cables.

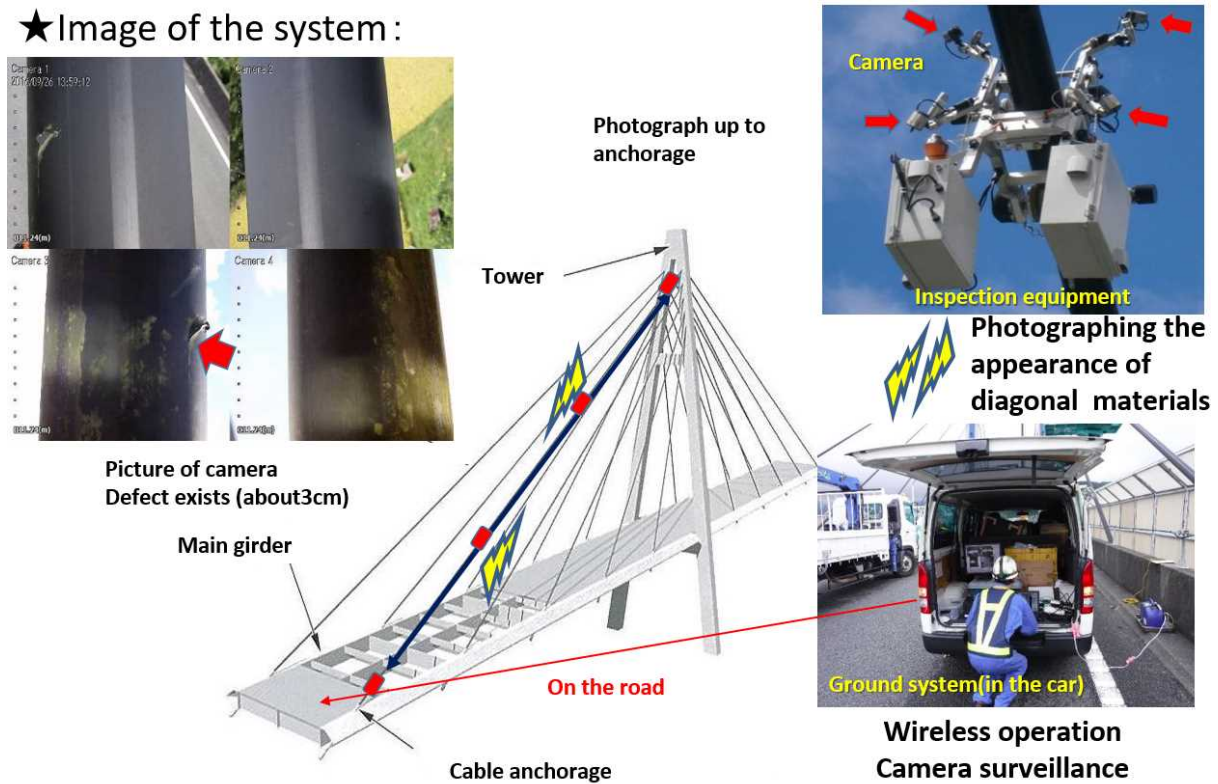
Figure 3-4-6 Image of Self-Driven Stay Cable Inspection System

Self-Driven Stay Cable Inspection system can investigate deformation of the protective tube of the cable and breakage of wires that make up cable. This device can move up and down automatically to inspect and record the appearance with video camera. And this can confirm whether or not the steel wire placed on the outer peripheral part of the steel wire inside the diagonal member is broken as shown in Figure 3-4-7.

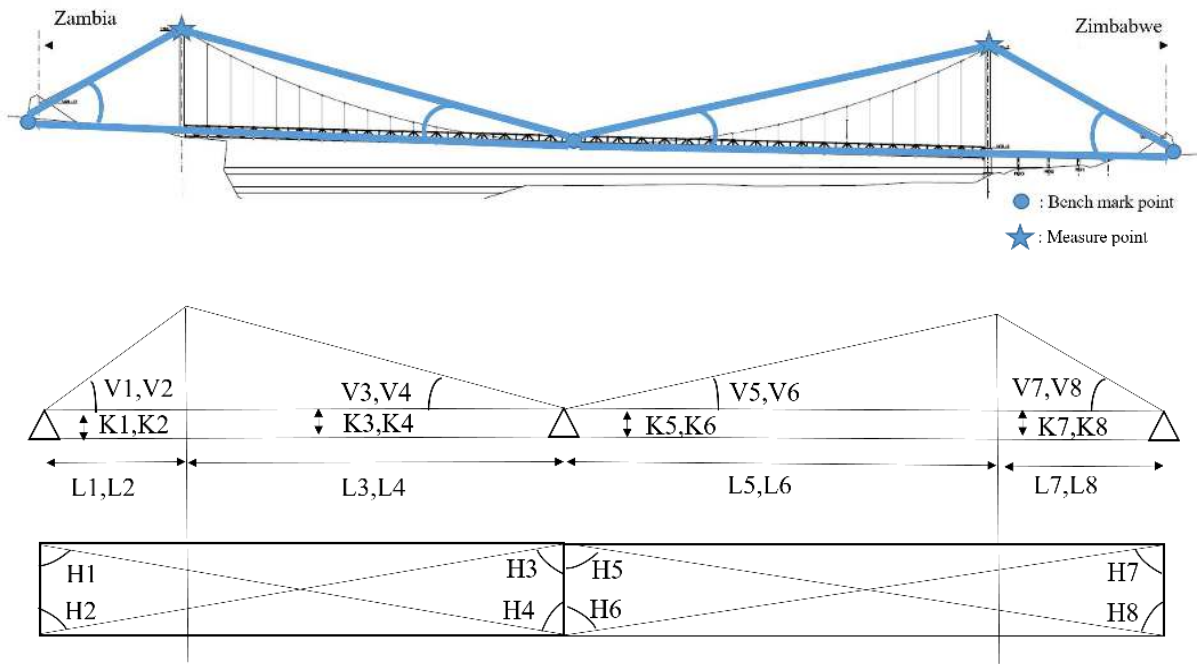
Figure 3-5-2 Geometrical Inspection:
Slope of Vertical Alignment of Tower

Measure: Angle (Vertical): $V1', V2', V3', V4', V5', V6', V7', V8'$
 Angle (Horizon): $H1', H2', H3', H4', H5', H6', H7', H8'$
 Length: $L1', L2', L3', L4', L5', L6', L7', L8'$
 Height: $K1', K2', K3', K4', K5', K6', K7', K8'$

Raise:	$K1' + L1' \cdot \tan V1'$	Slope:	$L1' / \tan H1'$
	$K2' + L2' \cdot \tan V2'$		$L2' / \tan H2'$
	$K3' + L3' \cdot \tan V3'$		$L3' / \tan H3'$
	$K4' + L4' \cdot \tan V4'$		$L4' / \tan H4'$
	$K5' + L5' \cdot \tan V5'$		$L5' / \tan H5'$
	$K6' + L6' \cdot \tan V6'$		$L6' / \tan H6'$
	$K7' + L7' \cdot \tan V7'$		$L7' / \tan H7'$
	$K8' + L8' \cdot \tan V8'$		$L8' / \tan H8'$

Geometrical Inspection methods are shown in Figure 3-5-1, 3-5-2 and 3-5-3. As a reference, Geometrical Inspection form (GIF) of Otto Beit Bridge are shown in Appendix A-3-3.

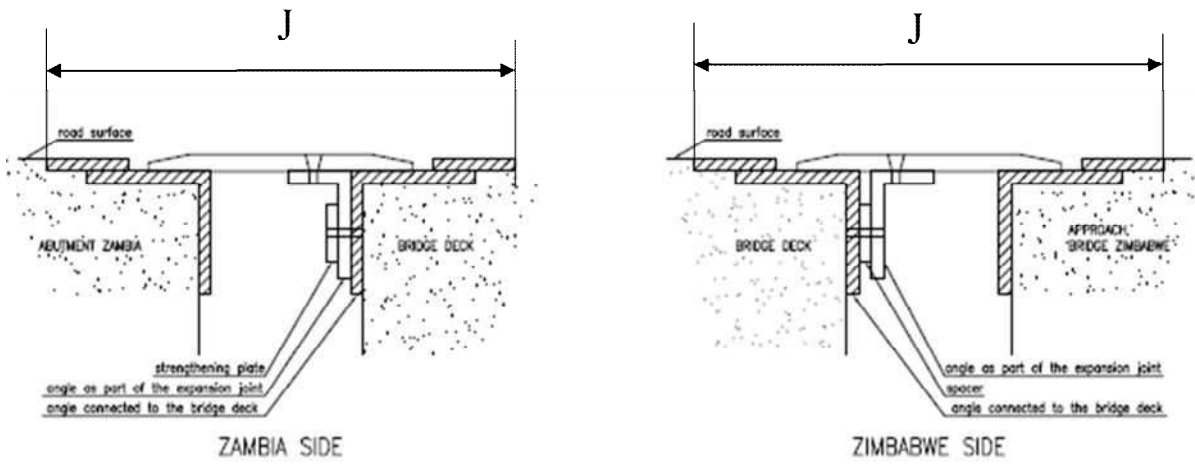
Figure 3-5-3 Geometrical Inspection:
Movement of Expansion Joints

Expansion Joint

Measure 5 selected points in each joint and average (everytime use same marking point)

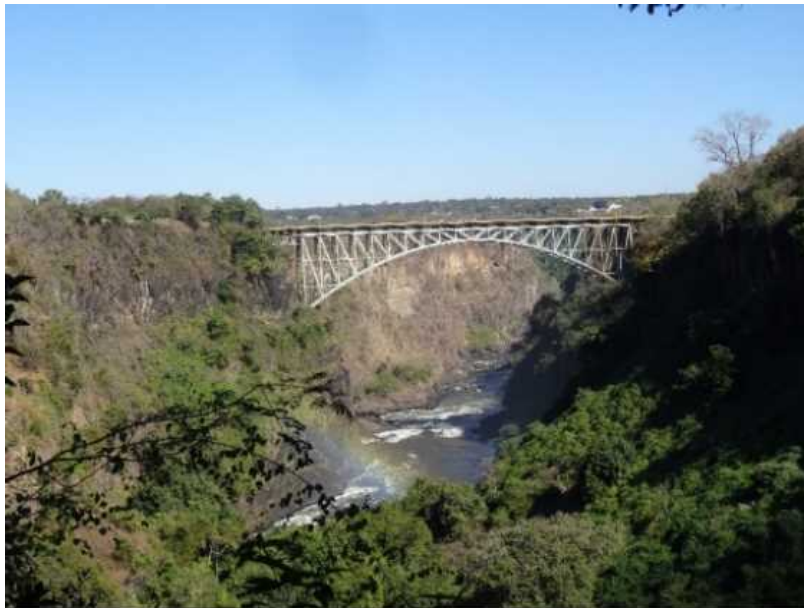
Figure 4-1-1 Steel Arch Bridge

Arch Bridge is a structure that supports load by compression stress in the arch member. Rigidity of bridge is high to avoid bending moment in the main members. At the same time, Arch Bridge generates large horizontal thrust by the arch reaction on their footing. In a Through Arch Bridge, they have massive foundation and the horizontal thrust of the arch reaction is transferred to large rock, masonry, or concrete foundation.

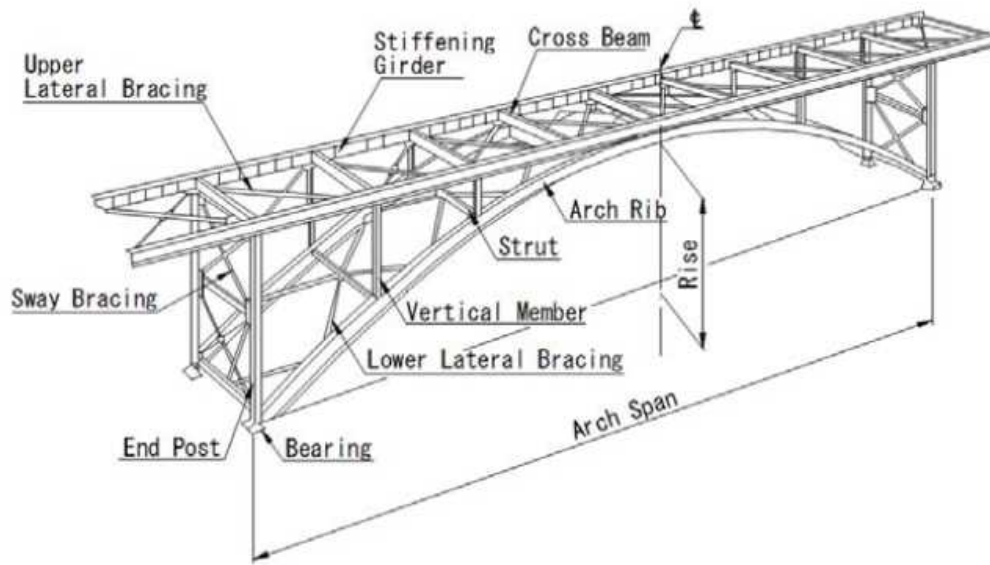
Figure 4-1-2 Bridge Component (Steel Arch Bridge)

In the Arch Bridge, Dead load (ex deck) and live road reach the bearing through the deck → longitudinal beam • Cross Beam → Stiffening Girder → Vertical Member → Arch Rib. Upper and lower Lateral Bracing stand for horizontal force such as wind seismic load and have a role to enhance safety which raise stiffness by functioning with Sway Bracing and Strut.

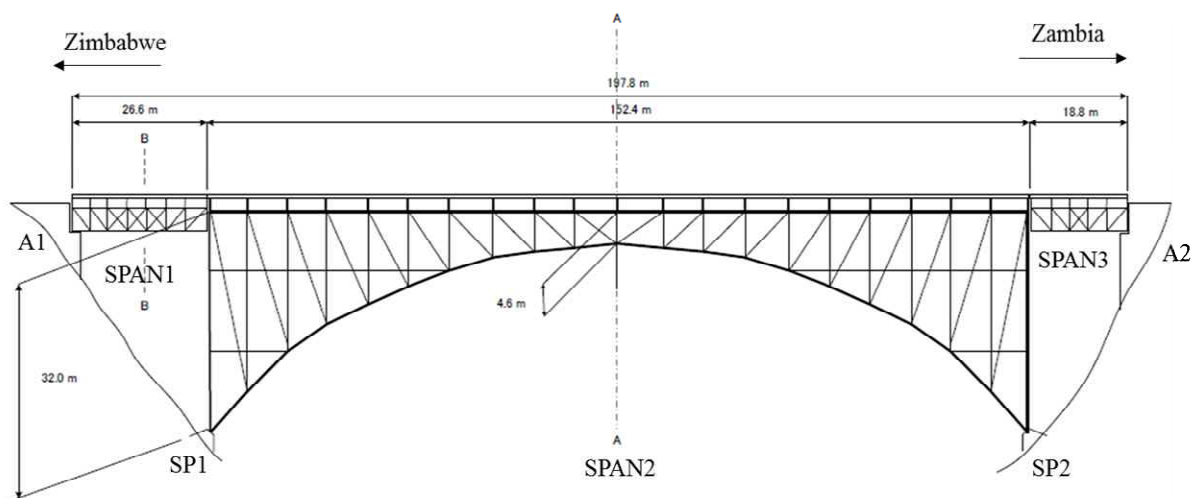
Figure 4-1-3 Bridge Geometry Definition

The bridge is assessed in the direction of increasing chainage. Refer to Figure 4-1-3.

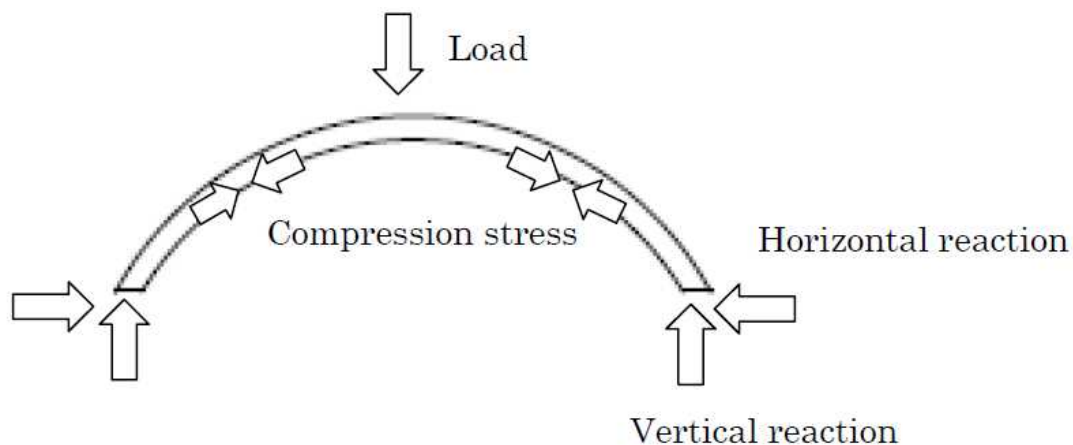
Figure 4-1-4 Load Distribution System for Through Arch Bridge

Arch Bridge is a structure that supports load by compression stress in the arch members as shown in the Figure 4-1-4. Rigidity of bridge is high to avoid bending moment in the main members. At the same time, Arch Bridge generate large horizontal thrust by the arch reaction on their footing. In a Through Arch Bridge, they have massive foundation and the horizontal thrust of the arch reactions is transferred to large rock, masonry, or concrete foundations. On the other hand, in a Deck Arch Bridge, the load is supported not only arch member but also deck slab. Load Distribution system for Deck Arch Bridge is shown in Figure 4-1-5.

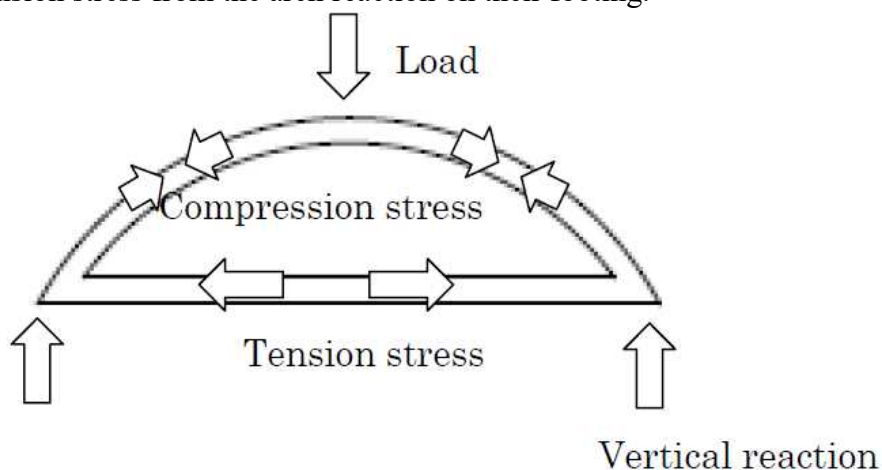
Figure 4-1-6 Load Distribution System for Tied Arch Bridge

A Tied Arch transfers the horizontal reactions through a horizontal tie which connects the ends of the arch together, like the string on an archer's bow. The tie girder is a tension member and is considered fracture critical. If the tie girders fail, the arch will lose its tension and will collapse. Since Tied Arch Bridge redistribute the horizontal loads to the tie girders, the piers for Tied Arch Bridge are smaller than the piers for Through Arch Bridge.

Traffic loads are supported by a deck. The load from the deck is transmitted to the stringers and then the floor beams. The stringer and floor beams resist the load in bending and shear.

The load is transferred to the hangers through tie member, which are in tension. The arch support the hangers and load transfers the compressive load to arch members. Tie girder has tension stress from the arch reaction on their footing.

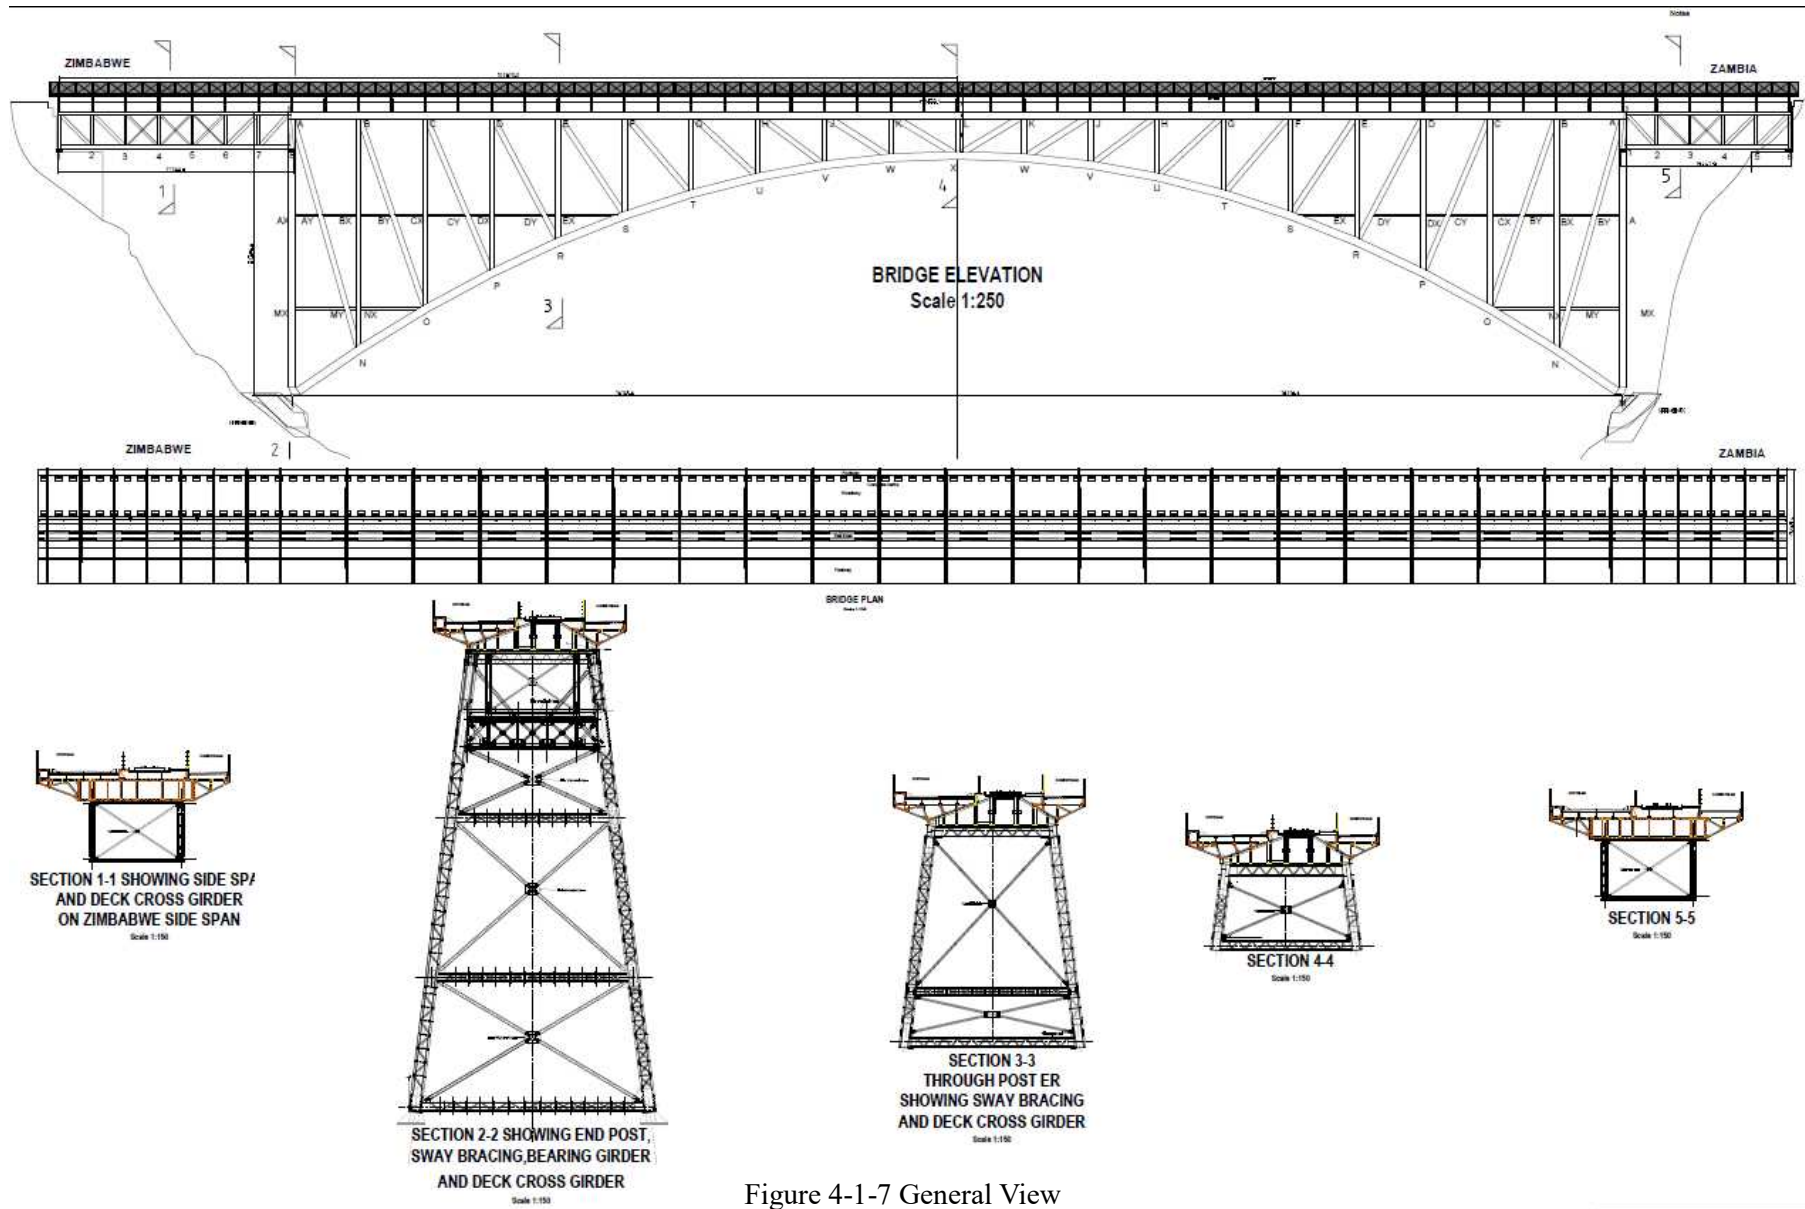
Figure 4-1-7 General View

Shown in Figure 4-1-7 is the General View of Victoria Falls Bridge.

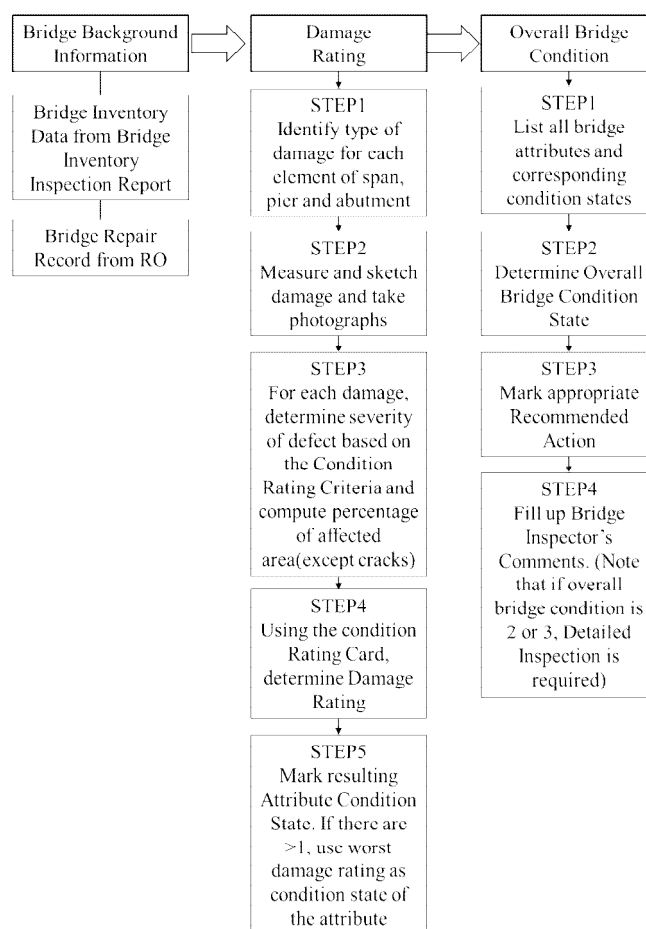
Figure 4-3-1 Flowchart of Bridge Periodic Inspection

The step-by step procedure for conducting the Periodic Inspection is illustrated in the following flowchart.

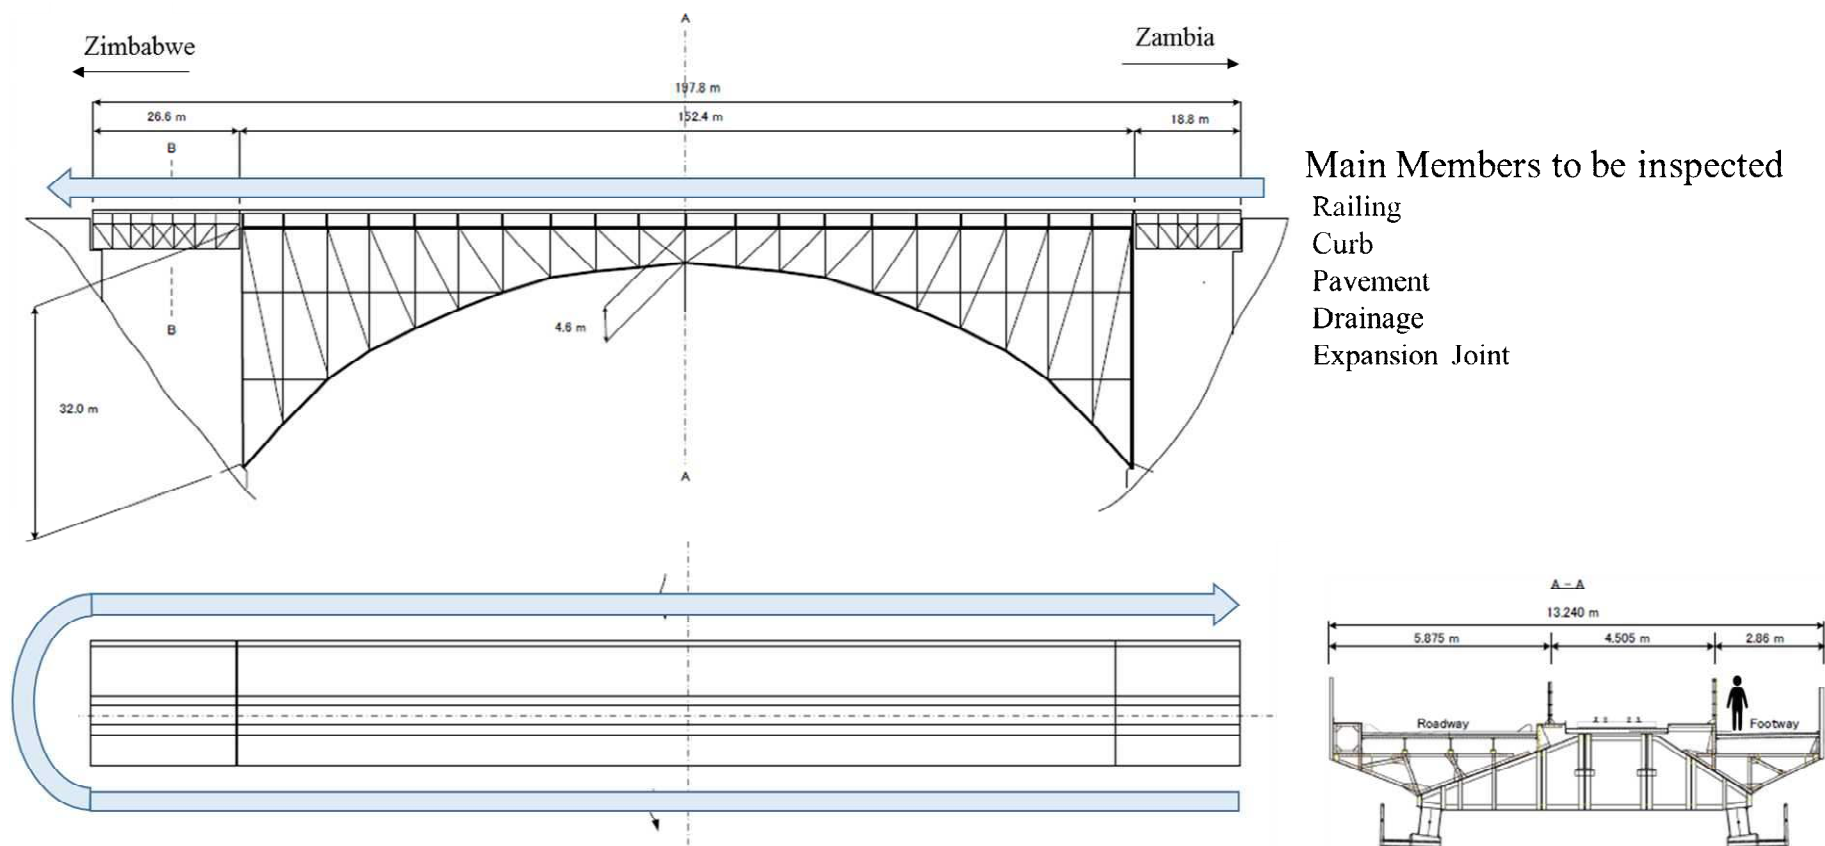
Figure 4-3-2 Periodic Inspection Route of Victoria Falls Bridge (1 of 3)

Inspection of Upper Deck

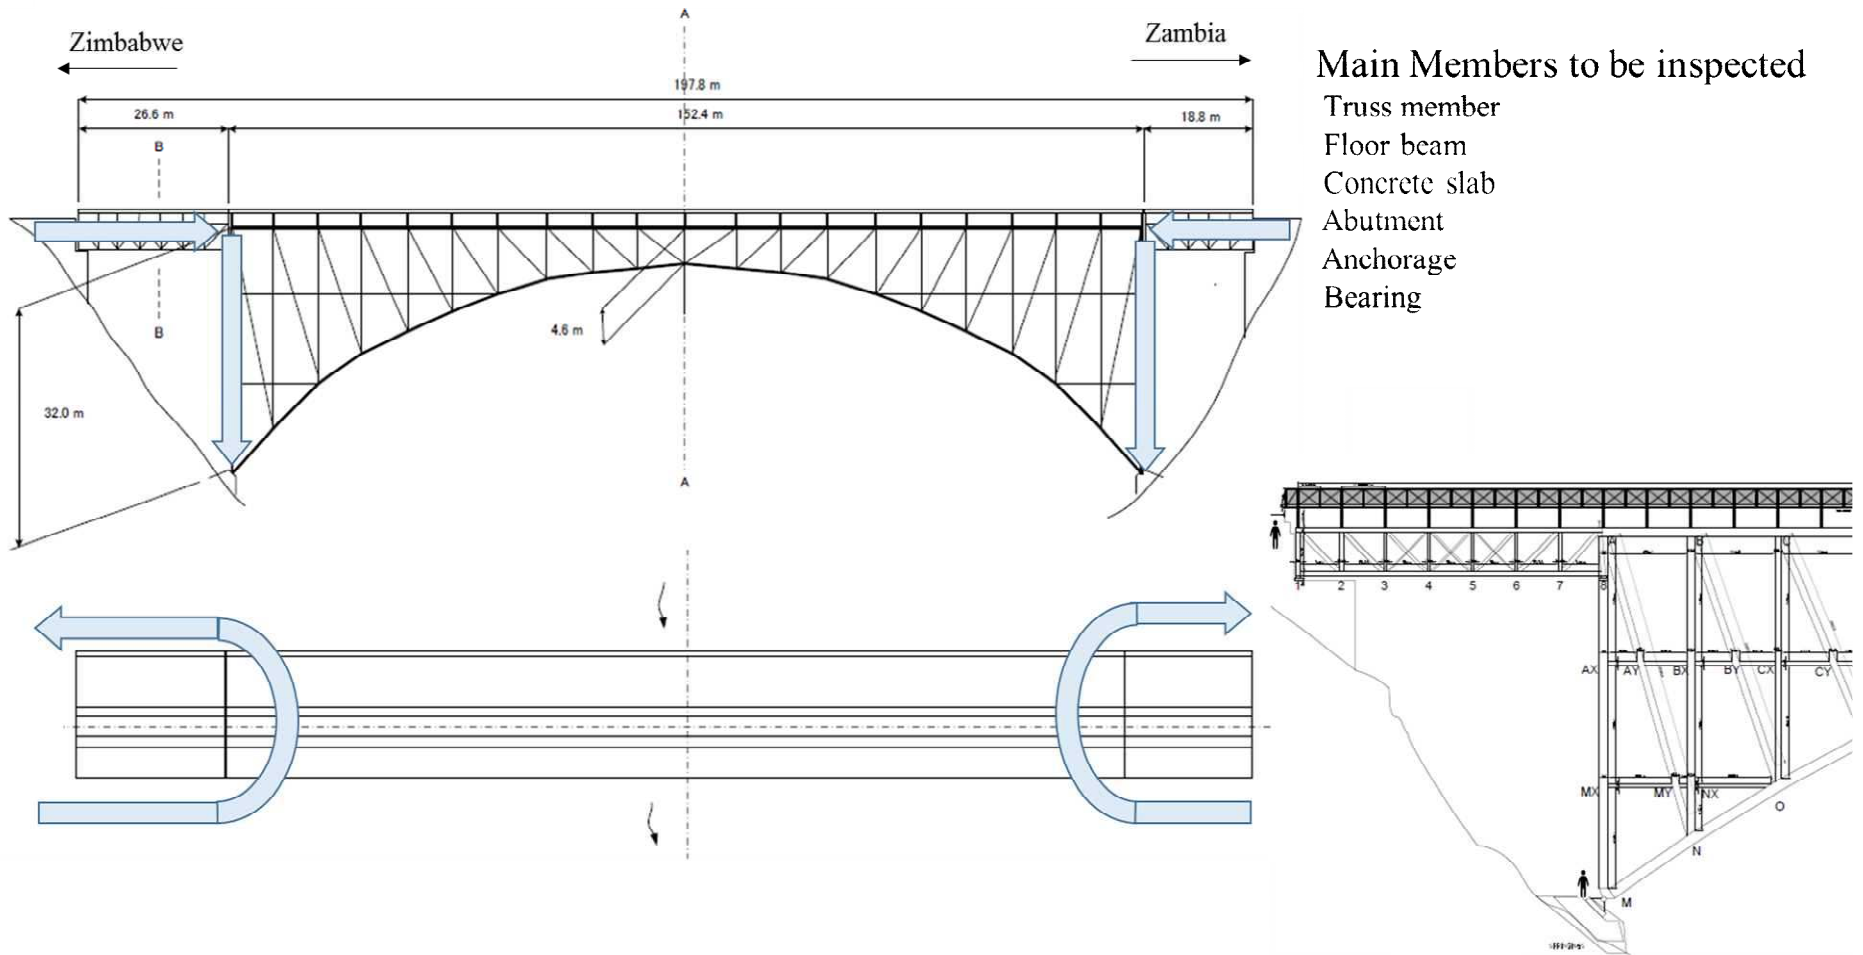
Figure 4-3-3 Periodic Inspection Route of Victoria Falls Bridge (2 of 3)

Inspection of Underside

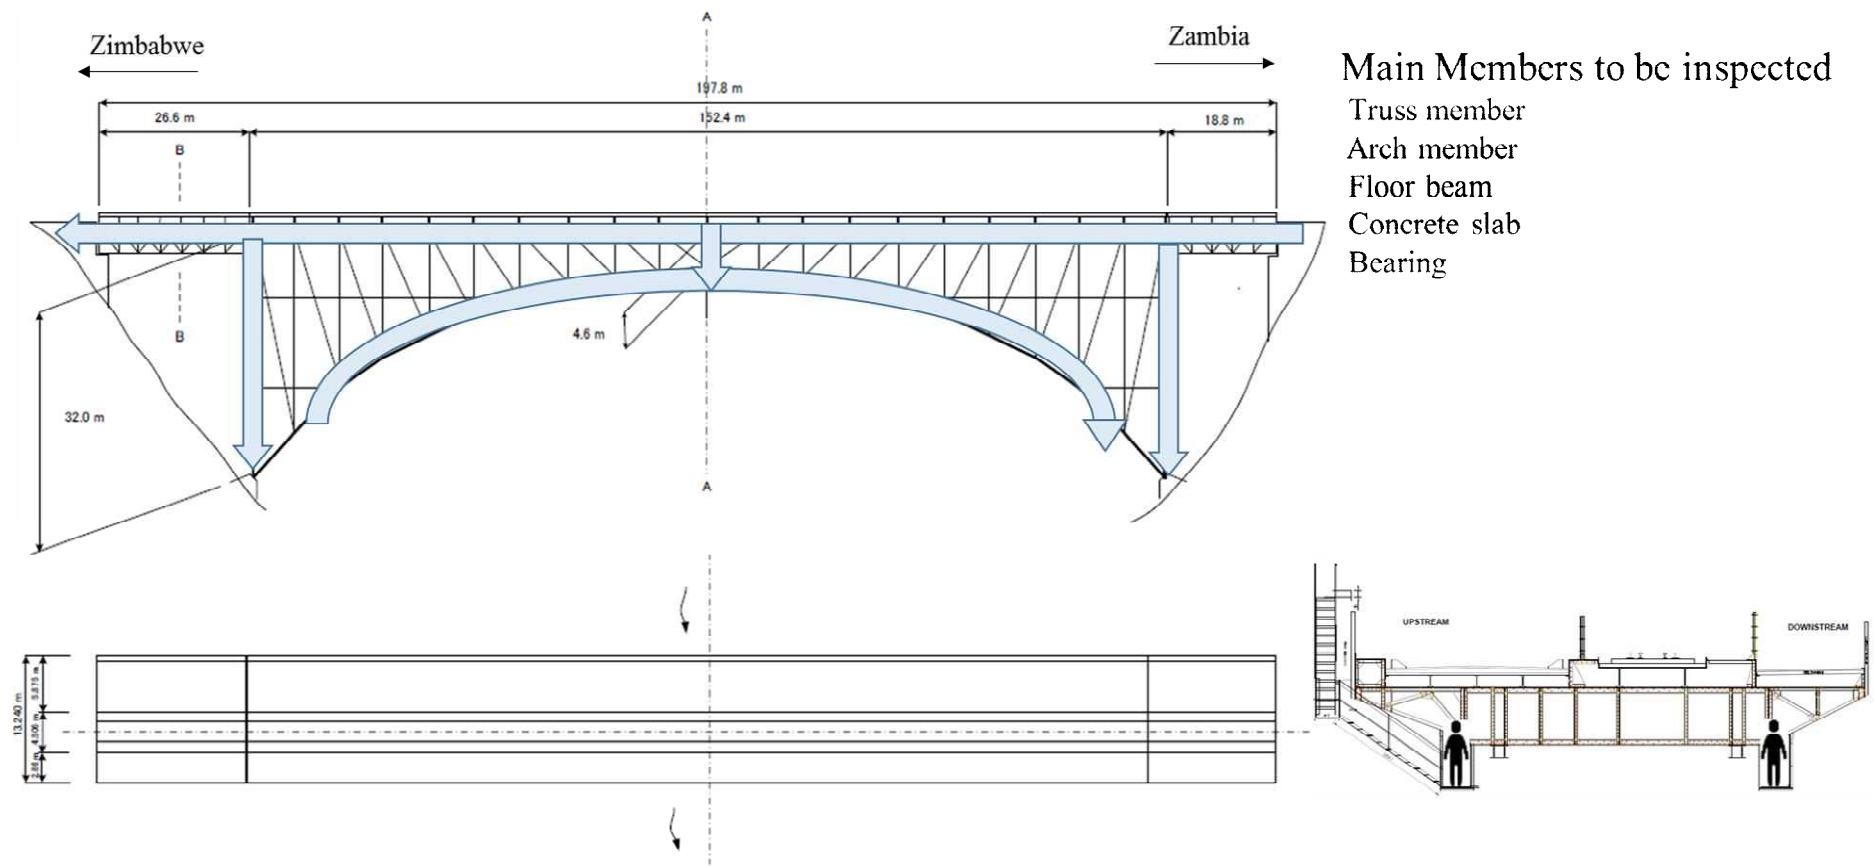
Figure 4-3-4 Periodic Inspection Route of Victoria Falls Bridge (3 of 3)

Inspection of Underside and Arch chord
