BRIDGE MAINTENANCE CAPACITY BUILDING IN ZAMBIA

BRIDGE INSPECTION GUIDEBOOK

2024

**Road Development Agency
Japan International Cooperation Agency**

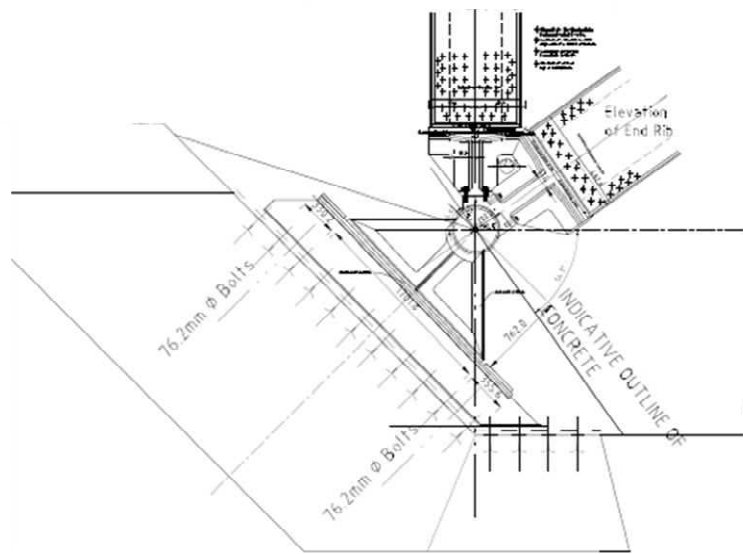
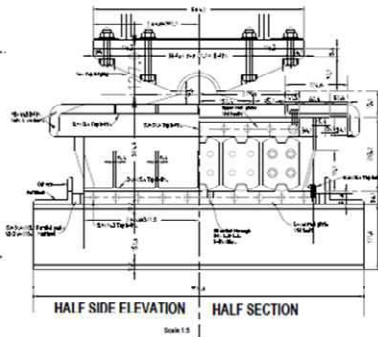
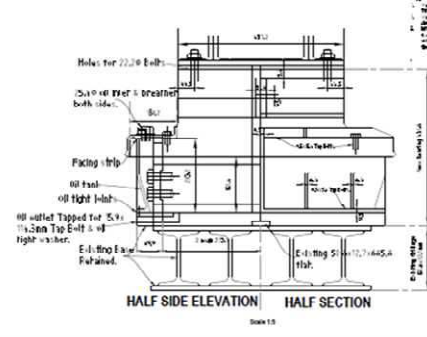
Figure 4-3-6 Check Points of Periodic Inspection – Victoria Falls Bridge (2 of 2)

Steel Type Bearing

Abnormal Displacement, Corrosion, Loose connection
 Paint Peer off, Bed (Support) Damage, Dirt Accumulation

Expansion Joint

Water leakage, Abnormal Space / Noise
 Difference in Elevation, Rupture

Cracking, Spalling/ Scaling / Disintegration
 Delamination, Rebar exposure, Corrosion
 Honey comb, Tilt / Settlement, Water Leakage

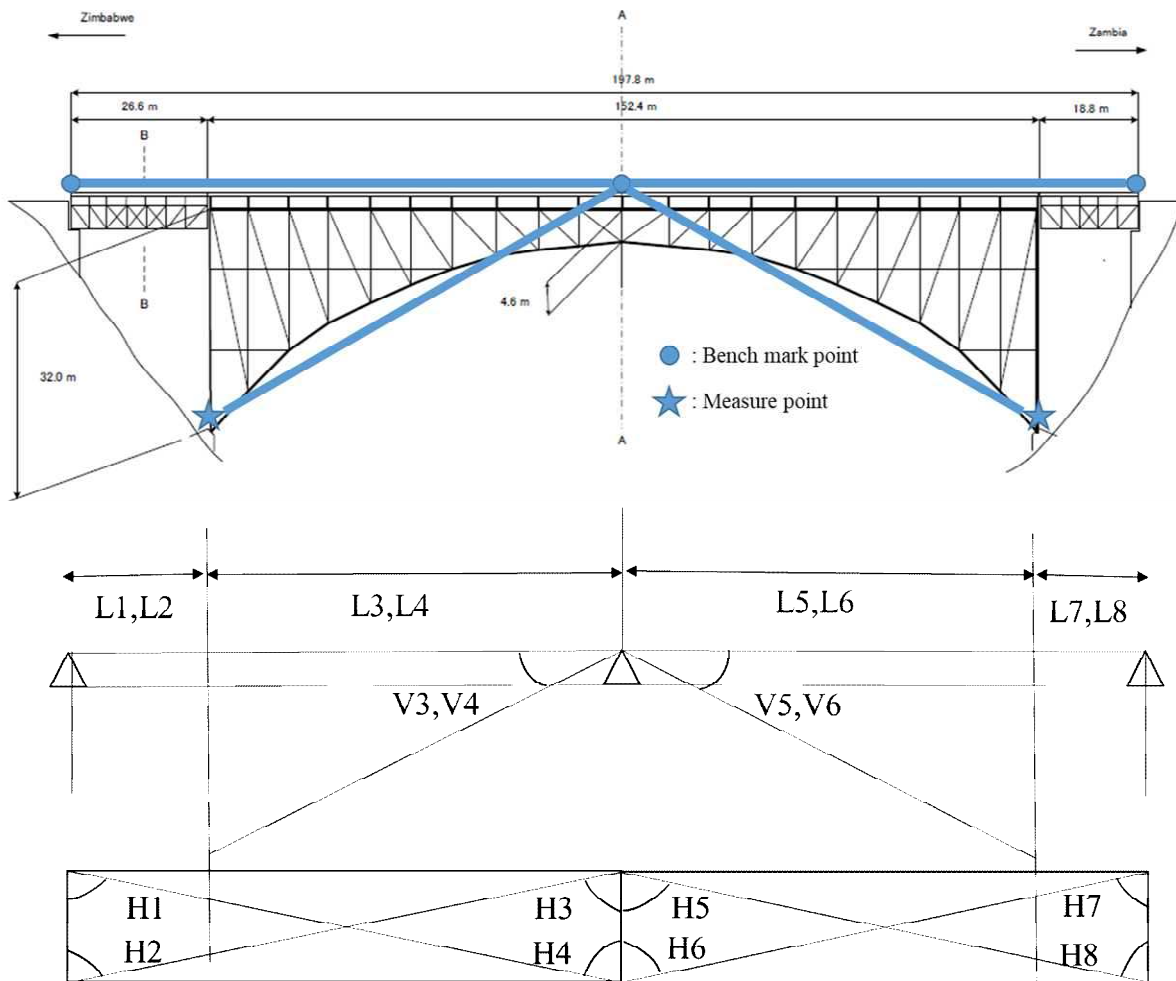
Figure 4-5-2 Geometrical Inspection:
Slope of Vertical Alignment of Arch Chord

Measure: Angle (Vertical): $V3', V4', V5', V6'$

Length: $L1', L2', L3', L4', L5', L6', L7', L8'$

Raise:	$L1' \cdot \tan V1'$	Slope: $L1' / \tan H1'$
	$L2' \cdot \tan V2'$	Slope: $L2' / \tan H2'$
	$L3' \cdot \tan V3'$	Slope: $L3' / \tan H3'$
	$L4' \cdot \tan V4'$	Slope: $L4' / \tan H4'$
	$L5' \cdot \tan V5'$	Slope: $L5' / \tan H5'$
	$L6' \cdot \tan V6'$	Slope: $L6' / \tan H6'$
	$L7' \cdot \tan V7'$	Slope: $L7' / \tan H7'$
	$L8' \cdot \tan V8'$	Slope: $L8' / \tan H8'$

Geometrical Inspection methods are shown in Figure 4-5-1, 4-5-2 and 4-5-3. As a reference, Geometrical Inspection form (GIF) of Victoria Falls Bridge are shown in Appendix A-2-4.

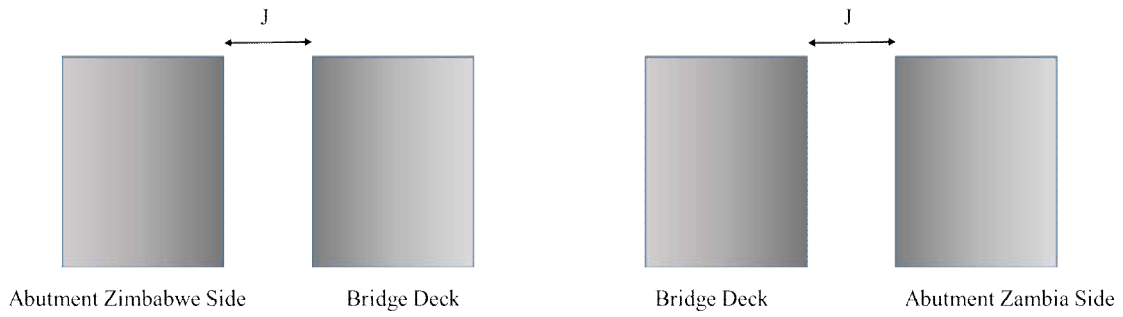
Figure 4-5-3 Geometrical Inspection:
Movement of Expansion Joints

Expansion Joint (seal)

Measure 5 selected points in each joint and average (everytime use same marking point)

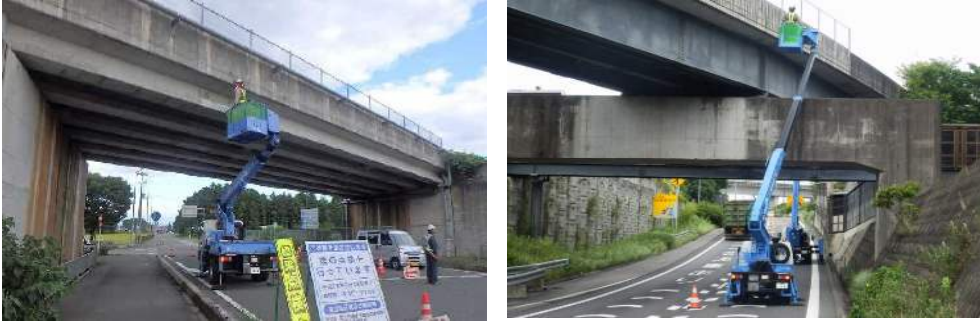
Photo 10-2 List Car

- Summary: Conduct inspections up to a height of approximately 15 meters above the ground.
- Main inspection targets: Bottom of deck slab, Girder, Substructure etc.
- Problems: Traffic control, Not available on the river and the ground-slope is large, There is a limit to the height of the bucket.

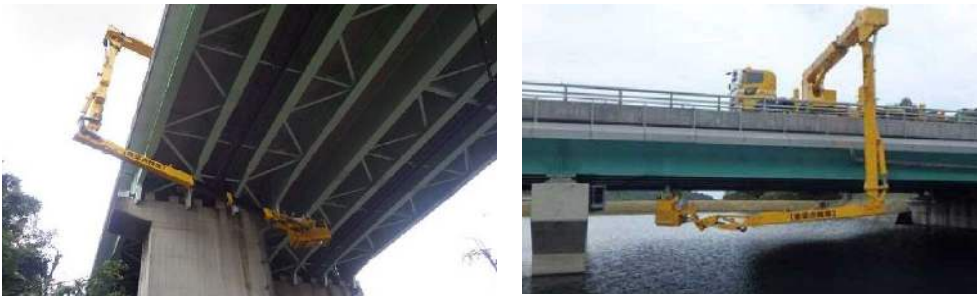
Photo 10-3 BIV

- Summary: BIV is placed on the bridge surface, and the arm is extended to inspect under the slab.
- Main inspection targets: Bottom of deck slab, Girder, Substructure etc.
- Problems: Arm cannot reach under high box girders (BIV owned by RDA is smaller than the photo), Space for vehicles is needed on the bridge surface, Expensive and few units owned, etc.

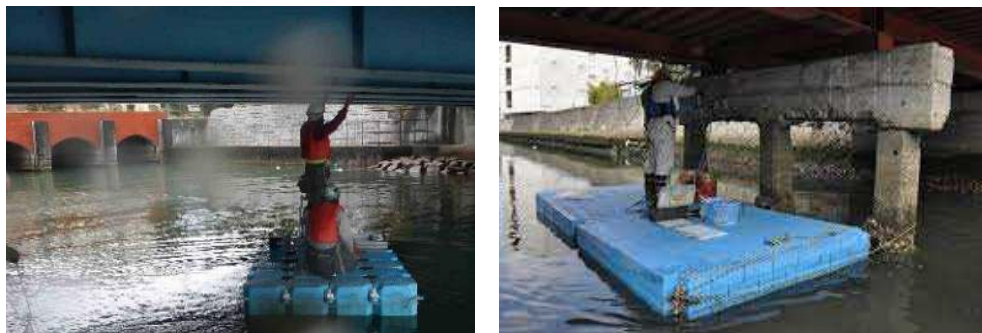
Photo 10-4 Floating Boat

- Summary: Conduct inspection of the girder from the river under the bridge.
- Main inspection targets: Bottom of deck slab, Girder, Sub-str. etc.
- Problems: It is difficult when the river flow is fast. No inspect on high points. And, An anchor is needed to secure the float, which is difficult when the river is deep. Animals such as crocodiles are also dangerous.

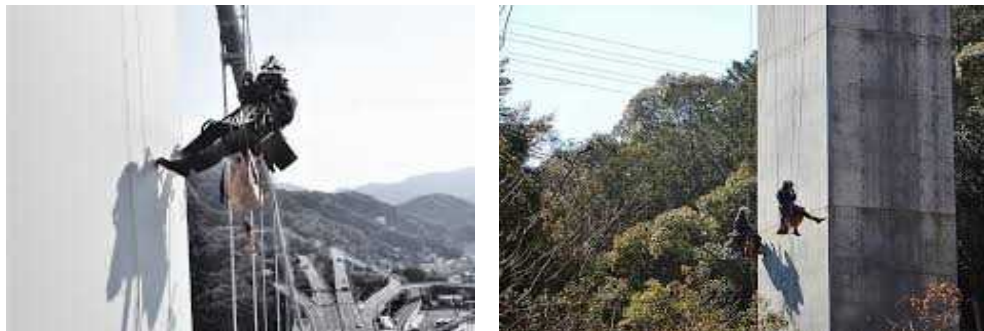
Photo 10-5 Special High-altitude Technology

- Summary: A technician using a rope will conduct a survey of difficult-to-inspect areas.
- Main inspection targets: Trusses, high piers, and other locations where it is difficult to install inspection equipment.
- Problems: Only technicians with this skill can inspect it.

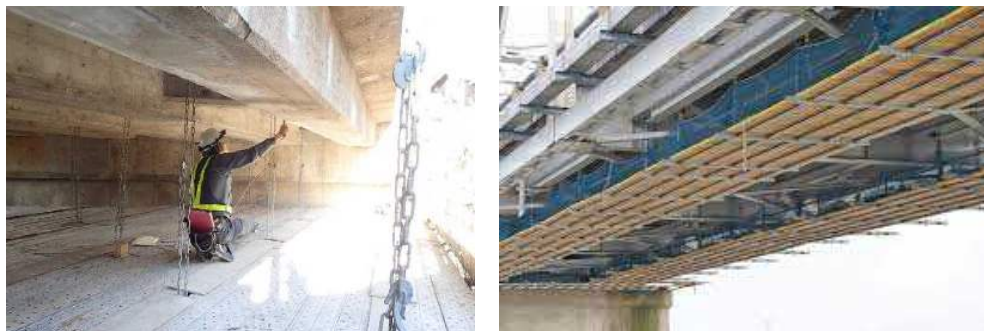
Photo 10-6 Suspended Scaffolding

- Summary: A scaffold is set up under the girder to conduct an inspection under the slab.
- Main inspection targets: Bottom of deck slab, Girder, etc.
- Problems: It will take time and money to install this. Especially for long bridges, the number of inspection days is not balanced by the preparation of time.

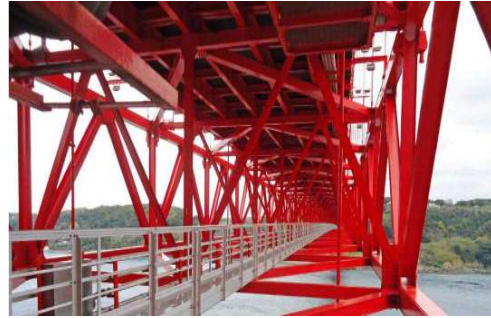
Photo 10-7 Example of an inspection facility installed on a special bridge

Tuss bridge (Japan)

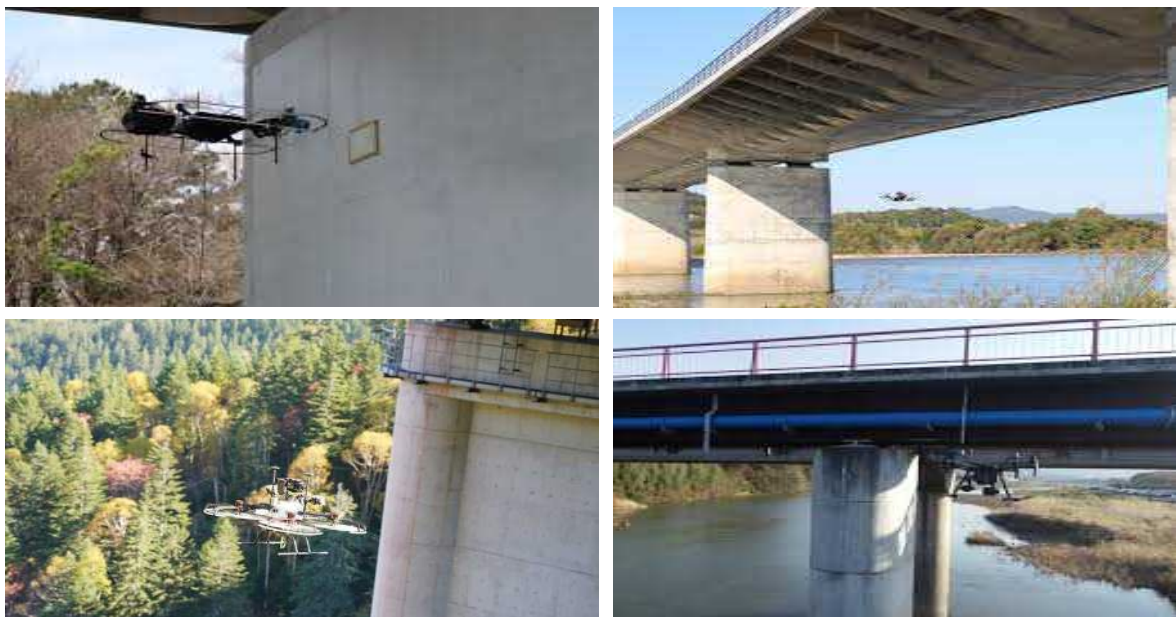
Photo 10-8 Status of bridge inspection by drone (Japan)

In Japan, conventional bridge inspections are based on direct visual confirmation. However, MLIT (The Ministry of Land, Infrastructure, Transport and Tourism) has approved the use of drones for from 2019 to improve the efficiency of inspection work and the development of drone technology in recent years. Currently, many bridge inspections using drones are being carried out.

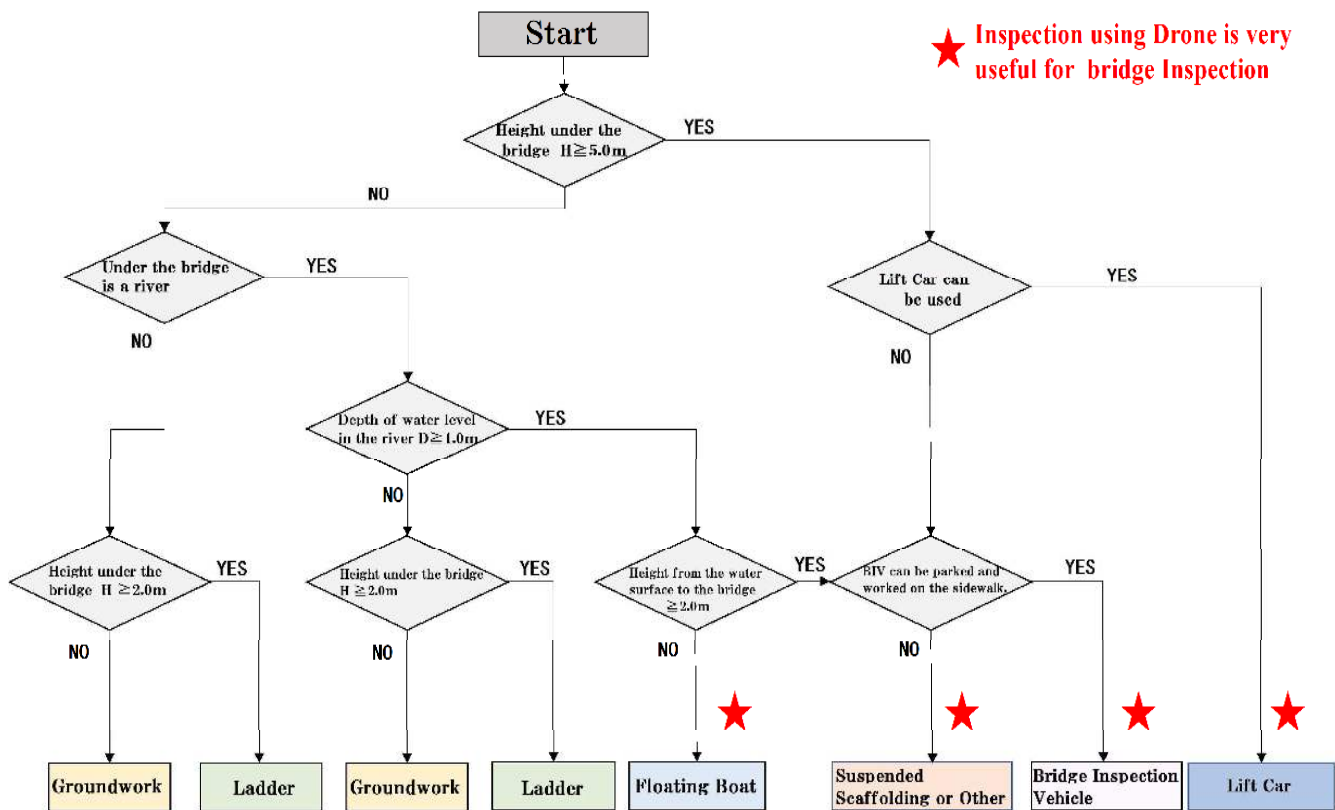
Figure 10-1 General selection flow of inspection methods

The figure below shows the selection flow of general bridge inspection methods and the scope of effective inspections by drones.

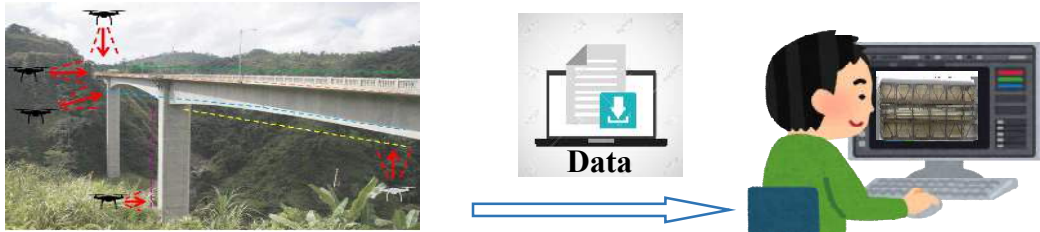
Figure 10-2 Flow of analysis of drone inspection results

- STEP1: Images shooting by drone
Use drones to acquire video and photos

- STEP2: Checking of all images by bridge engineers
Check all retrieved Image data
- STEP3: Extraction of Interest-Points
Detection of Interest Points (damaged or abnormal areas) by engineers
- STEP4: Interest-Point analysis and damage evaluation
Analysis and evaluation of the type, scope, and level of damage
- STEP5: Report on inspection results

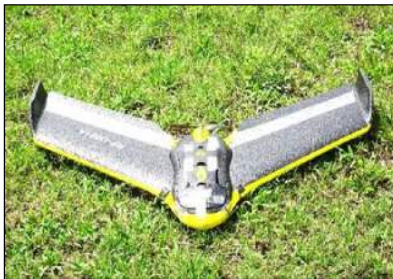
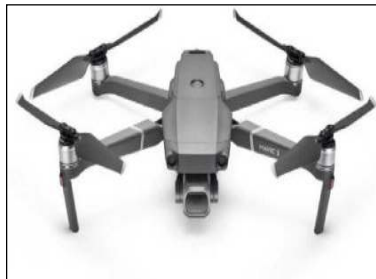
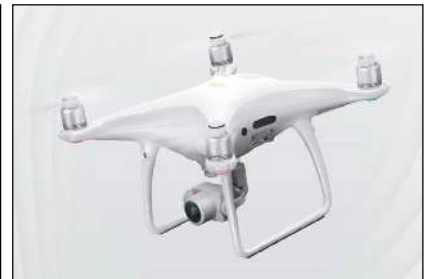
Photo 10-9 Type of Drones

Different types of drones shall be deployed depending on the type of operation to be conducted. Both fixed and rotor types of drones are suitable for area mapping. The former uses (Bridge Inspection) its wings that generate lift from the aircraft’s airspeed, while the latter is a propeller-based system having a set of rotor blades attached to the drone.

Fixed Type

Rotor Type

For taking tight shot photographs and video recordings, only the rotor type shall be used. The required drone maneuverings to obtain the necessary images makes fixed wings unfit to perform the task.

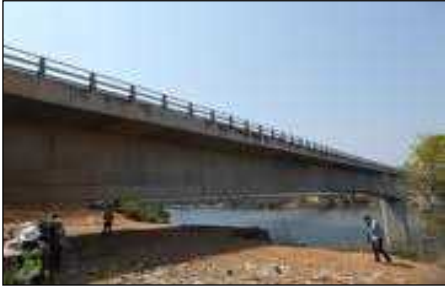
- Opened in 2002 with the financial aid of Japan
- Bridge Length:400.0m, Width:10.3m
- 3span-continuous PC Box Girder

- The height of the girders varies from 4.5 to 9.0 m.
- The height of the piers located on the river are also high, exceeding about more than 10 meters.

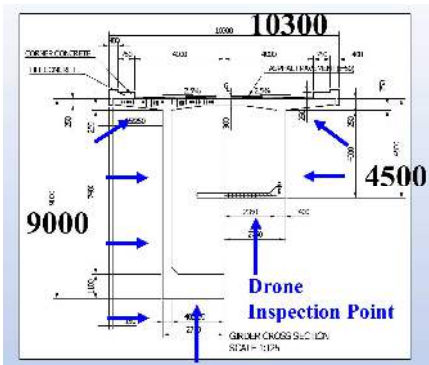
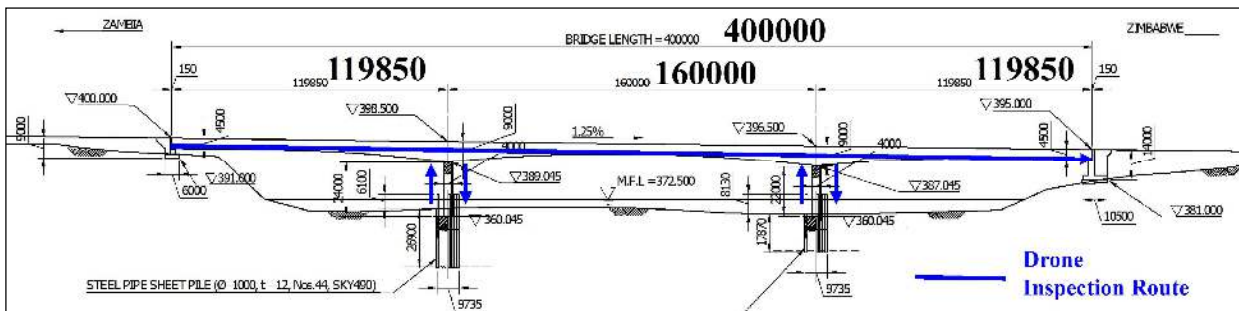
Figure 10-3 Points of Interest Survey and Inspection Route of Drone (Chirundu BRG)[Reference]

- Use of drone to inspect the following parts.
Side and bottom of girder, Overhang of slab,
Pier, Bearing etc.

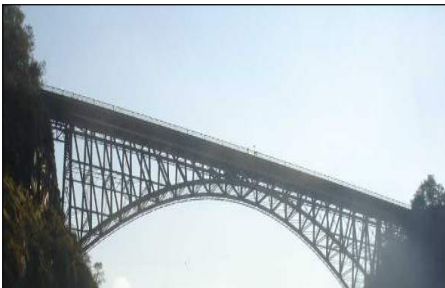
- Opened in 1905
- Bridge Length:198.2m
- Steel Arch Bridge
- Multi-purpose (Road and Rail)

- It is an arch bridge, and the height from the pier's bearing to the bridge surface is very high.
- There are many steel members in the bridge, and visual inspection method is very time consuming.

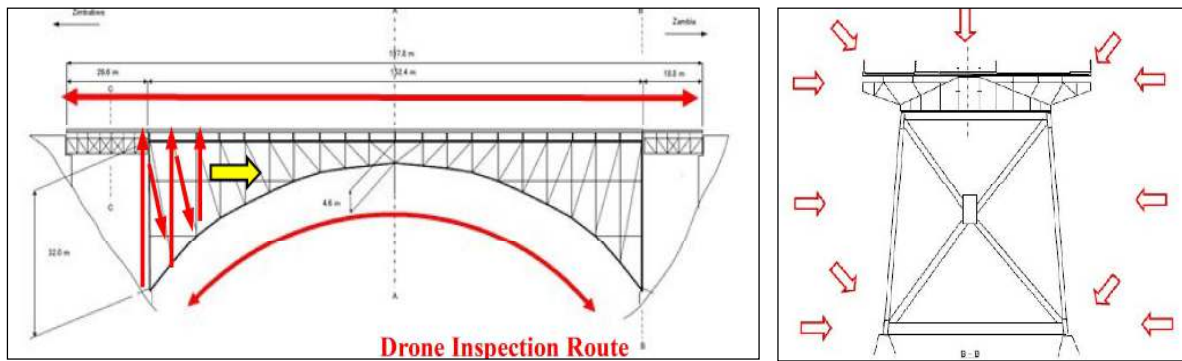
Figure 10-4 Points of Interest Survey and Inspection Route of Drone

- Use of drone to inspect the following damages.

(Victoria Falls Bridge) [Reference]

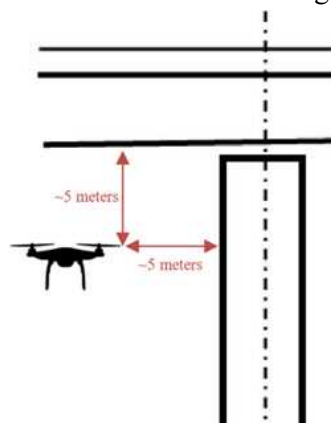
Figure 10-5 Safety Distance of Drone

When a certain quality in the report of the inspection by the drone is required, the skill of the photographer must be kept at a certain level. The appropriate distance between drone and object is about 5 m when shooting. It is to avoid drone colliding with the bridge when gust of wind is blowing. If the distance is far from the bridge, the accuracy of the picture will be lower. It requires considerable skill to always keep the distance of 5 m under the wind blowing condition.

Close-up video shall be taken at an approximate distance of 5 meters between the Drone and the structure as conditions would allow. While camera angles shall, as much as possible, accommodate the client requirements, these are still bound by hardware and safety limitations.

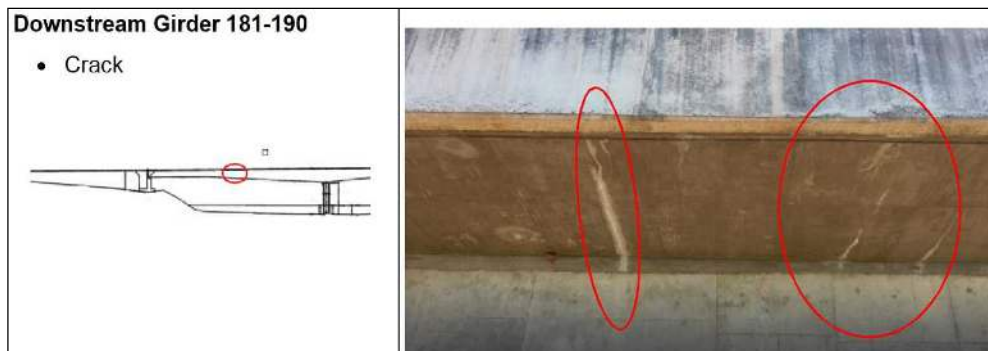
Photo 10-10 Isolated limes at Overhang of Slab

The videos and photos acquired at Chirundu Bridge were reviewed for damages. Damages mainly consisted of isolated limes and cracks on the concrete surface.

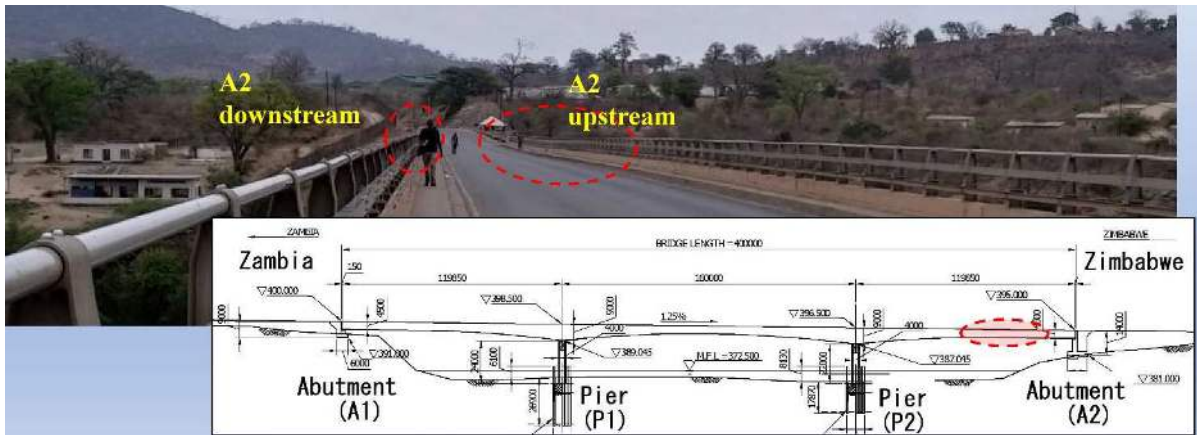
Photo 10-13 Sagging of the bridge surface (Between P2 and A2)

And, in the field check conducted in advance, slight settlement of the bridge surface was observed between P2 and A2 (Zimbabwe Side). The Gap of the abutment (A2) on the Zimbabwe side is larger in the upper part. (Upstream side.) This may indicate that the surface of the bridge is slightly settled between P2 and A2.

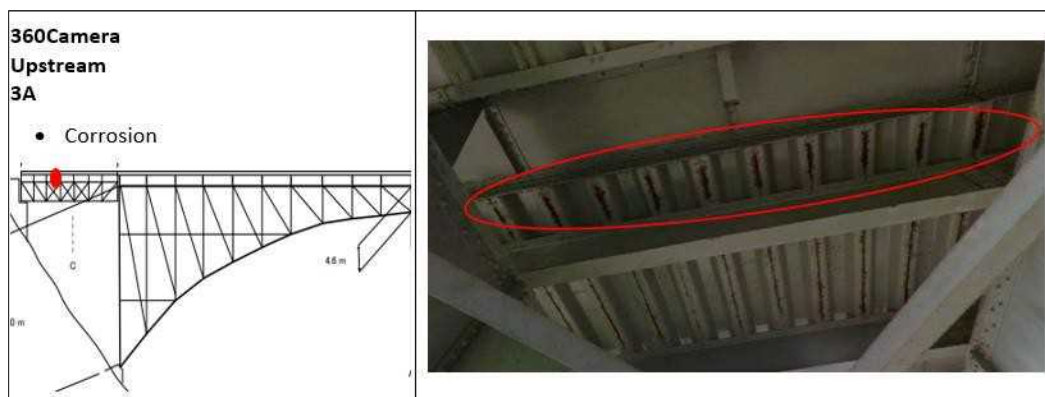
Photo 10-14 corrosion at bottom deck

- corrosion
- Missing bolt
- Buckling of steel member

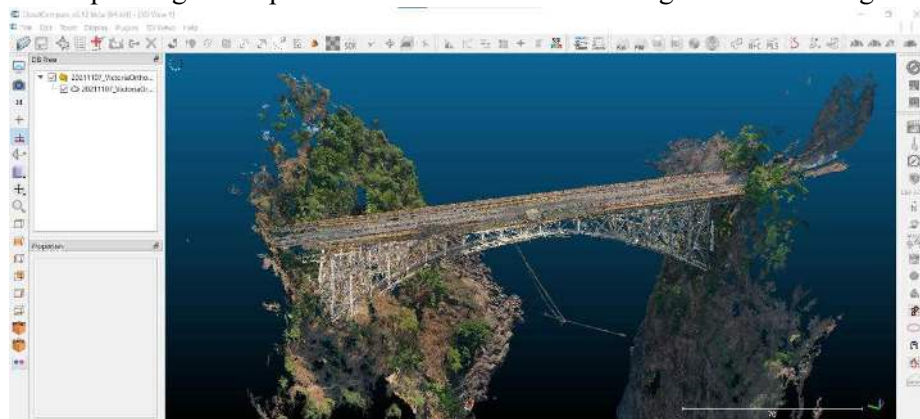
Figure 10-6 Point Cloud of Victoria Falls Bridge viewed using Cloud Compare software

Pix4d software was used to create a 3D model in the form of a point cloud of Victoria Falls Bridge from drone imagery. A point cloud is a set of data points in space where each point has 3D coordinates and color. It can be used to visualize the bridge and make measurements. The Victoria Falls Bridge point cloud can be viewed and measured using Cloud Compare, an open-source software for visualizing and measuring point clouds. The software can be downloaded from the following link: <https://www.cloudcompare.org/>. The point cloud of Victoria Falls Bridge is shown in Figure10-6 .

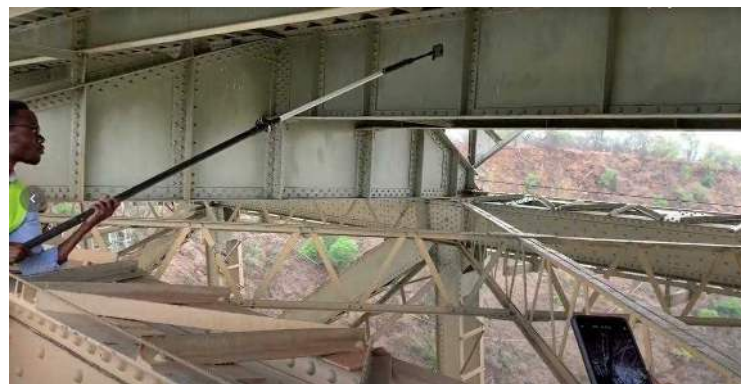
Photo 10-17 Interior areas of bridge capture using 360 camera mounted on range pole

The interior areas of the bridge under the road deck were inspected using 360 camera since it was difficult to safely fly drones in these enclosed spaces. The free software to view the 360 camera outputs of Victoria Falls Bridge that was used by the drone team is Render stuff. It can be accessed through the following link: <https://renderstuff.com/tools/360-panorama-web-viewer/>. Photo 10-17 shows how the interior areas of Victoria Falls Bridge were captured by 360 Camera. Photo 10-18 shows a raw 360 image of an interior section of the bridge while Figure 3.7 shows the rendered image which can be panned and zoomed using Render stuff application. The inspection methods of the different sections of the bridge are summarized in Table 10-1.

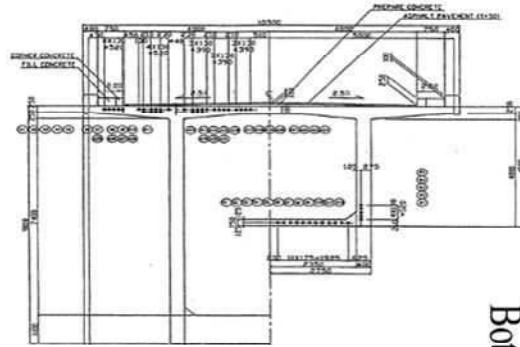
【Damage Drawing】

Bottom of Box girder and side deck slab

Web (Left side)

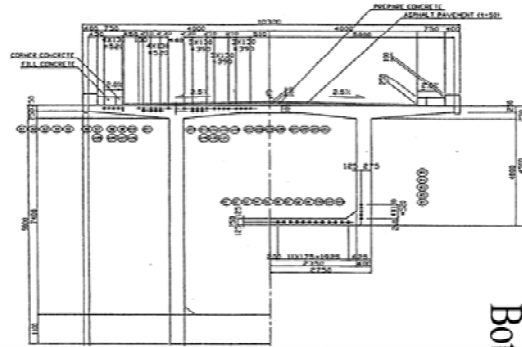
【Damage Drawing】

P1
Web (Left side)

Bottom of Box girder and side deck slab

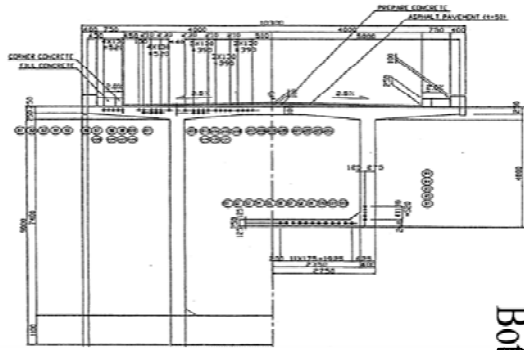
【Damage Drawing】

Web (Left side)

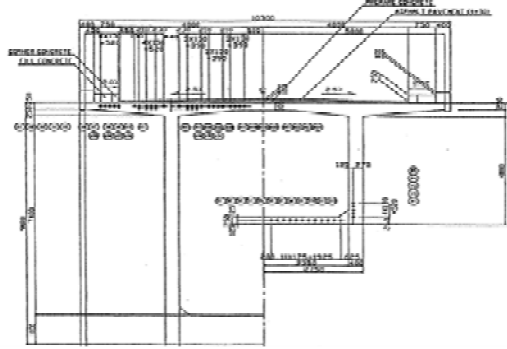
【Damage Drawing】

A1
Web (Left side)

Slab

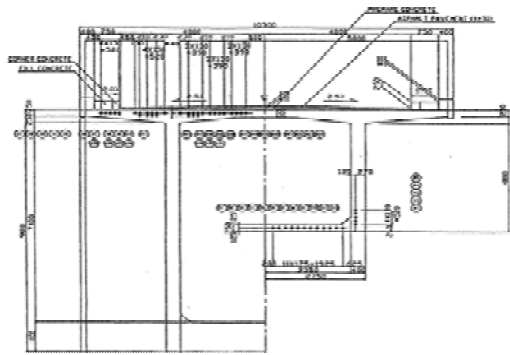
【Damage Drawing】

Web (Left side)

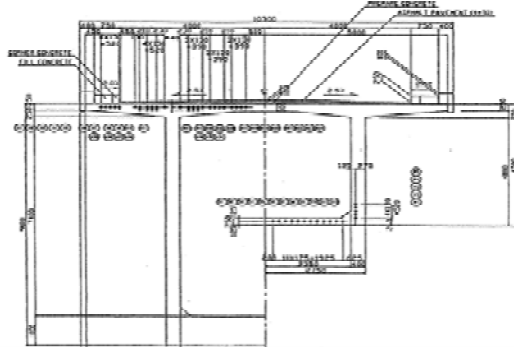
[Damage Drawing]

Web (Left side)

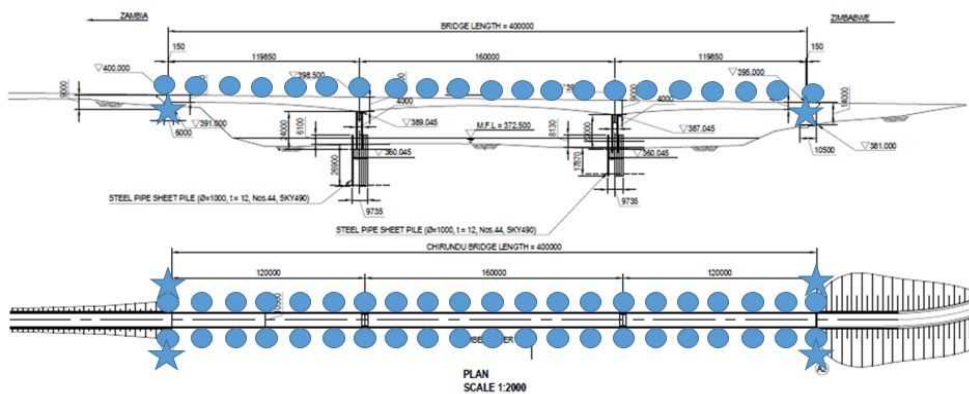
- Leveling measure point for deck surface
- ★ Leveling measure point for abutment surface

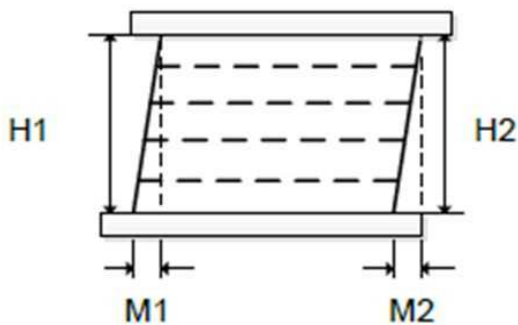
Bearing

Measure every bearing (everytime use same marking point)

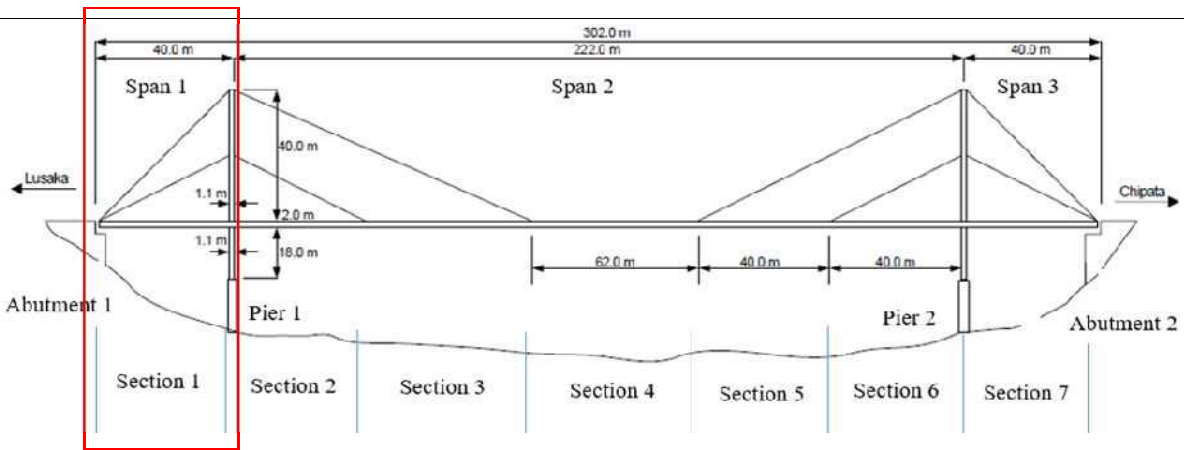
【Damage Drawing】

Railing and Guardrail (left side)

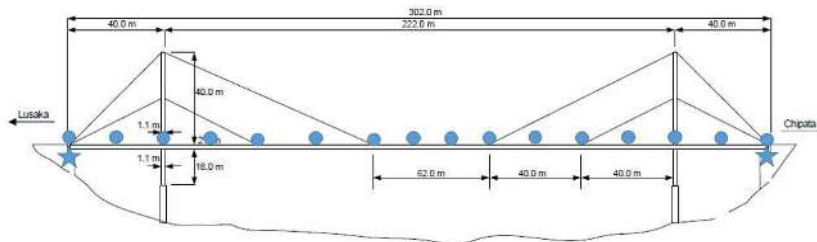
- Leveling measure point for deck surface
- ★ Leveling measure point for abutment surface

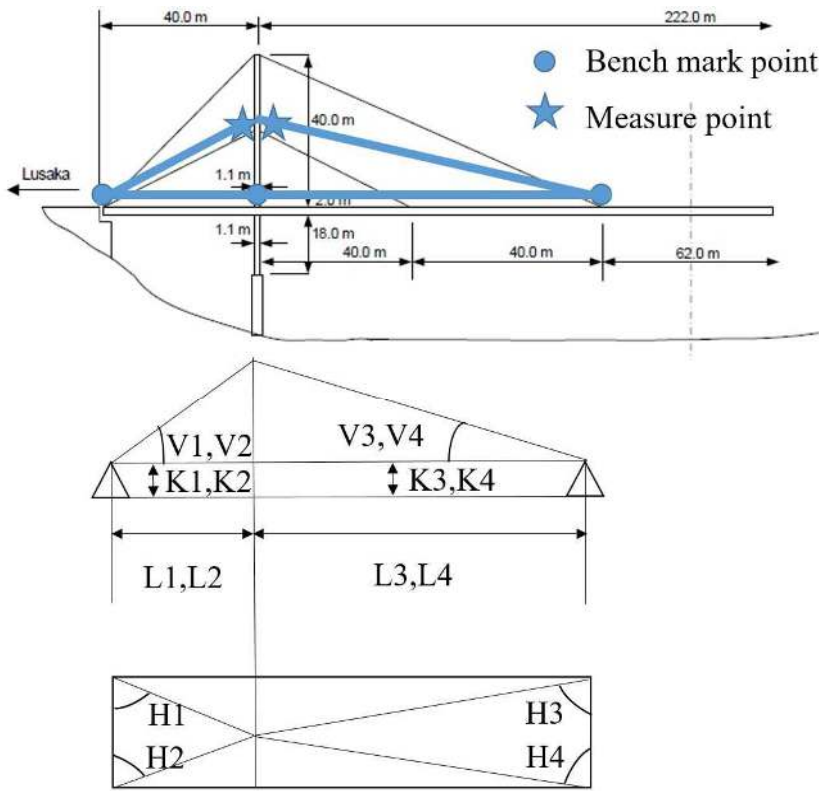
Measure	Place	1968	2021	Difference	Remark
Angle (Vertical)	K1+L1tanV1				
	K2+L2tanV2				
	K3+L3tanV3				
	K4+L4tanV4				
Angle (Vertical)	K5+L5tanV5				
	K6+L6tanV6				
	K7+L7tanV7				
	K8+L8tanV8				
Angle (Horizontal)	L1/tanH1				
	L2/tanH2				
	L3/tanH3				
	L4/tanH4				
Angle (Horizontal)	L5/tanH5				
	L6/tanH6				
	L7/tanH7				
	L8/tanH8

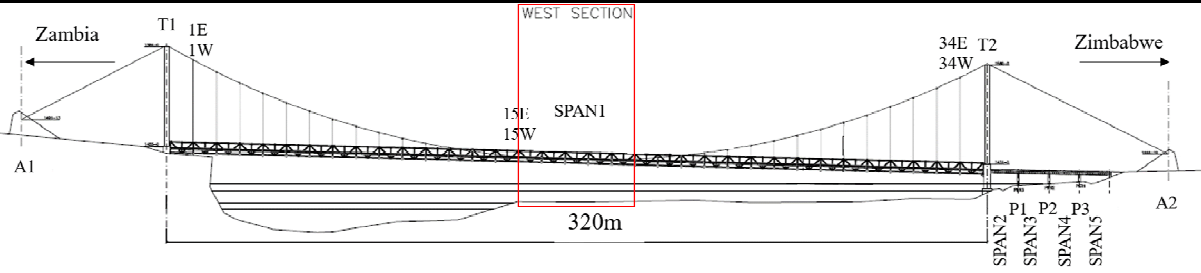
Bridge Number		Span	1	Section	4
---------------	--	------	---	---------	---

Railing (left side)

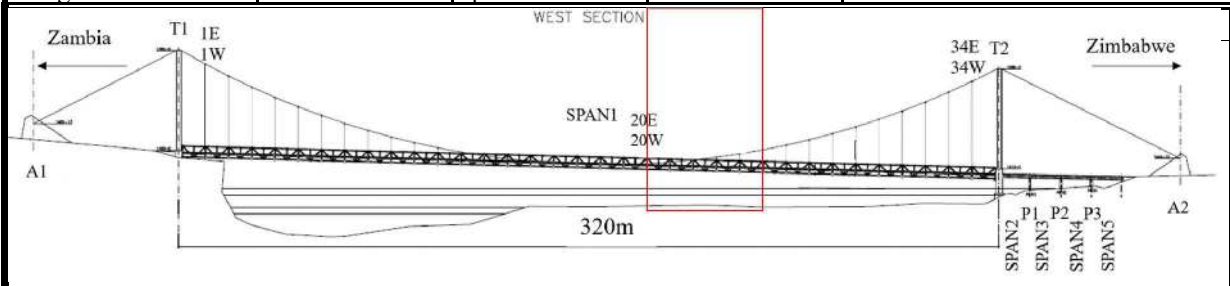
Bridge Number	Span	1	Section	5
---------------	------	---	---------	---

Railing (left side)

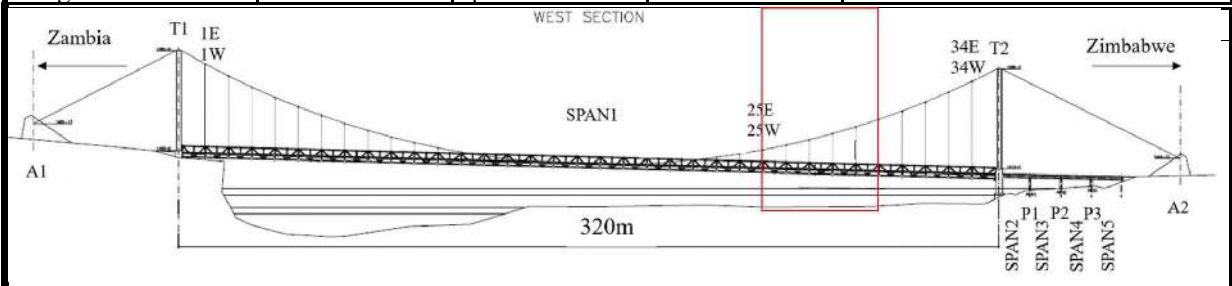
Bridge Number		Span	1	Section	6
---------------	--	------	---	---------	---

Railing (left side)

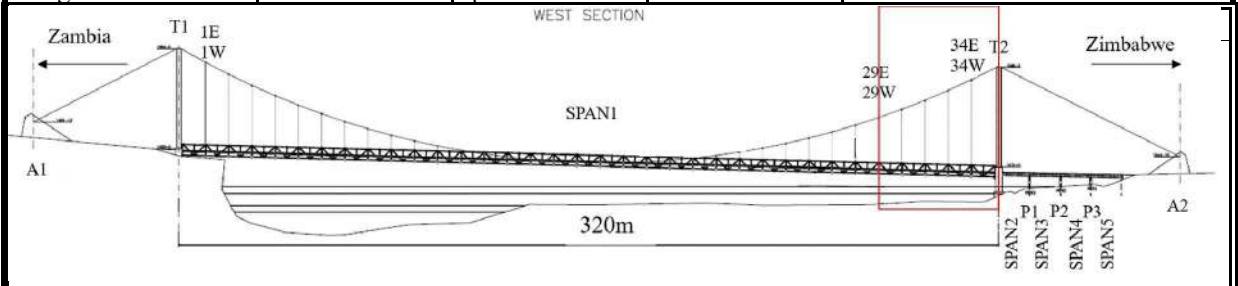
Bridge Number		Span	1	Section	7
---------------	--	------	---	---------	---

Railing (left side)

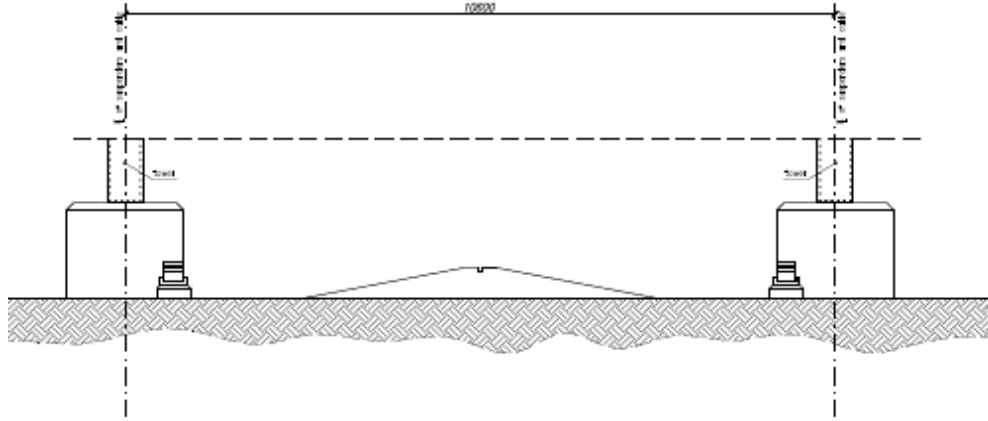
PLAN ABUTMENT
SC. 130

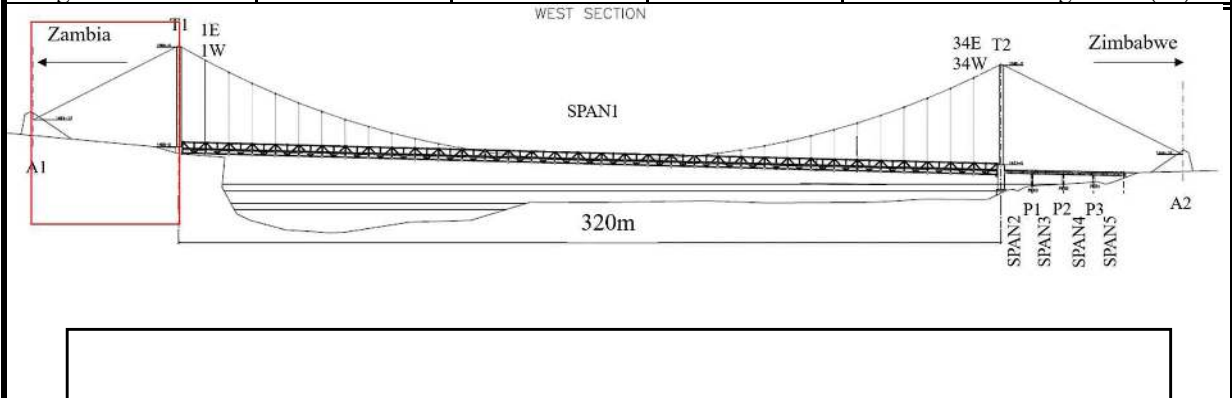
Bridge Number	Cable	Main cable	right side (W)
---------------	-------	------------	----------------

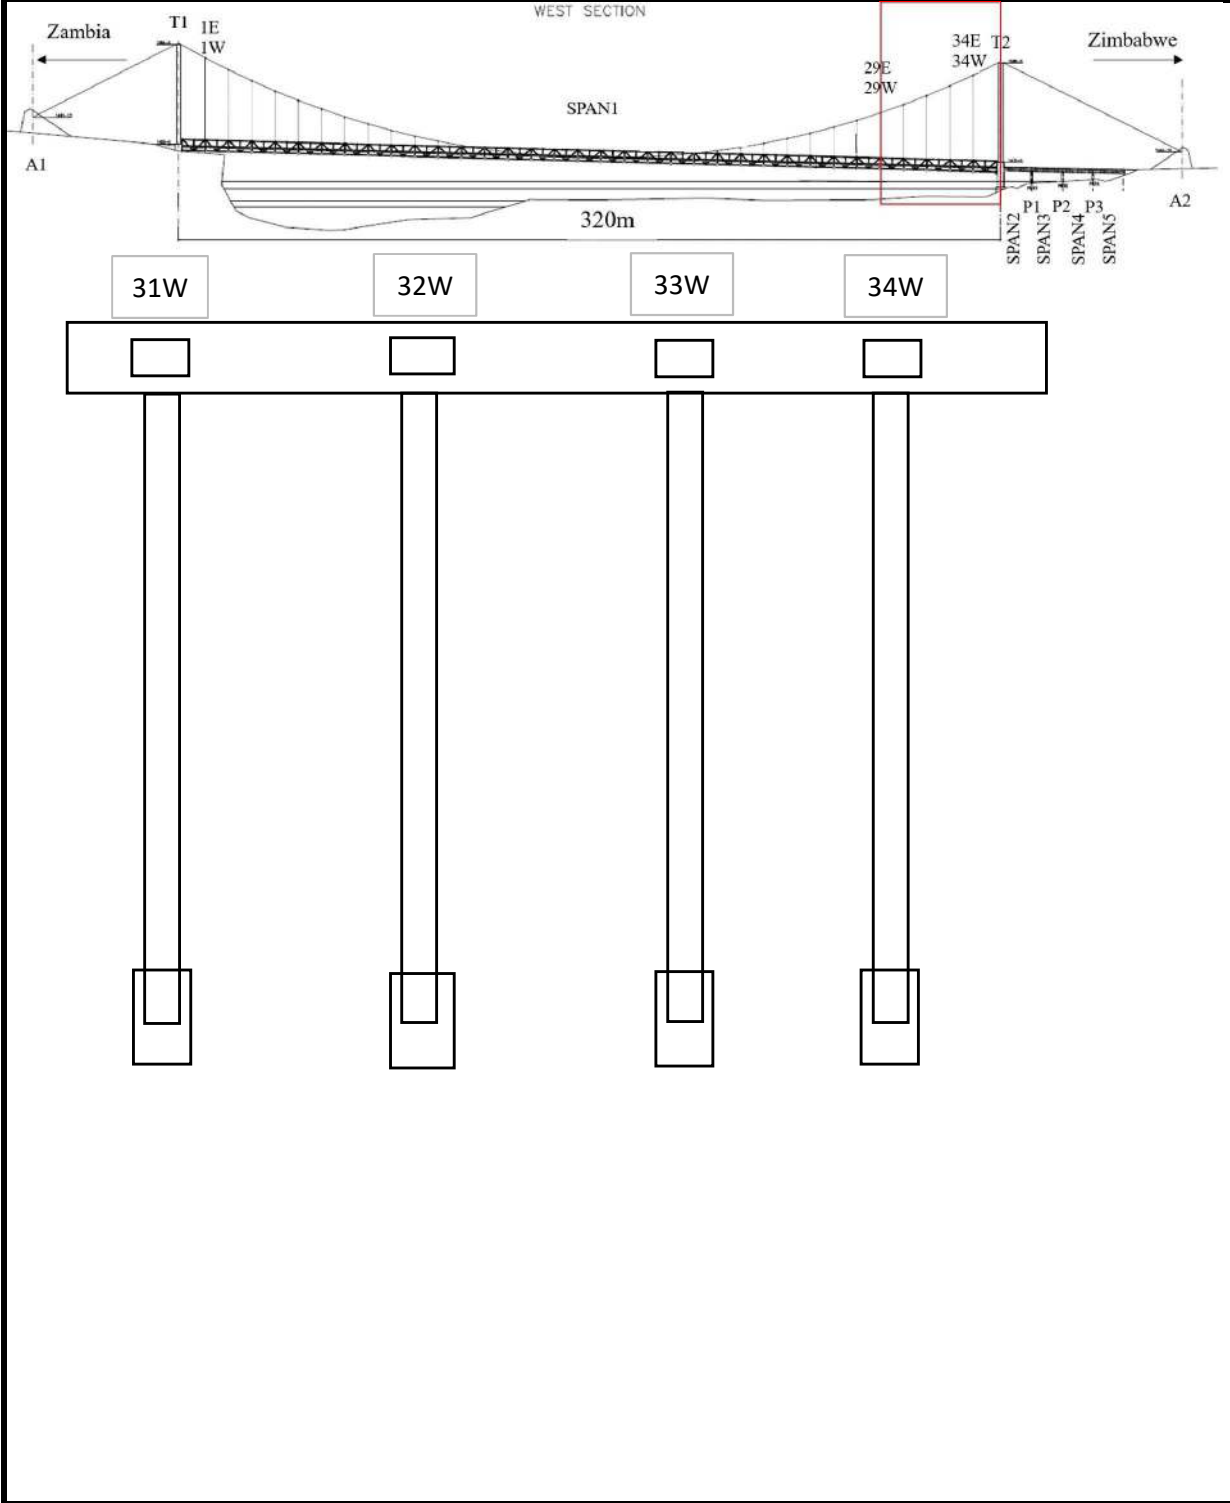
Bridge Number		Cable	Main cable and Hanger rope	right side (W)
---------------	--	-------	----------------------------	----------------

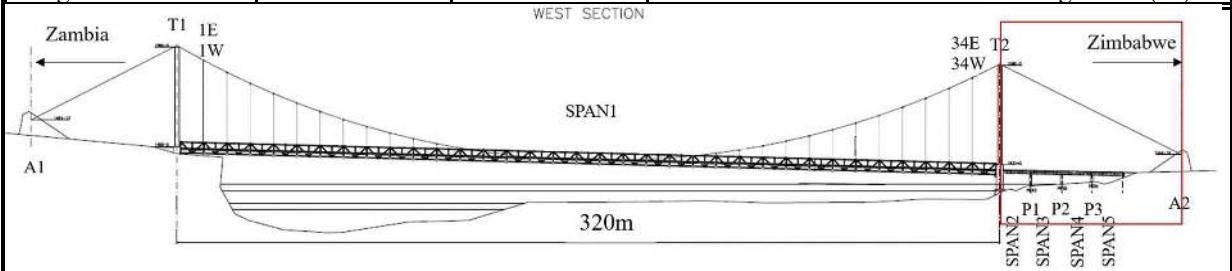
Bridge Number _____ Cable _____ Main cable _____ right side (W)

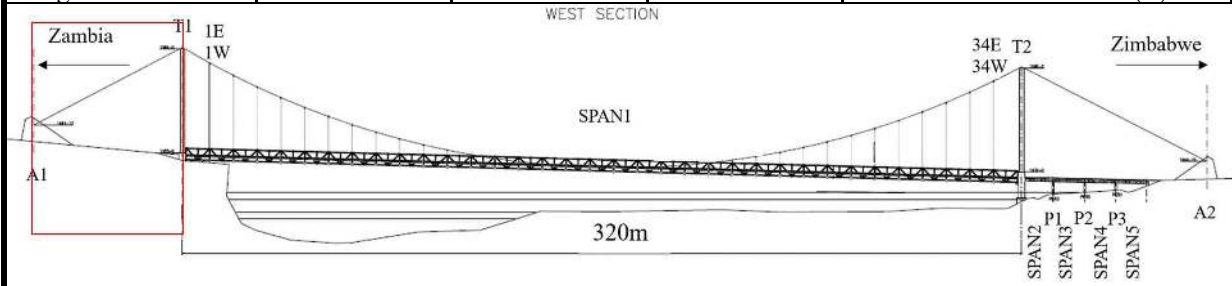
Bridge Number _____ Cable _____ Main cable _____ left side (E)

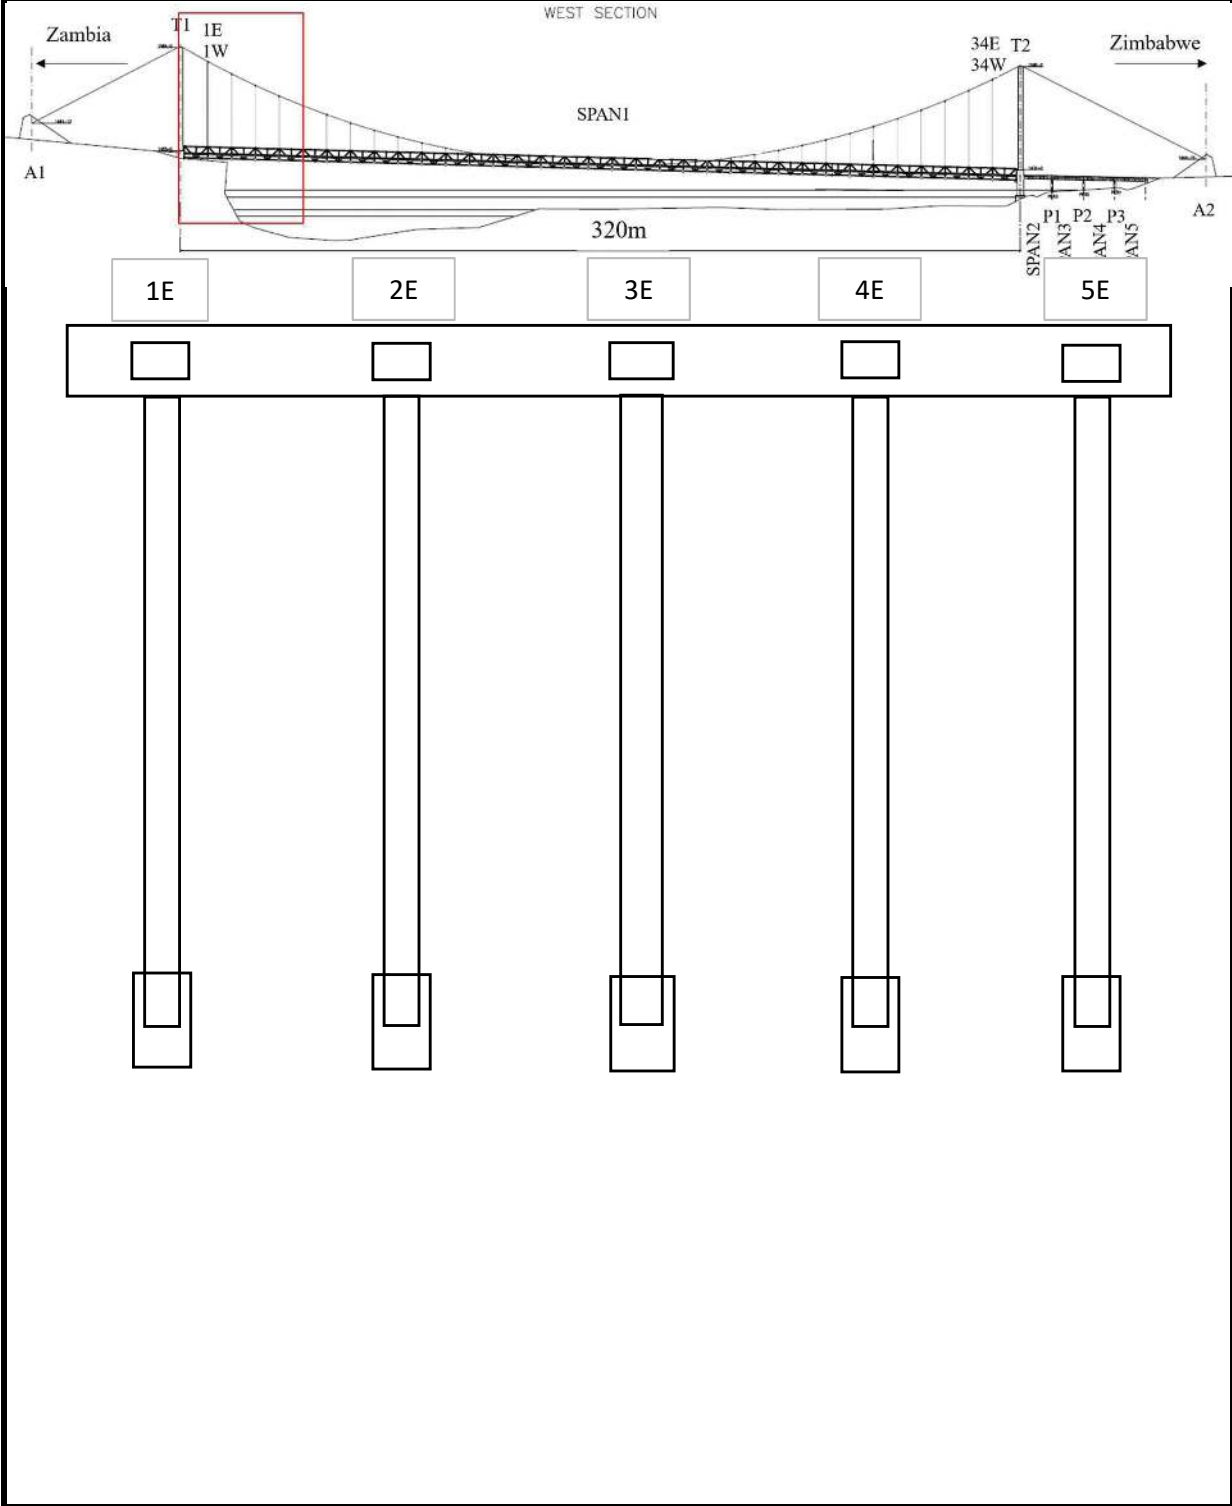
Bridge Number _____ Cable _____ Main cable and Hanger rope _____ left side (E)
