BRIDGE MAINTENANCE CAPACITY BUILDING IN ZAMBIA

BRIDGE INSPECTION GUIDEBOOK

2024

**Road Development Agency
Japan International Cooperation Agency**

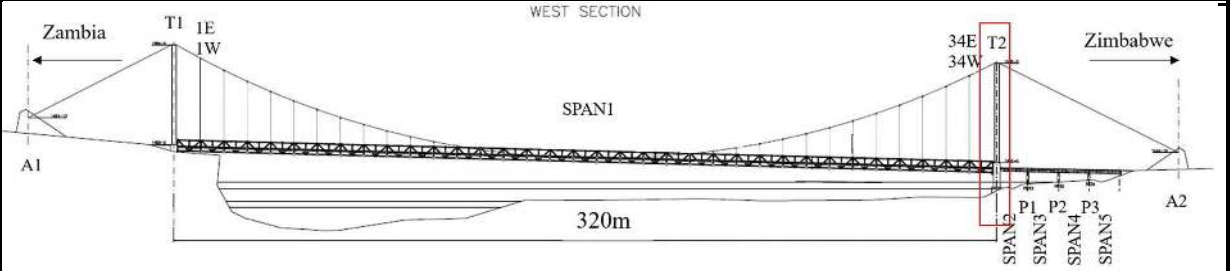
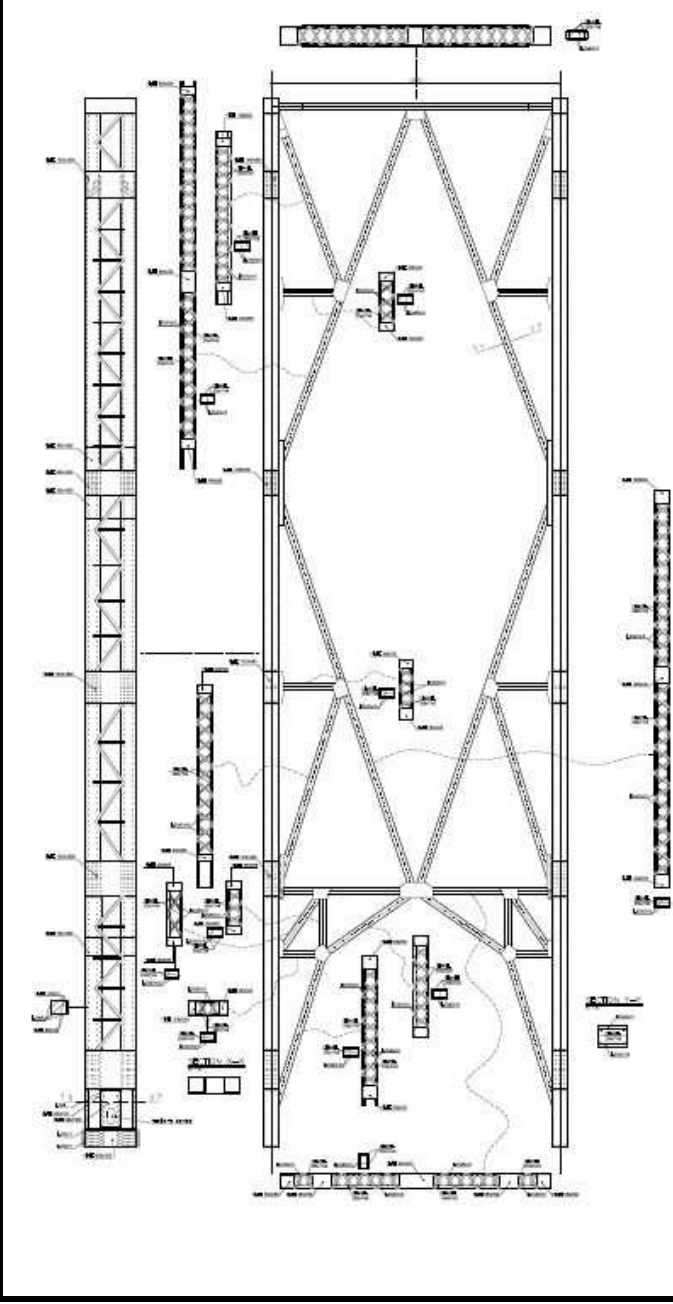
Bridge Number _____ Tower _____

Left Side		Right Side	
Left	Right	Left	Right

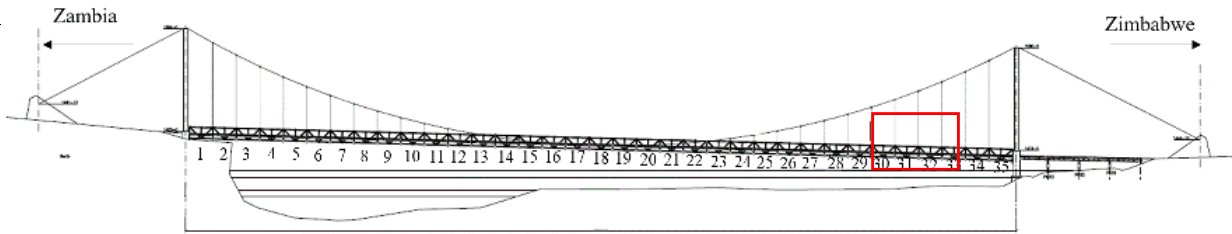
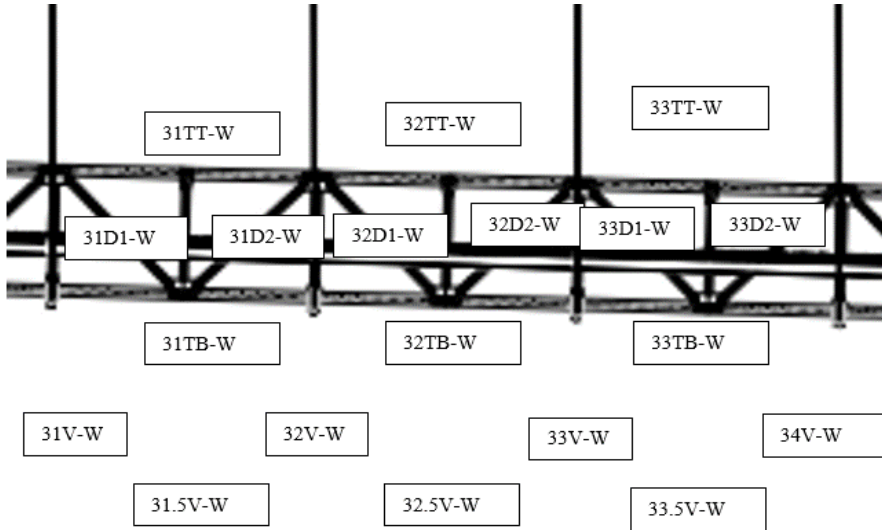
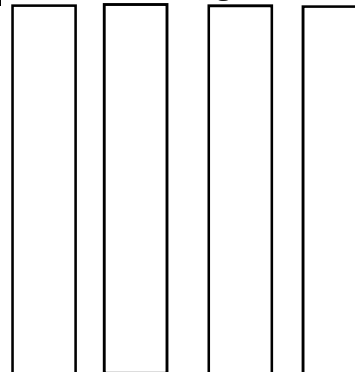
【Damage Drawing】

member name

OTT-△

※○: number

△: E or W (east or west)

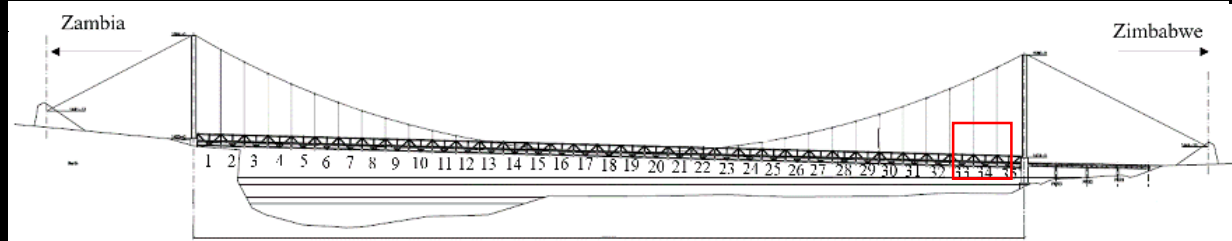
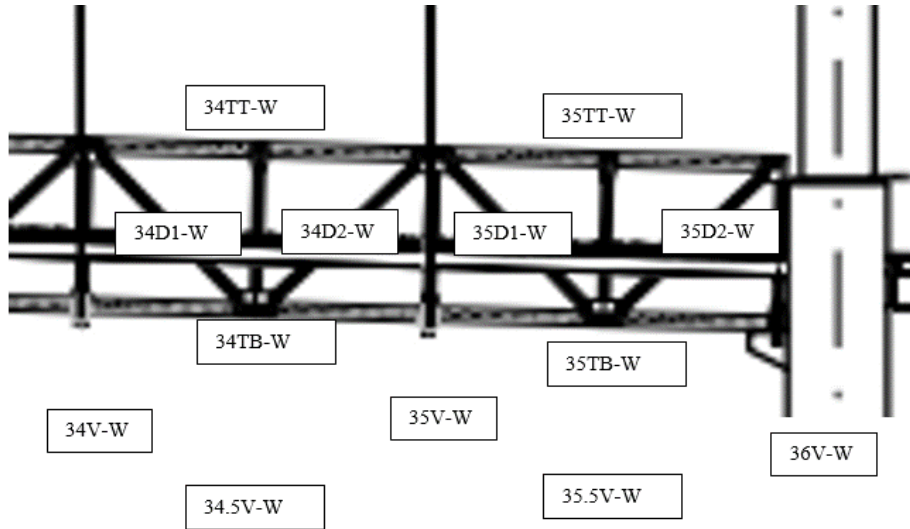
【Damage Drawing】

member name

OTT-△

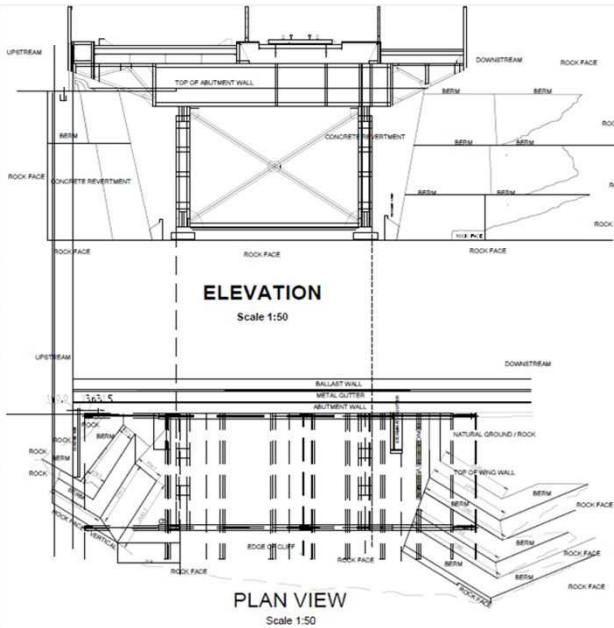
A2

ZAMBIA ABUTMENT

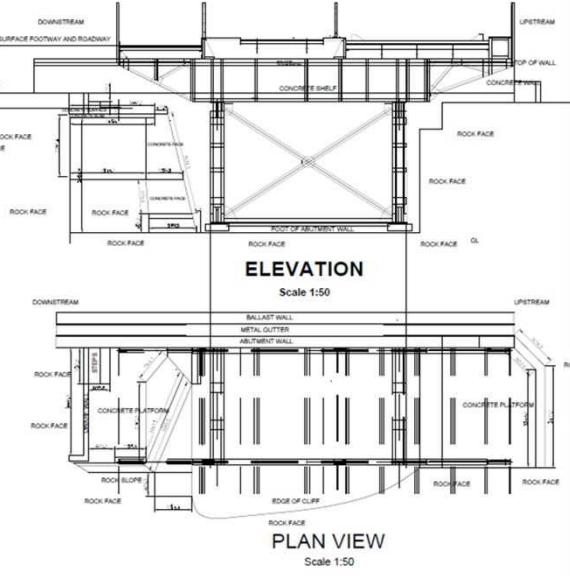
A1

ZIMBABWE ABUTMENT

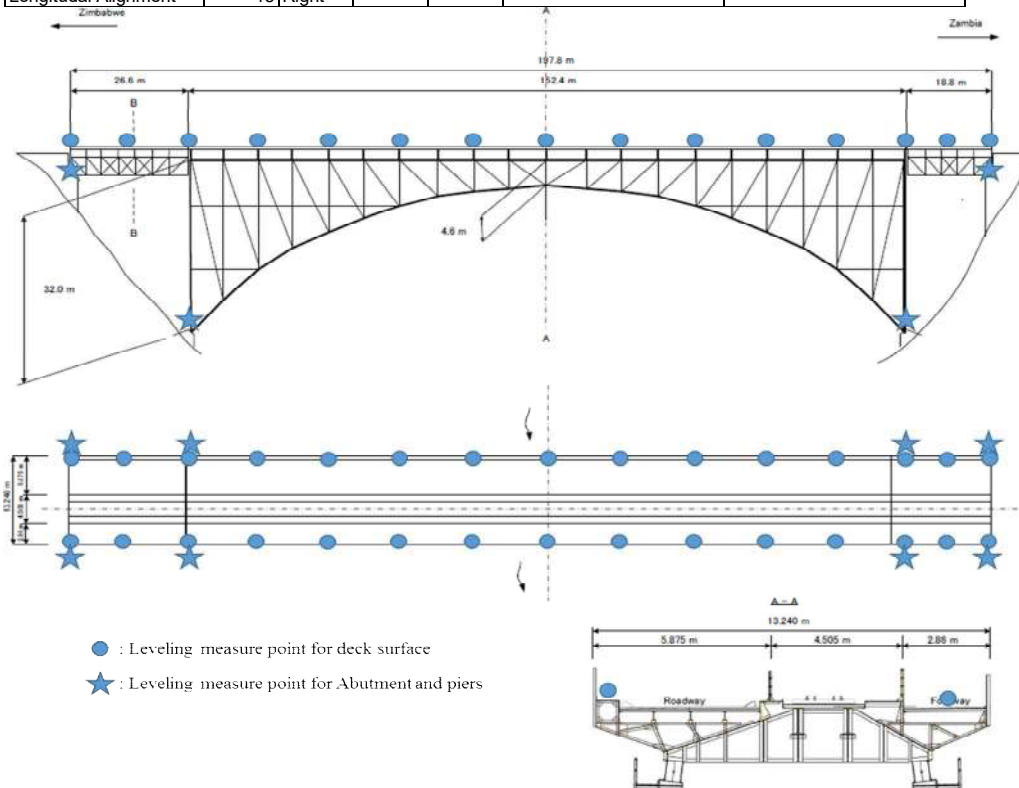
Element	Place	1905	2022	Difference	Remark
Abutment 1	Left				
	Right				
Abutment 2	Left				
	Right				
Springing 1	Left				
	Right				
Springing 2	Left				
	Right				
Longitudal Alignment	1 Left				
Longitudal Alignment	2 Left				
Longitudal Alignment	3 Left				
Longitudal Alignment	4 Left				
Longitudal Alignment	5 Left				
Longitudal Alignment	6 Left				
Longitudal Alignment	7 Left				
Longitudal Alignment	8 Left				
Longitudal Alignment	9 Left				
Longitudal Alignment	10 Left				
Longitudal Alignment	11 Left				
Longitudal Alignment	12 Left				
Longitudal Alignment	13 Left				
Longitudal Alignment	14 Left				
Longitudal Alignment	15 Left				
Longitudal Alignment	1 Right				
Longitudal Alignment	2 Right				
Longitudal Alignment	3 Right				
Longitudal Alignment	4 Right				
Longitudal Alignment	5 Right				
Longitudal Alignment	6 Right				
Longitudal Alignment	7 Right				
Longitudal Alignment	8 Right				
Longitudal Alignment	9 Right

Longitudal Alignment	10 Right				
Longitudal Alignment	11 Right				
Longitudal Alignment	12 Right				
Longitudal Alignment	13 Right				
Longitudal Alignment	14 Right				
Longitudal Alignment	15 Right

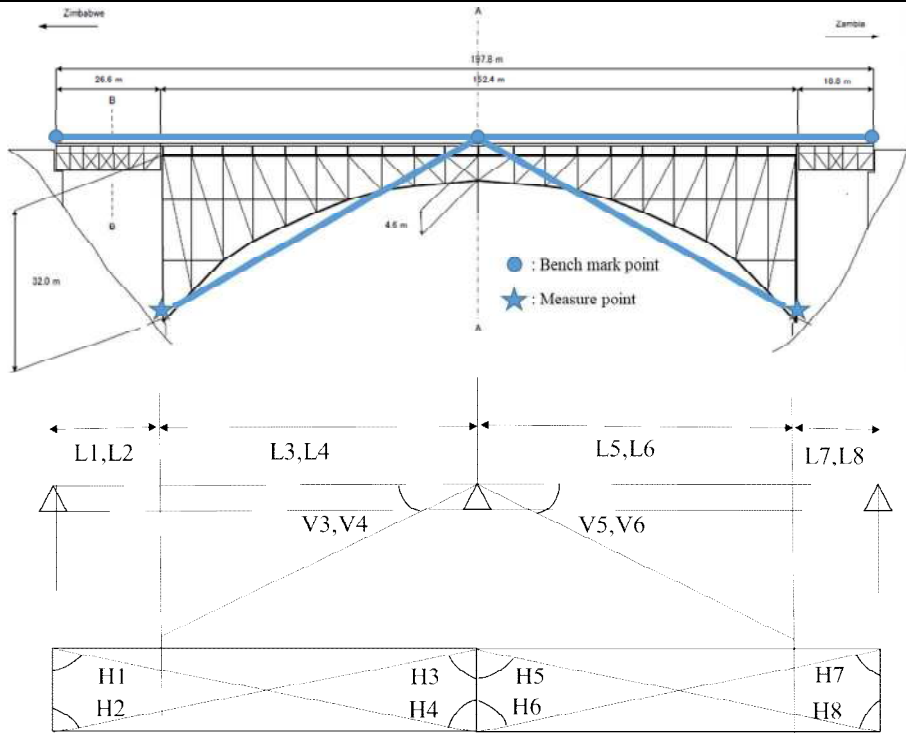
Measure	Place	1905	2021	Difference	Remark
Angle (Vertical)	L1tanV1				
	L2tanV2				
	L3tanV3				
	L4tanV4				
Angle (Vertical)	L5tanV5				
	L6tanV6				
	L7tanV7				
	L8tanV8				
Angle (Horizontal)	L1/tanH1				
	L2/tanH2				
	L3/tanH3				
	L4/tanH4				
Angle (Horizontal)	L5/tanH5				
	L6/tanH6				
	L7/tanH7				
	L8/tanH8

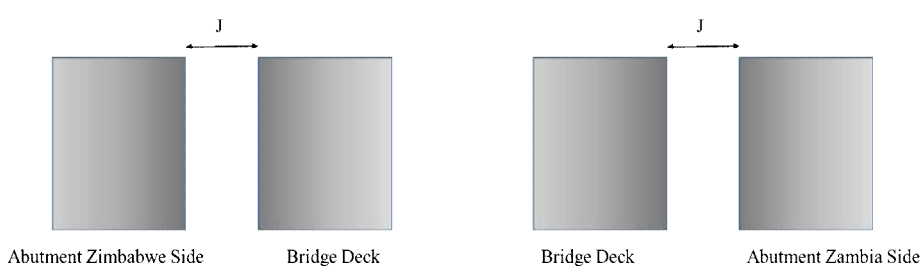
Expansion Joint

Measure	Place	1905	2022	Difference	Remark
Abutment 1	expansion Joint J				
Abutment 2	expansion Joint J

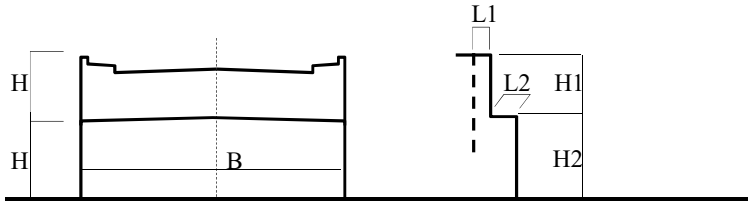
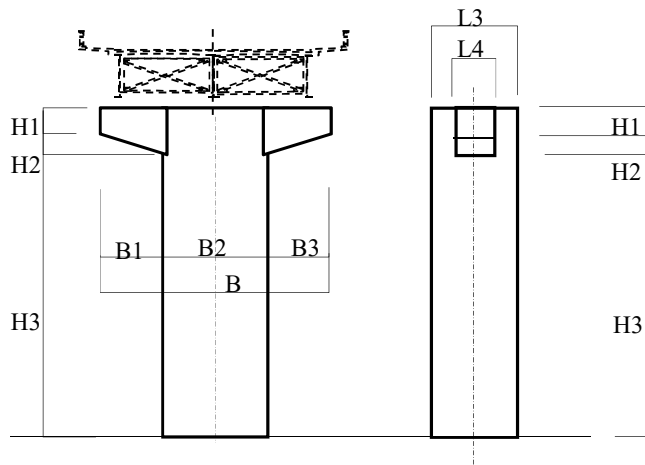
Steel Girder Measurement			
Depth of Girder and Flange Width			
Section	Component	l(m)	Remarks
S1	S	11.4	
	H	0.71	
	B1	0.255	
S2	S	13.2	
	H	0.71	
	B1	0.255	
S3	S	11.4	
	H	0.71	
	B1	0.255	
S4	S		
	H		
	B1		
S5	S		
	H		
	B1		
	S		
	H		
	B1		
	S		
	H		
	B1		
	S		
	H		
	B1		
	S		
	H		
	B1

Abutment and Pier Measurement			
Height and Width			
No.	Component	L (m)	Remarks
A1	H1	1.1	
	H2	0.4	
	B	9	
	L1		
P1	L2	0.45	
	H1	1	
	H2	0	
	H3	4.6	
	B	6.1	
	B1	1.67	
	B2	6.1	
	B3	1.67	
	L3	0.7	
	L4		
P2	H1	0.9	
	H2	0	
	H3	4.9	
	B	6.1	
	B1	1.67	
	B2	6.1	
	B3	1.67	
	L3	0.7	
L4			
P3	H1		
	H2		
	H3		
	B		
	B1		
	B2		
	B3		
	L3		
P4	L4		
	H1		
	H2		
	H3		
	B		
	B1		
	B2		
	B3		
	L3		
	L4		
	H1		
	H2		
	H3		
	B		
	B1		
	B2		
	B3		
	L3		
	L4		
	H1		
	H2		
	H3		
	B		
	B1		
	B2		
	B3		
	L3		
	L4		
	H1		
	H2		
	H3		
	B		
	B1		
	B2		
	B3		
	L3		
	L4		
	H1		
	H2		
	H3		
A2	B	9	
	L1		
	L2	0.45	
	H1	1.1	
	H2	0.4

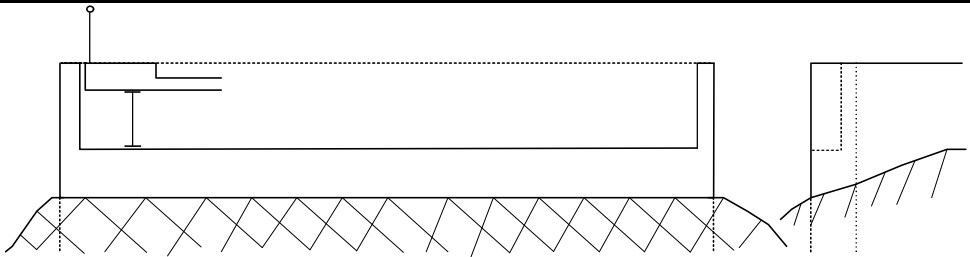
A1

Abutment

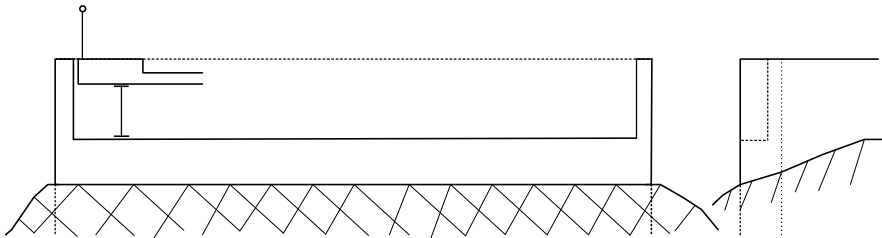
A2

Abutment

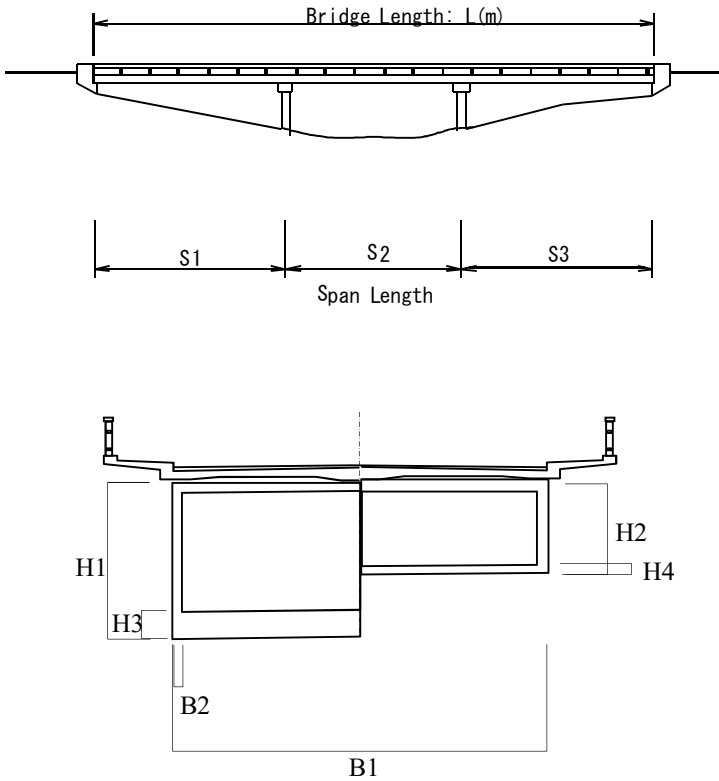
Steel Girder Measurement			
Depth of Girder and Flange Width			
Section	Component	l(m)	Remarks
S1	S	119.85	
	H1	8.5	
	H2	4	
	H3	1.1	
	H4	0.25	
	B1	5.5	
S2	S	160	
	H1	8.5	
	H2	4	
	H3	1.1	
	H4	0.25	
	B1	5.5	
S3	S	119.85	
	H1	8.5	
	H2	4	
	H3	2.1	
	H4	0.25	
	B1	5.5	
	B2	0.4

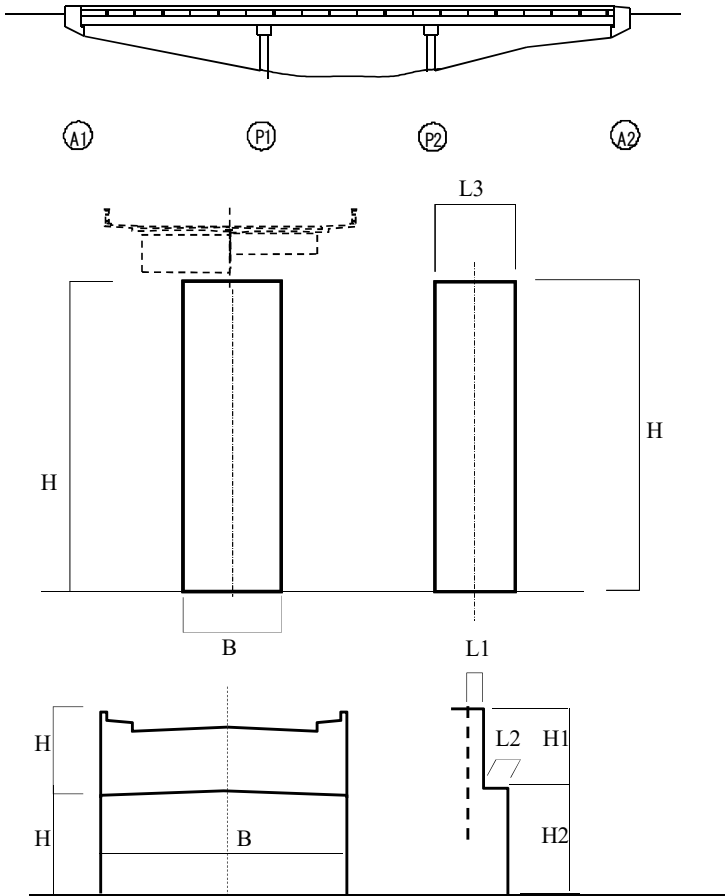
Height and Width			
No.	Component	L (m)	Remarks
A1	H1	5.08	
	H2	1.902	
	B	10.3	
	L1	0.7	
	L2	1.8	
P1	H	24	
	B1	7	
	L3	4	
P2	H	22	
	B1	7	
	L3	4	
A2	H1	5.05	
	H2	6.932	
	B	10.3	
	L2	1.8

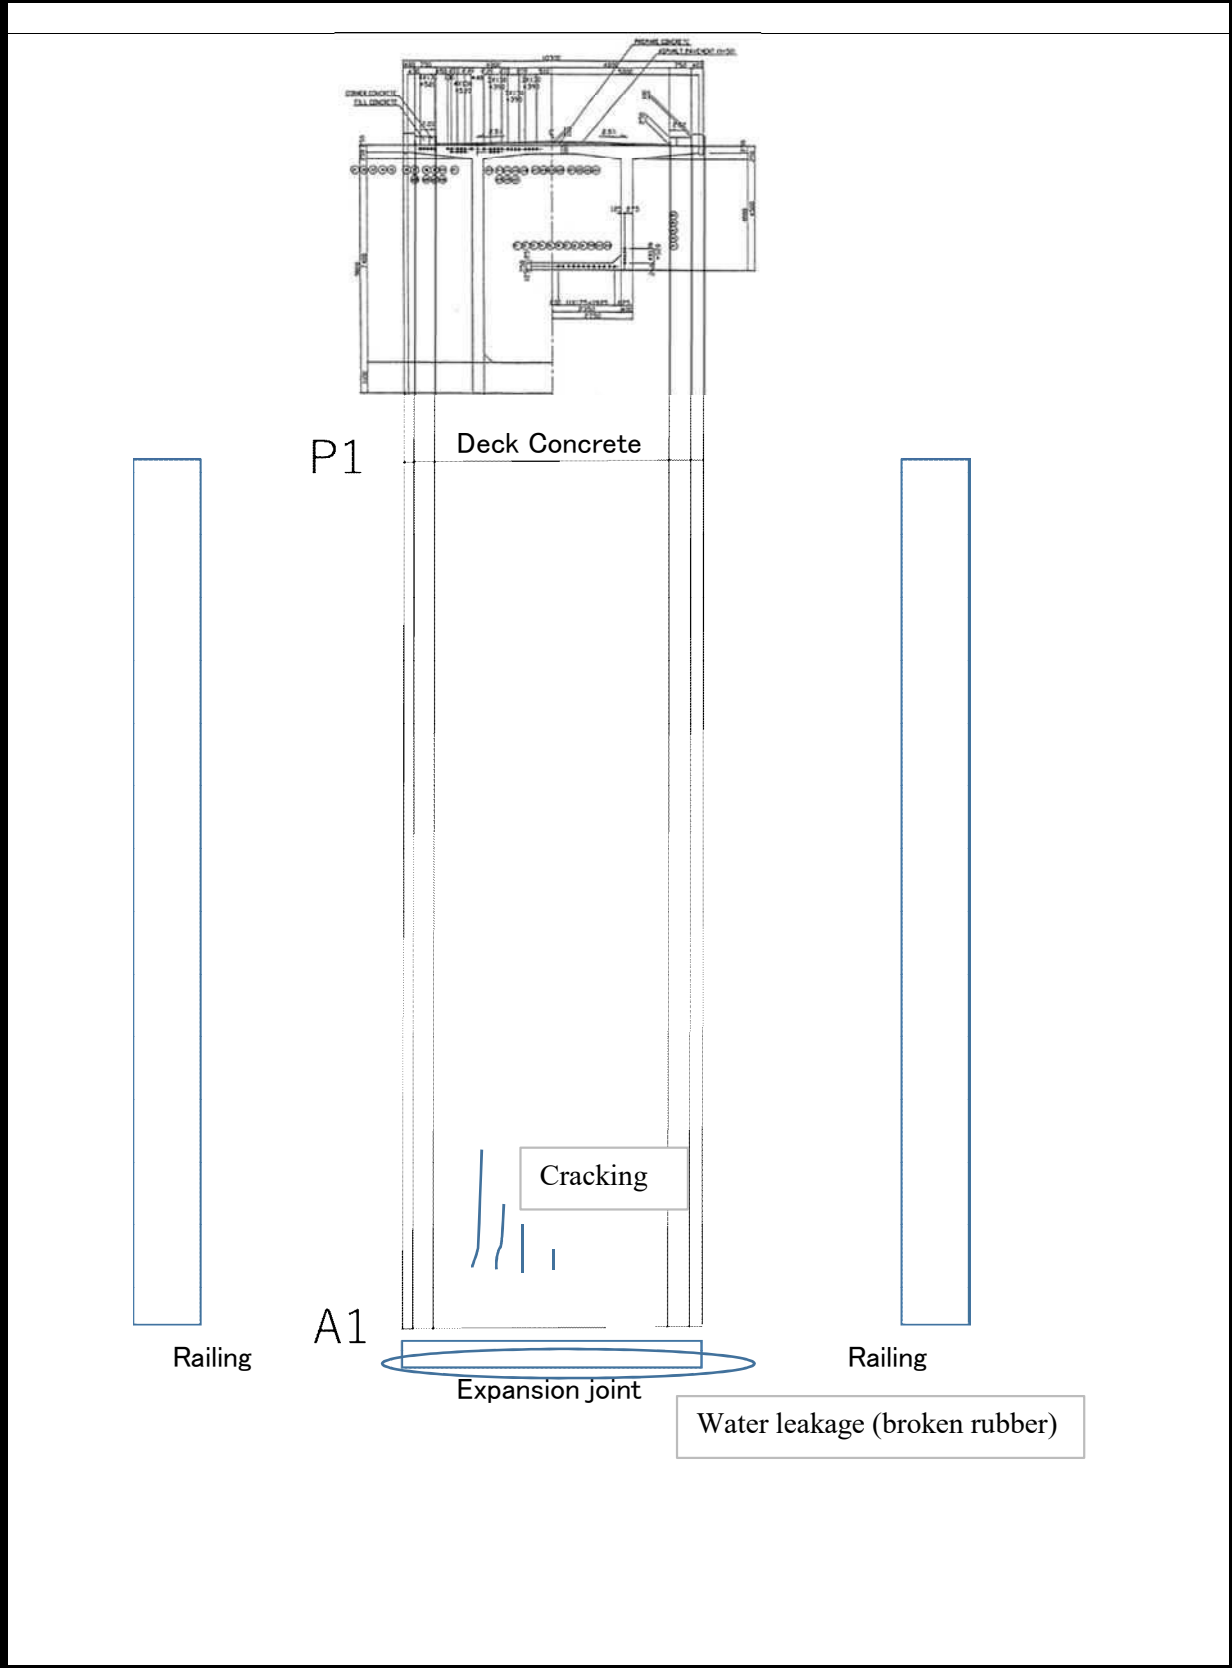
Bridge Number	Span	1
---------------	------	---

【Damage Drawing】

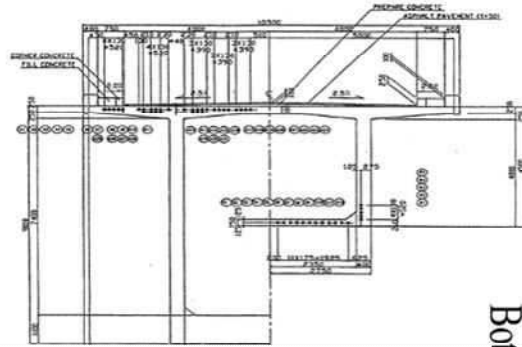
Bottom of Box girder and side deck slab

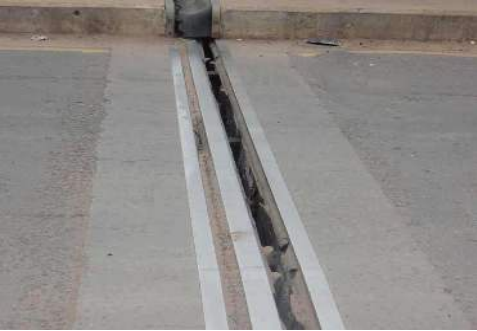
rubber at expansion joint is broken	Comment

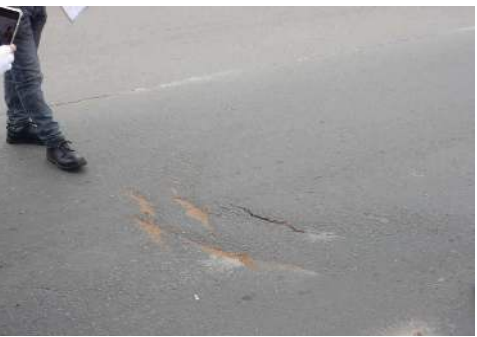
Cracking at road surface	Comment

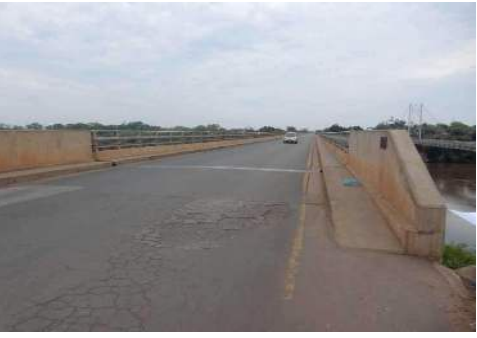
Alligator crack on approach road surface	Comment

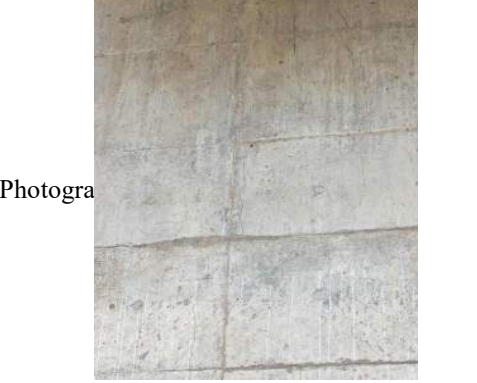
cracking at A2	Comment

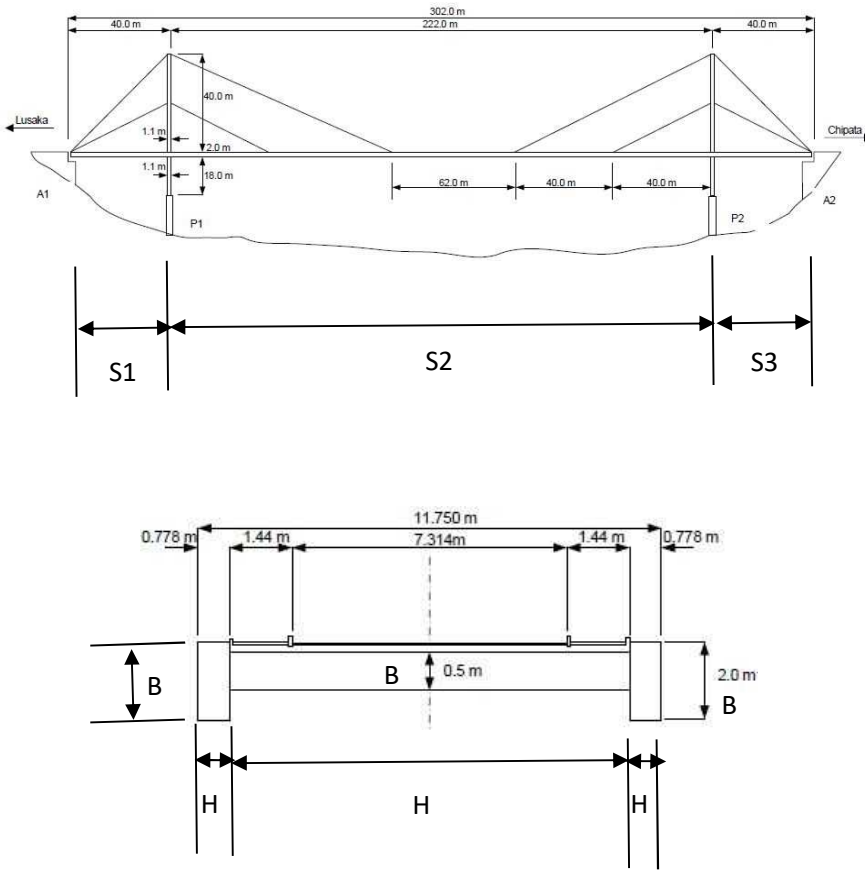
Steel Girder Measurement			
Depth of Girder and Flange Width			
Section	Component	l(m)	Remarks
S1	S	40	
	H1	0.778	
	H2	10.194	
	H3	0.778	
	B1	2.0	
	B2	0.5	
S2	S	222	
	H1	0.778	
	H2	10.194	
	H3	0.778	
	B1	2.0	
	B2	0.5	
S3	S	40	
	H1	0.778	
	H2	10.194	
	H3	0.778	
	B1	2.0	
	B2	0.5

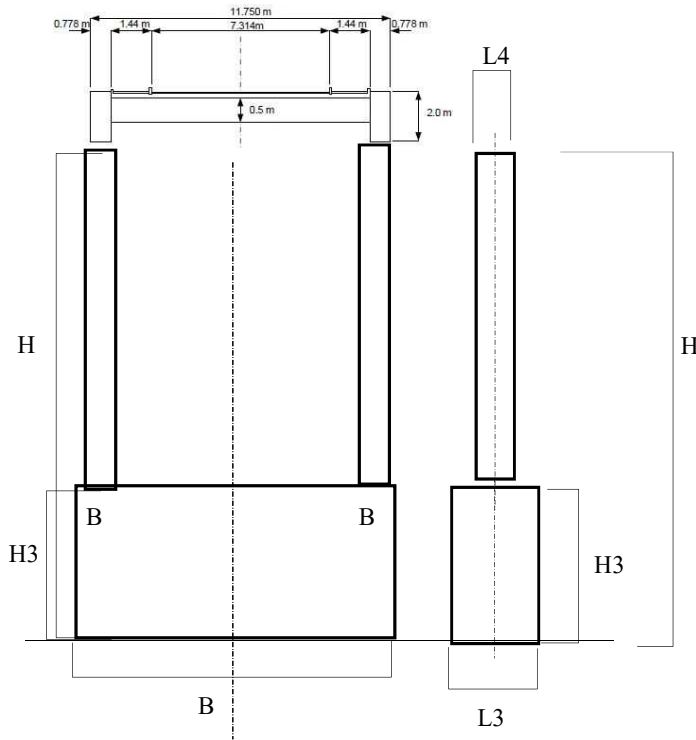
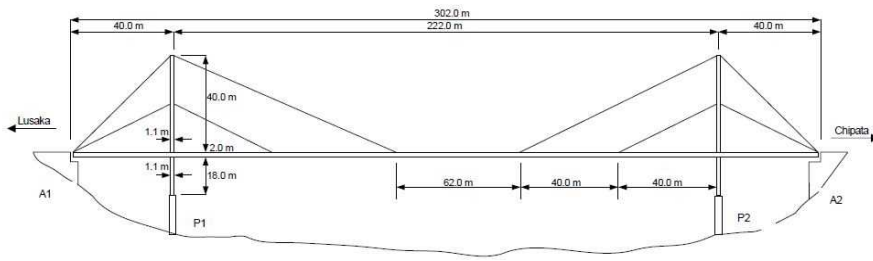
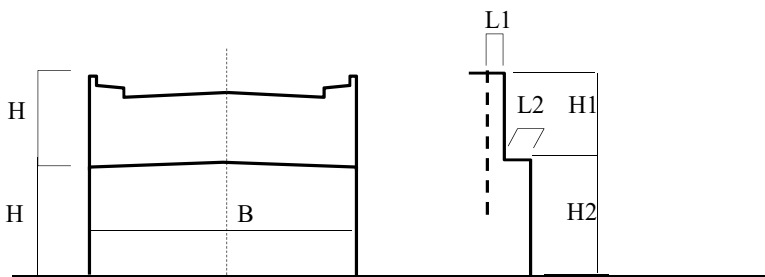
Height and Width			
No.	Component	L (m)	Remarks
A1	H1	3.5	
	H2		
	B	12.83	
	L1	0.49	
	L2	2.33	
P1	H		
	H3	8.76	
	B1	13.86	
	B2	1.18	
	B3	1.18	
	L3	1.7	
	L4	1.0	
P2	H		
	H3	8.76	
	B1	13.86	
	B2	1.18	
	B3	1.18	
	L3	1.7	
A2	H1	1.924	
	H2		
	B	17.86	
	L1	1.95	
	L2	6.5

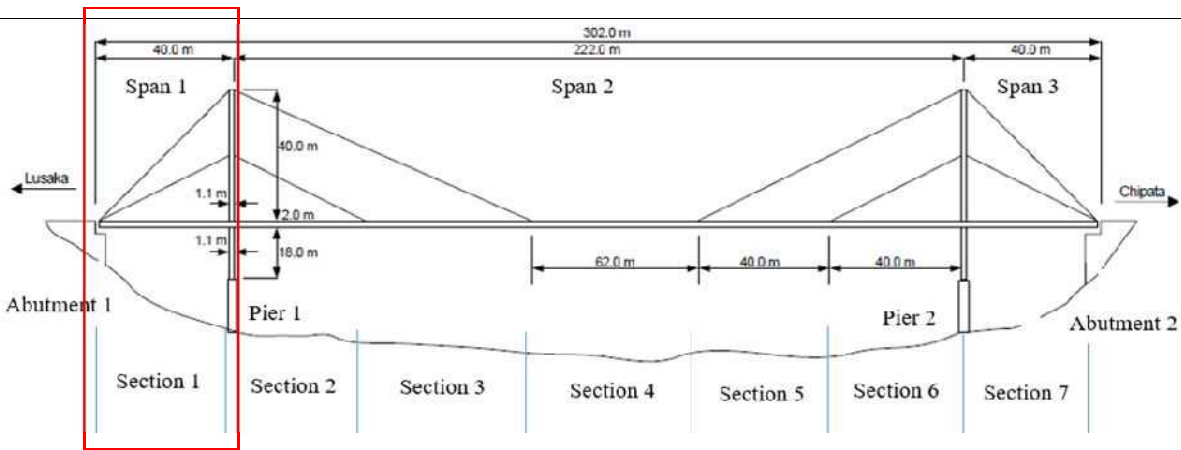
Railing and Guardrail (left side)

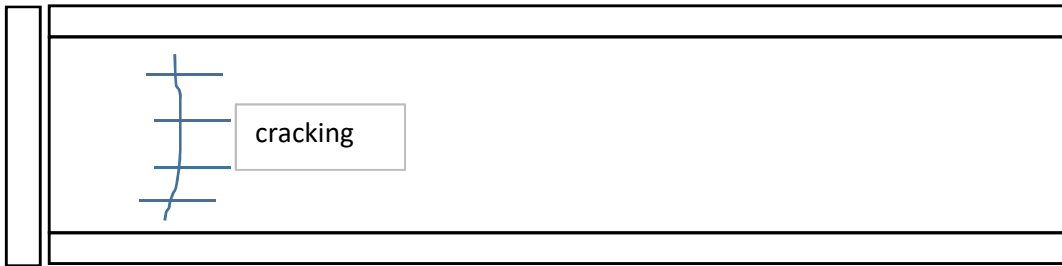
Railing and Guardrail (right side)

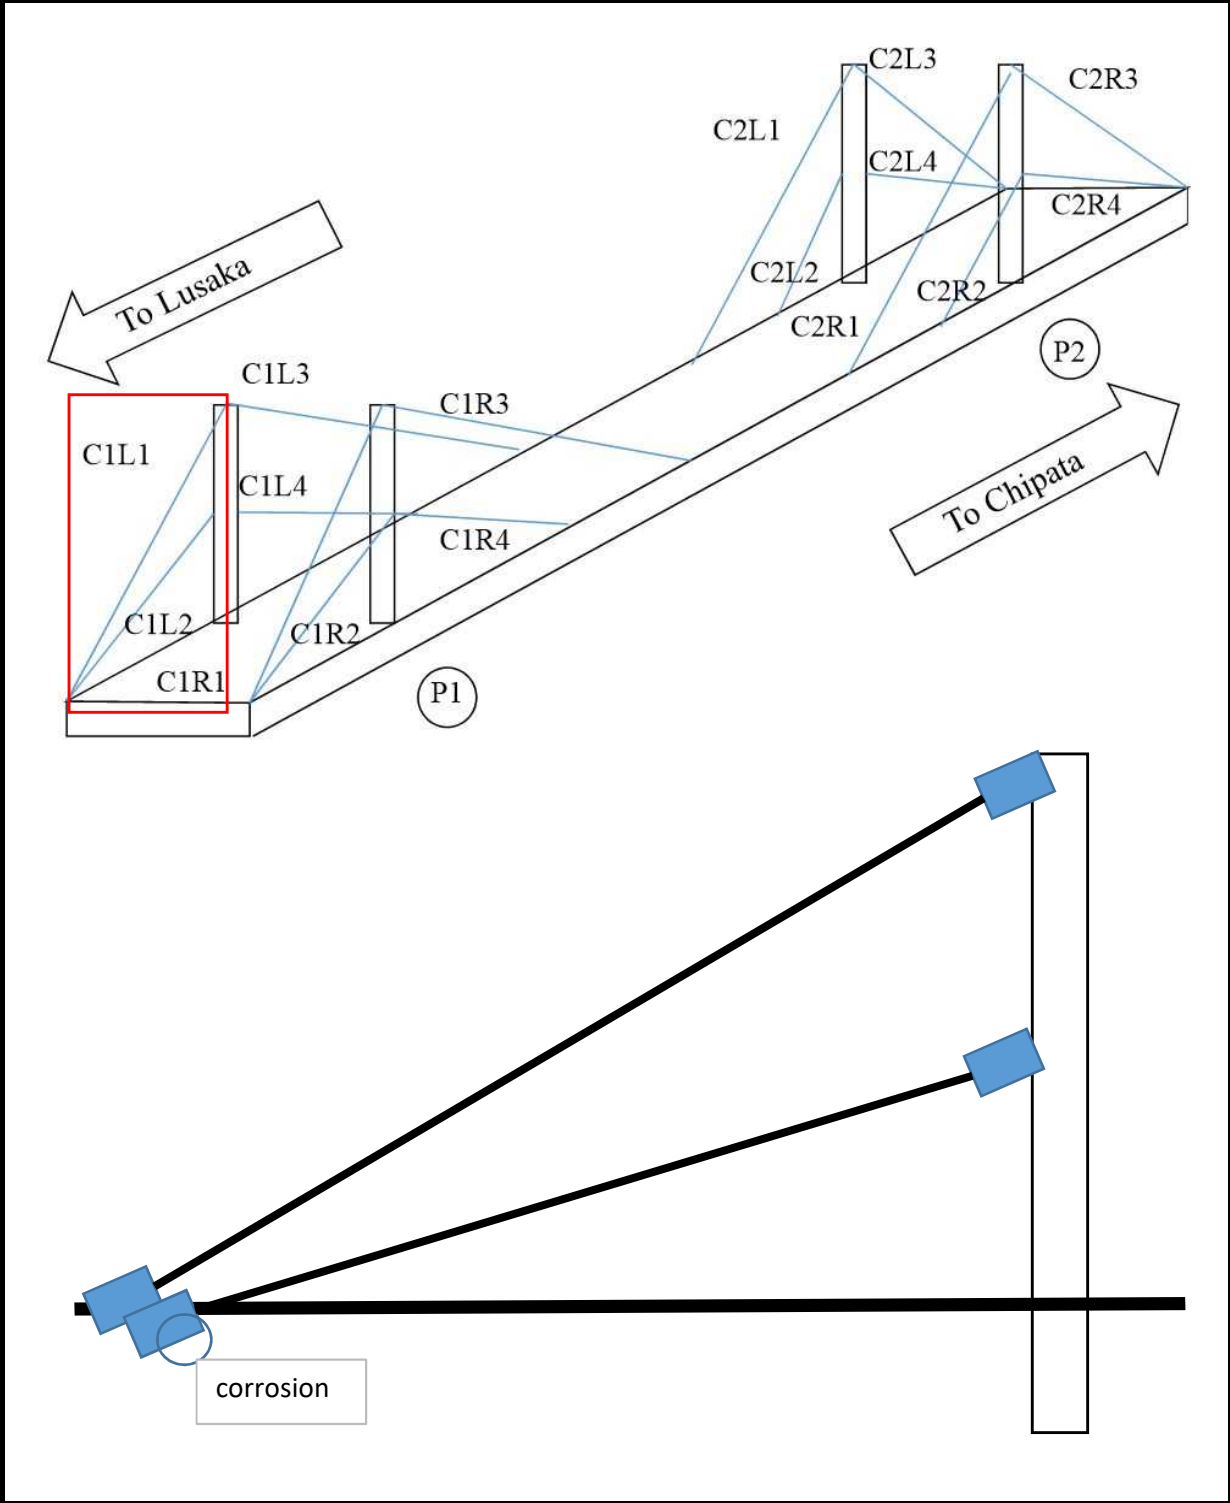
Bridge Number	Cable	C1L1	C1L2
---------------	-------	------	------

【Damage Drawing】

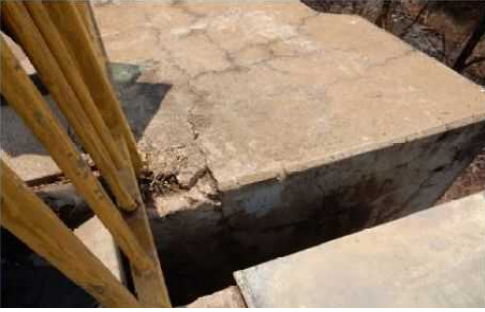
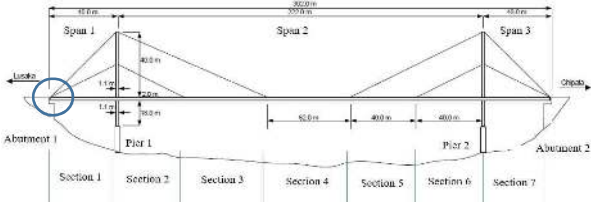
Comment cracks are observed on the top surface of western side A1

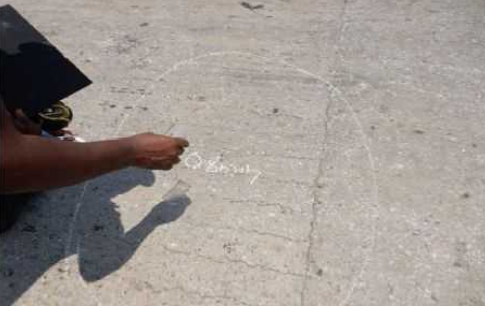
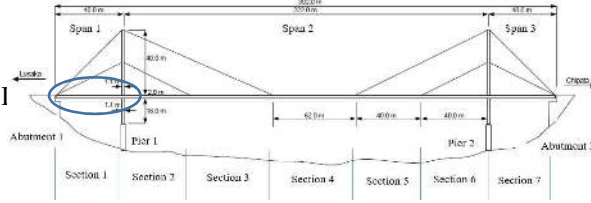
Comment Many cracks are observed on the top surface of deck slab

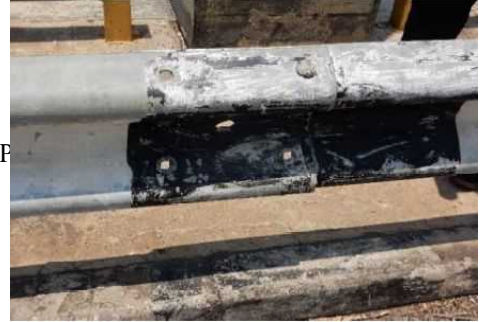
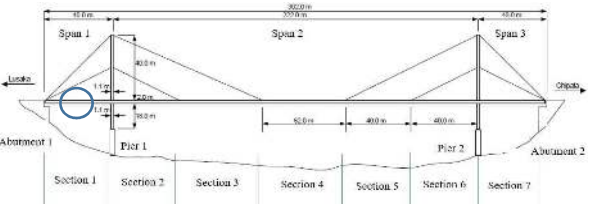
Comment Missing bolts on right guardrail

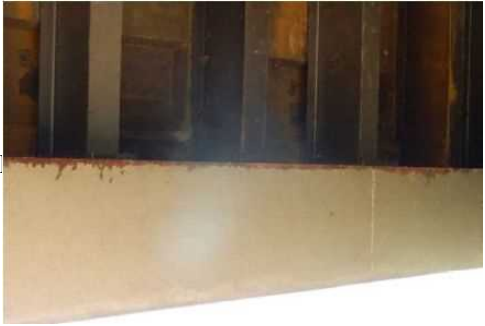
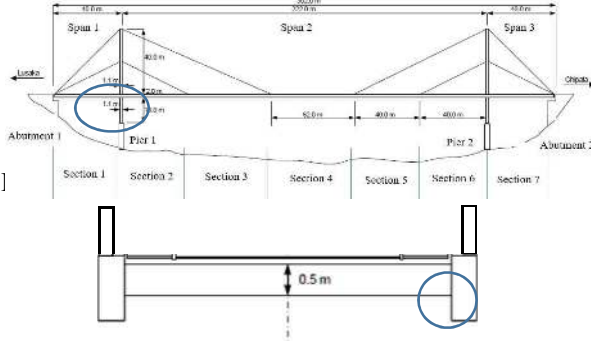
Comment Corrosion is observed at the edge of lower flange on the main girder

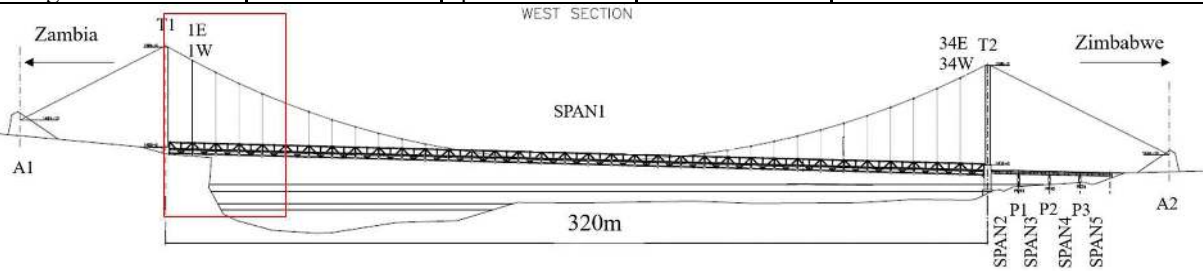
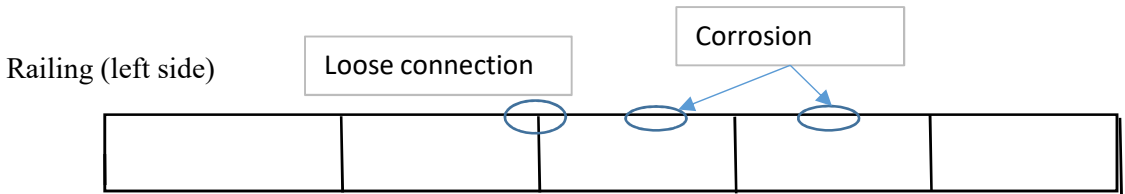
Bridge Number _____ Span **1** Section **1**

Expansion Joint and Deck Concrete

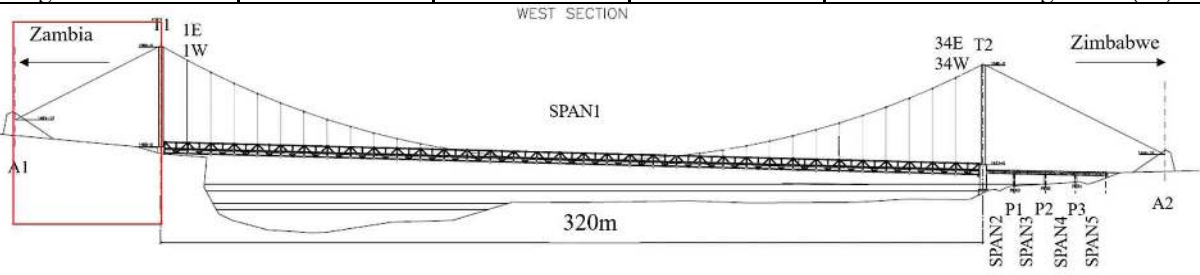
Bridge Number _____ Cable _____ Main cable _____ right side (W)

Delamination

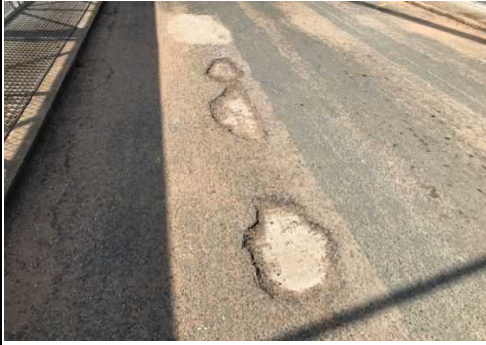
Comment big potholes are observed on the top surface near Zambian side

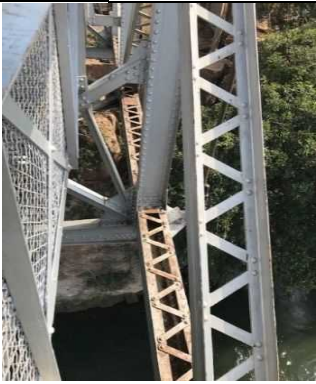
Comment Corrosion are observed on the bottom steel girder at east side

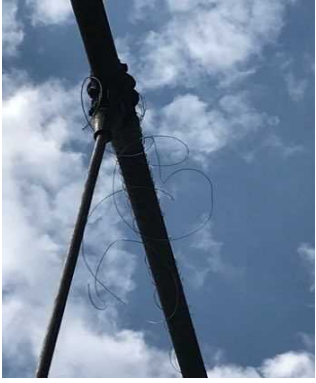
Comment Cable rapping is delaminated in E29

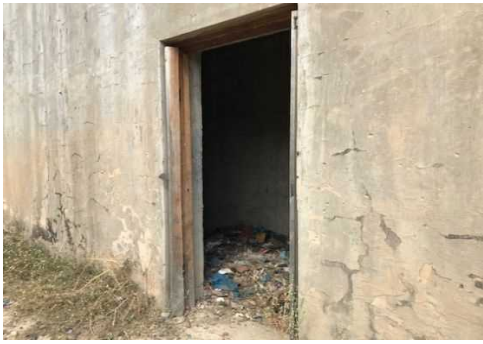
Comment There is no door at the Anchorage at Zimbabwe side and much trash scattered in the anchorage.

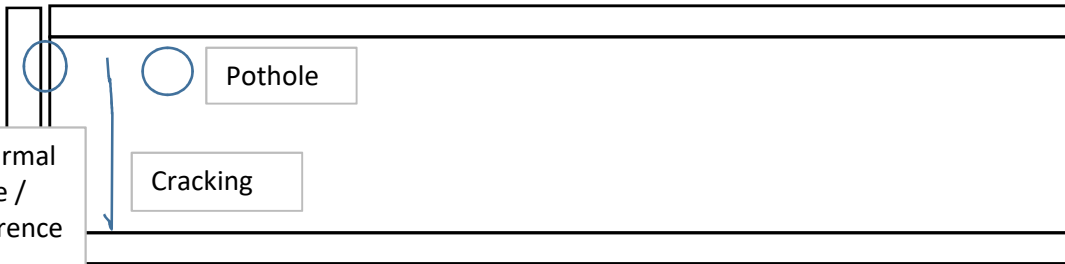
Expansion Joint and Deck Concrete

Abnormal Space / Difference in

Railing (right side)

Corrosion

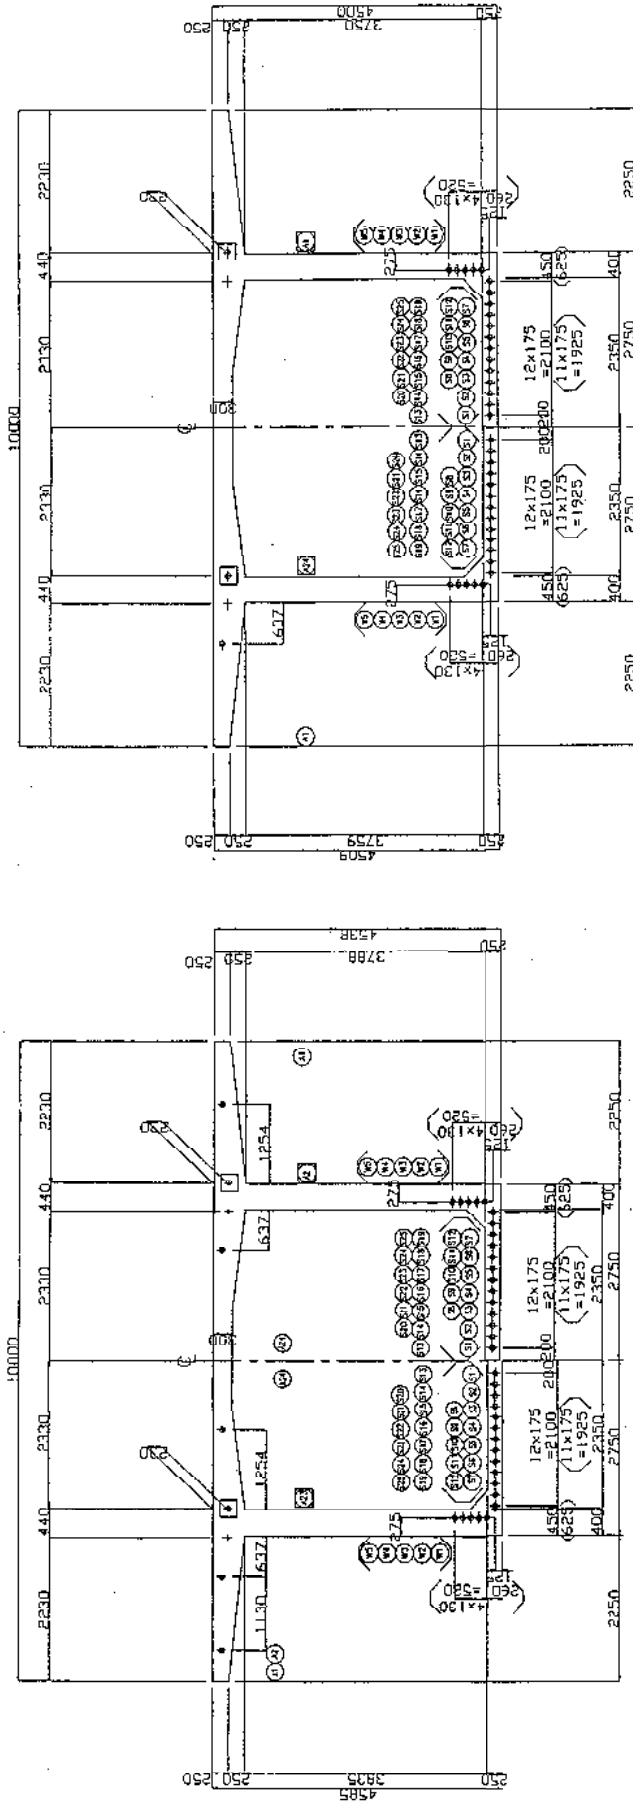
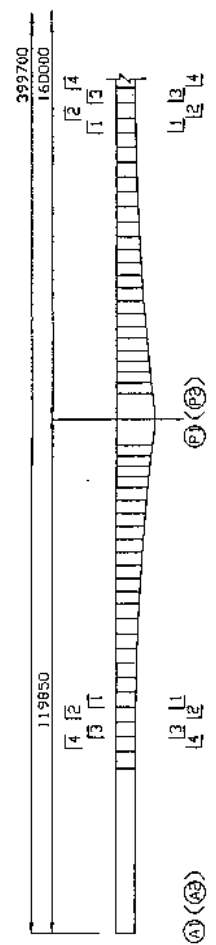
DATE	11/19/85	ASSOCIATED ENGINEERS	DESIGN
BY		APPROVED	
CHECKED		DATE	
THE REPUBLIC OF ZAMBIA MINISTRY OF WATER AND POWER THE REPUBLIC OF ZAMBIA PROJECT OF ZAMBIA CIVIL ENGINEERING			
PRESTRESSING CABLES ARRANGEMENT SECTION (9)			45
DATE			11/19/85
PAGE			11

SEC 3-3
④① ④②

SEC 4-4
④① ④②

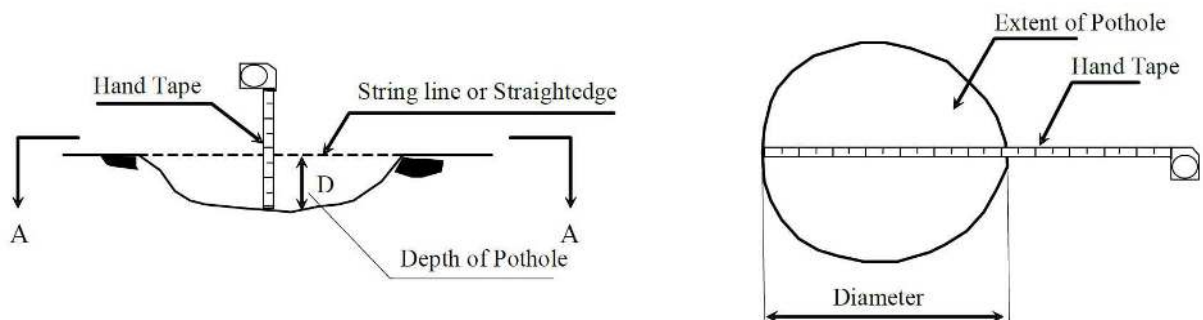
2.1 Potholes

Potholes are bowl-shaped holes in the pavement caused by the penetration of water through the pavement due to heavy rains and breaking up of the pavement due to subsequent traffic action. Pavements already deteriorated with defects such as alligator cracking and raveling are prone to the occurrence of potholes.

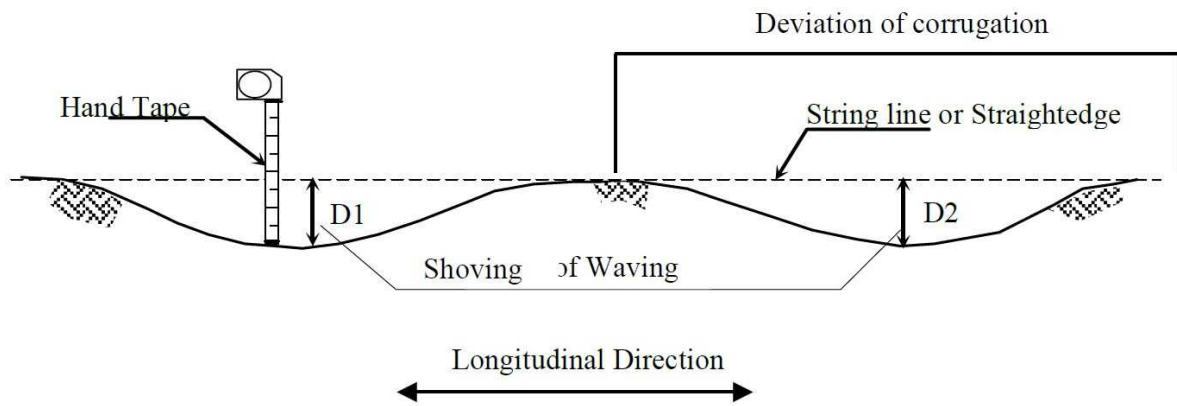
2.2 Shoving

Shoving is defined as the unevenness of the roughness on the carriageway surface along the longitudinal of the road. This deformation, as it progresses, will lead to an increasingly severe impact loading under traffic, particularly at joints. It is usually the result of the combined effects of traffic and warm weather. Blisters are found in the surface during warm weather while traffic normally prevents them from rising.

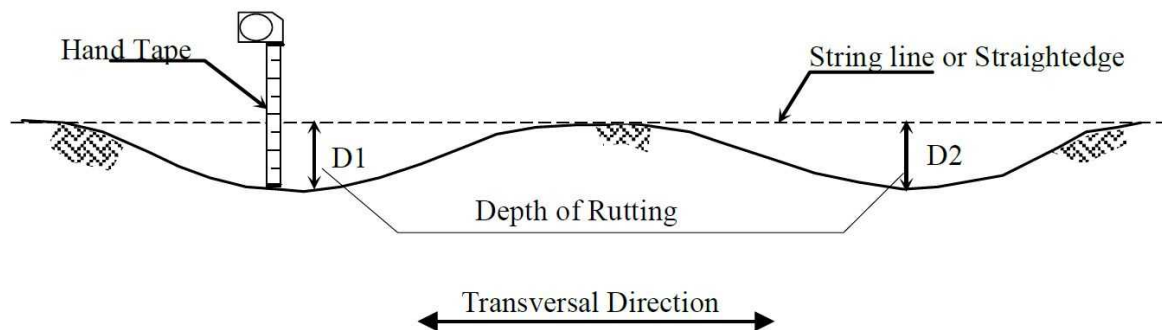
2.3 Rutting

Rutting is defined as the unevenness on the carriageway surface in the transverse direction of the road. This deformation is caused by continuous heavy wheel loads passing along the carriageway in the longitudinal direction.

Rutting progresses rapidly in warm weather and does indicate failure of the surfacing materials. The main effect is that it prevents water to drain from the carriageway and in some severe cases, prevent vehicles from leaving the rut affected depressed areas, causing a temporary loss of control on the vehicle. In some instances, the combined effect with rain makes breaking extremely difficult with a strong possibility of the vehicle aquaplaning.

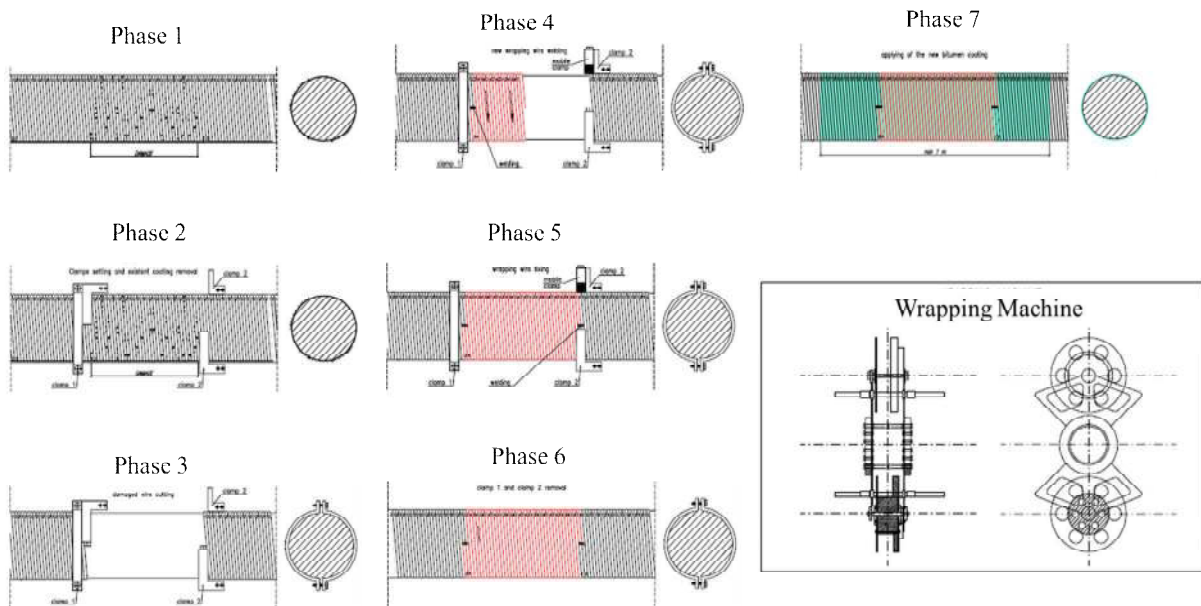
Figure G-1 the repair phase in main cable (proposed plan)

2 cables with parallel wires is adopted in a main cable of Otto Beit Bridge. Wires are covered by wrapping. Main cable was inspected in 2016 and repair plan was proposed shown in Figure G-1.
