BRIDGE MAINTENANCE CAPACITY BUILDING IN ZAMBIA

BRIDGE INSPECTION GUIDEBOOK

2024

**Road Development Agency
Japan International Cooperation Agency**

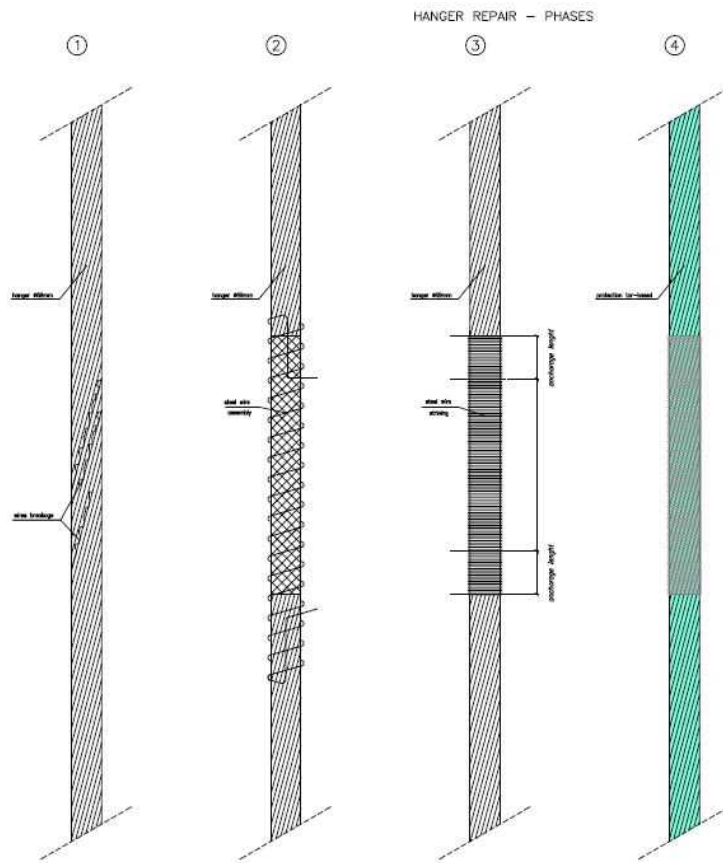
Figure G-2 the repair phase in Hanger rope (proposed plan)

Spiral strands is adopted in a hanger rope of Otto Beit Bridge. Wires are galvanized for the protection against corrosion. Hanger rope was also inspected in 2016 and repair plan was proposed shown in Figure G-2.
